Underwater Inspection Blackwater River Pump House & Pipeline

City of Norfolk
April 07, 2010

Project Description

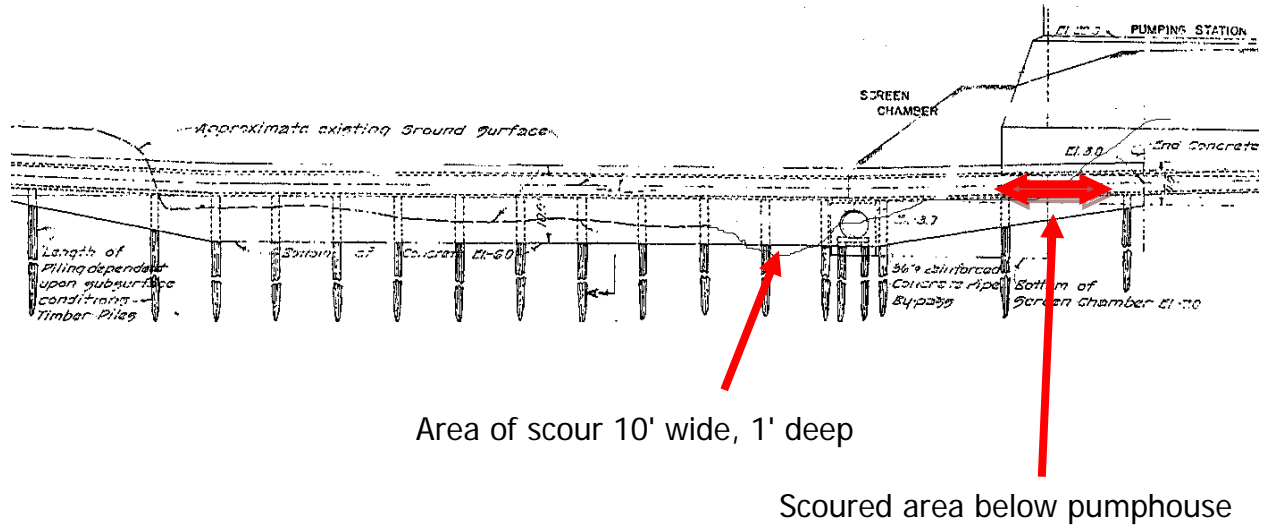
Profile View of Pump House / Pipeline

- Diver found the 30" RCP pipeline to be in good condition with a large amount of debris located against the north or upstream side. Only one area of scouring was found and that was located toward the east side of the pipeline, running from 5 feet west of the 36" pipeline to 15 feet west of the pipeline. At the deepest part of the scoured area there was a one foot deep area that ran completely across the underside of the pipeline (north to south) tapering to zero on both sides. Due to the large amount of debris, diver was unable to determine if any of the wood support piles were exposed in this area. **Note:** From the corner of the 30" and 36" pipeline intersection out to the scoured area there were what seemed to be concrete bags pyramided against the pipeline, likely indicating a prior scour area that was repaired.

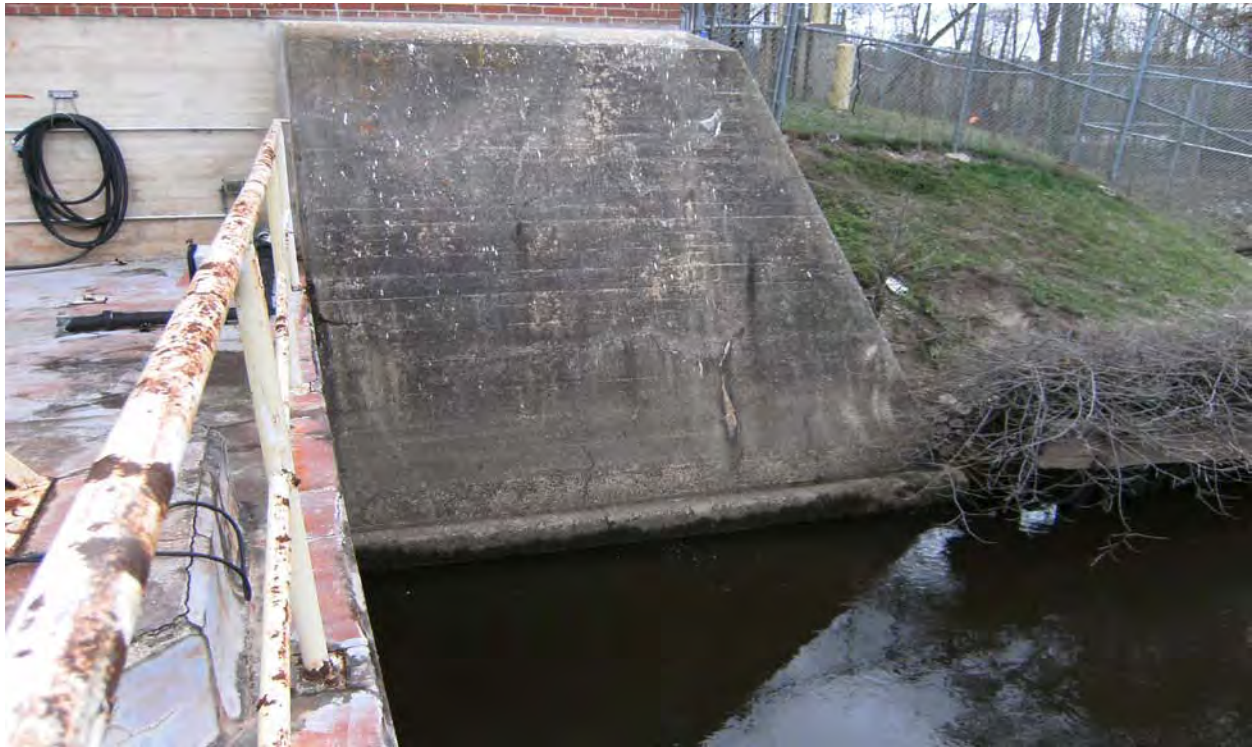
- At the south end of the pump house along the west face, the diver discovered a large area of scour beneath the pumphouse itself. This area ran from the 2 by 6 bulkhead located 2 feet off the screen chamber to the southern most point of the pumphouse. It ran approximately ten feet under the pumphouse flooring with a maximum depth of five feet at the bulkhead and tapering to zero ten feet in. Diver was physically able to feel two of the exposed wood piles in this area and found them to be free of damage. Using a probe he was able to feel three additional exposed piling in this scoured area.

View of west face, south end above the scoured area.

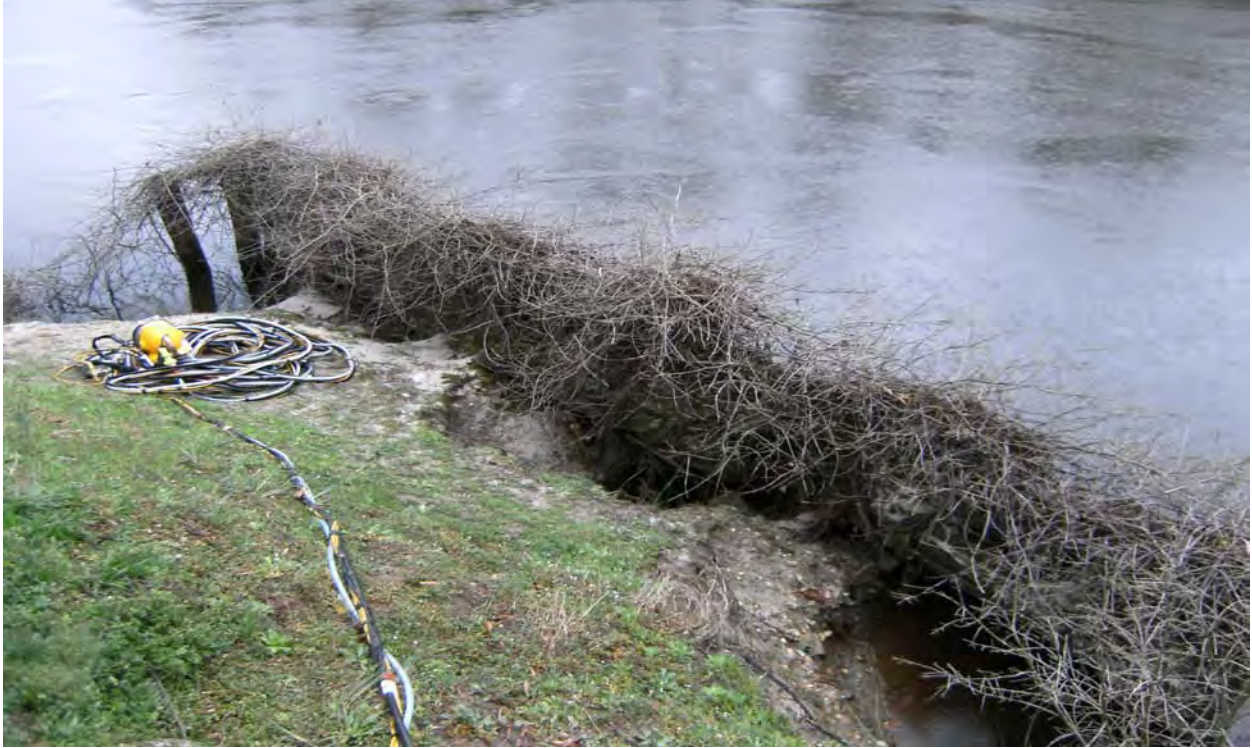
Southern piling bulkhead on east side of river. Note loss of bank behind bulkhead.

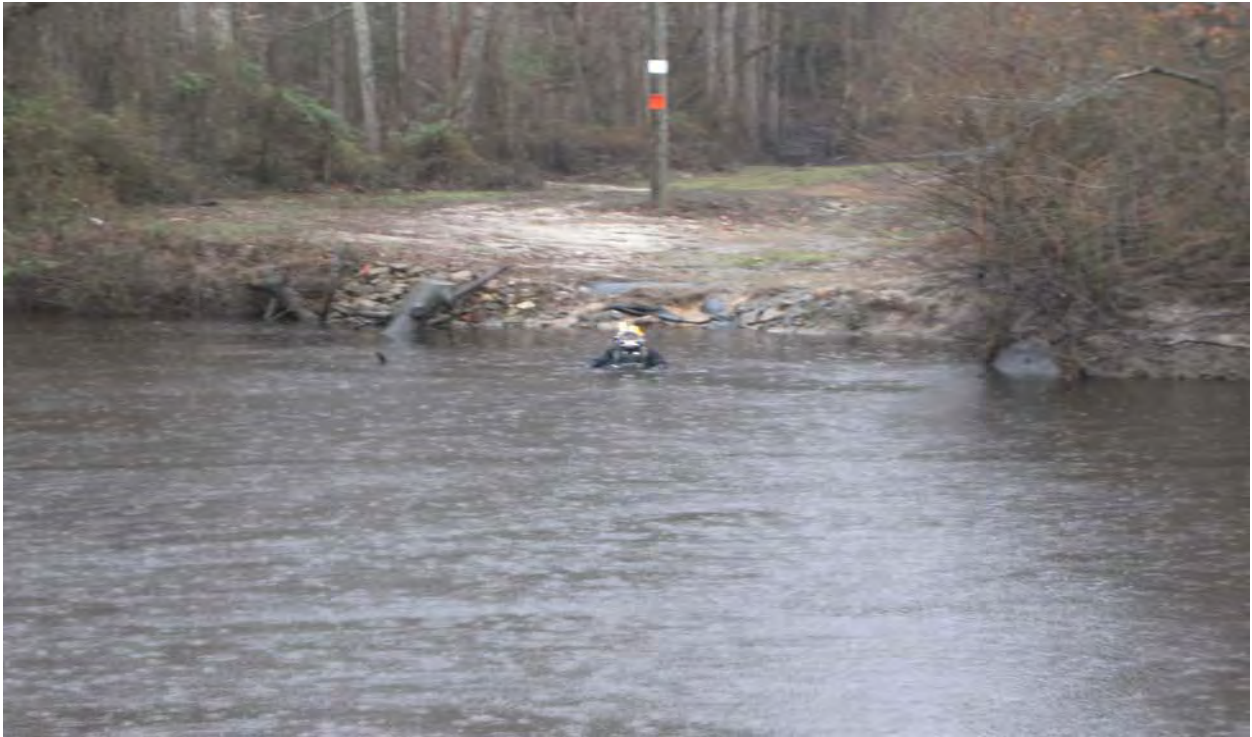
Diver standing on 30" pipeline at the west bank of the river.
