## Chrysler Museum Culvert Inspection

City of Norfolk  
Public Works Department

*November 1, 2013*

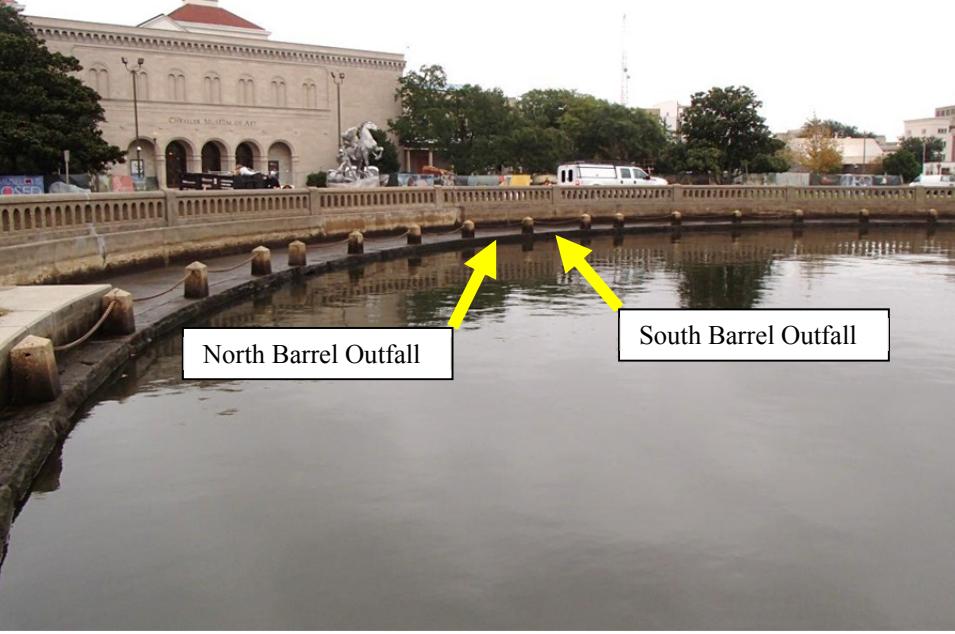
<p><b>Photo No.: 1</b></p> <p><b>Location:</b> Looking east at North and South Barrel outfalls that flow into Smith Creek on the southwest side of the Chrysler Museum</p>
	<p><b>Description:</b> Outfall locations for 72" diameter circular concrete barrels</p>
<p><b>No Action</b></p>

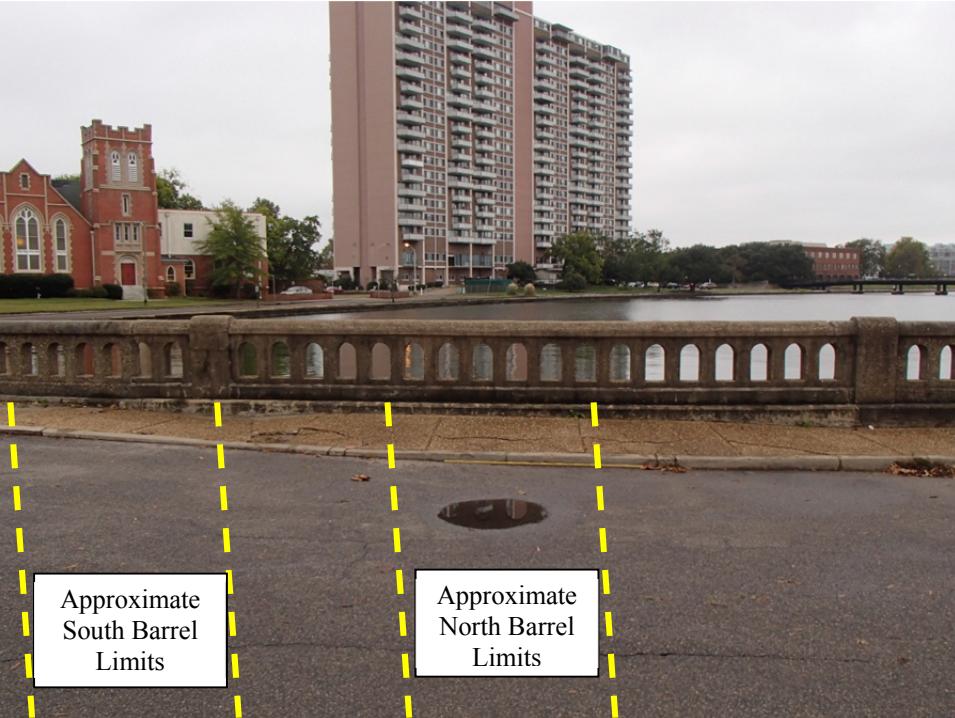
<p><b>Photo No.: 2</b></p> <p><b>Location:</b> Looking southwest at street level over North and South Barrels</p> <p><b>Description:</b> Outfall locations for 72" diameter circular concrete barrels</p>
	<p><b>No Action</b></p>

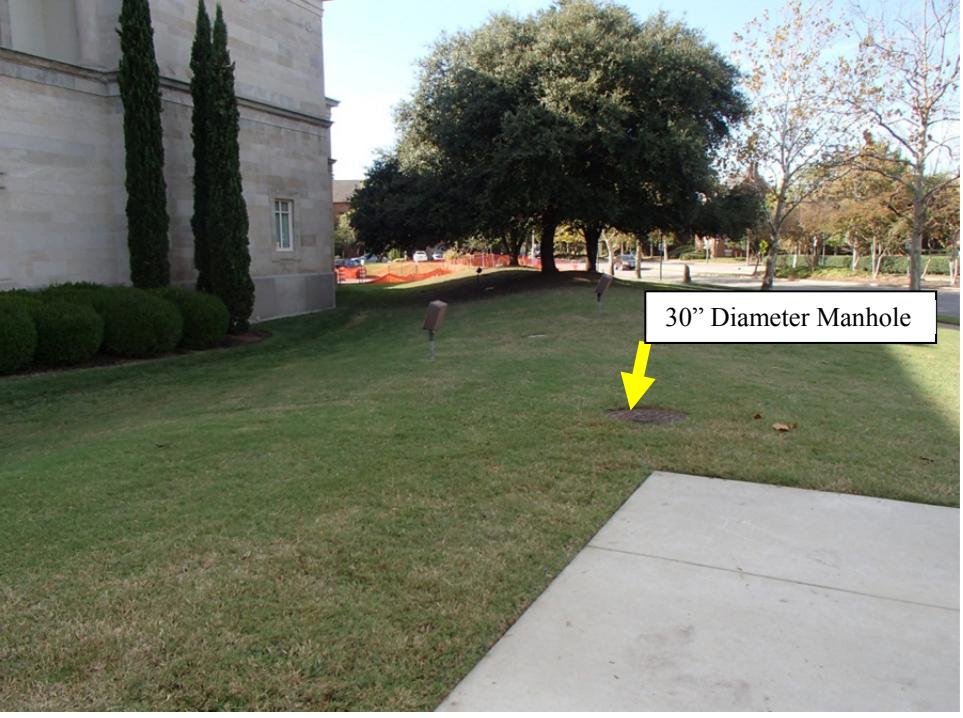
<p><b>Photo No.:</b> 7</p> <p><b>Location:</b> Looking northwest at 30" diameter manhole located on the lawn on the northeast side of the Chrysler Museum</p>

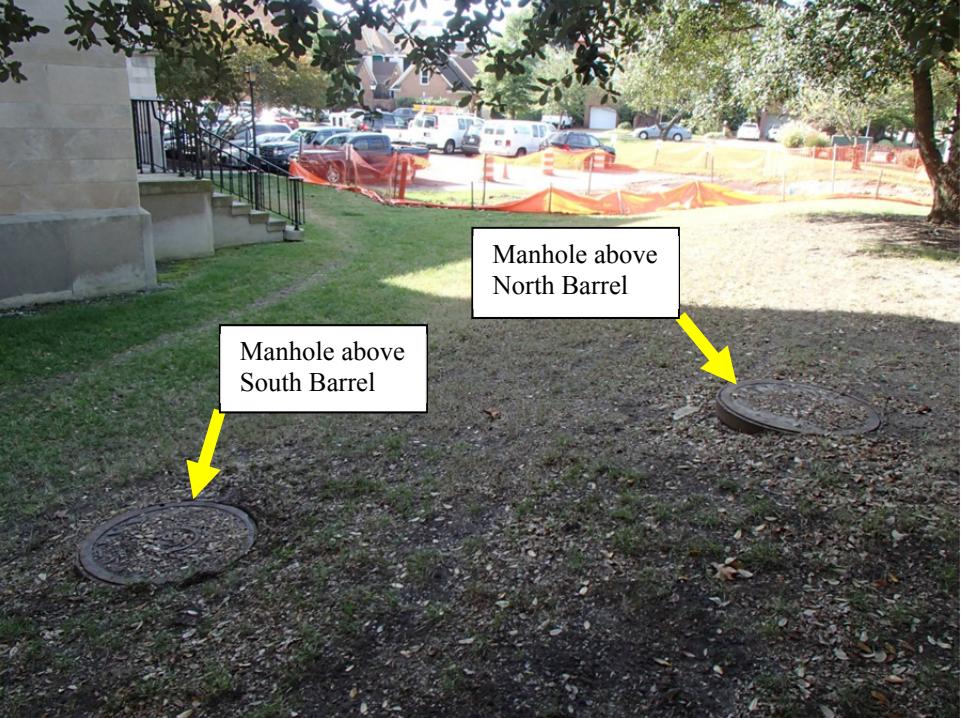
<p><b>Description:</b> 30" diameter manhole used to access underground concrete junction box below</p> <p><b>No Action</b></p> <p><b>Photo No.:</b> 8</p> <p><b>Location:</b> Looking west at 30" diameter manholes located on the lawn on the north side of the Chrysler Museum at STA 5+20</p> <p><b>Description:</b> Manholes used to access North and South Barrels</p> <p><b>No Action</b></p>

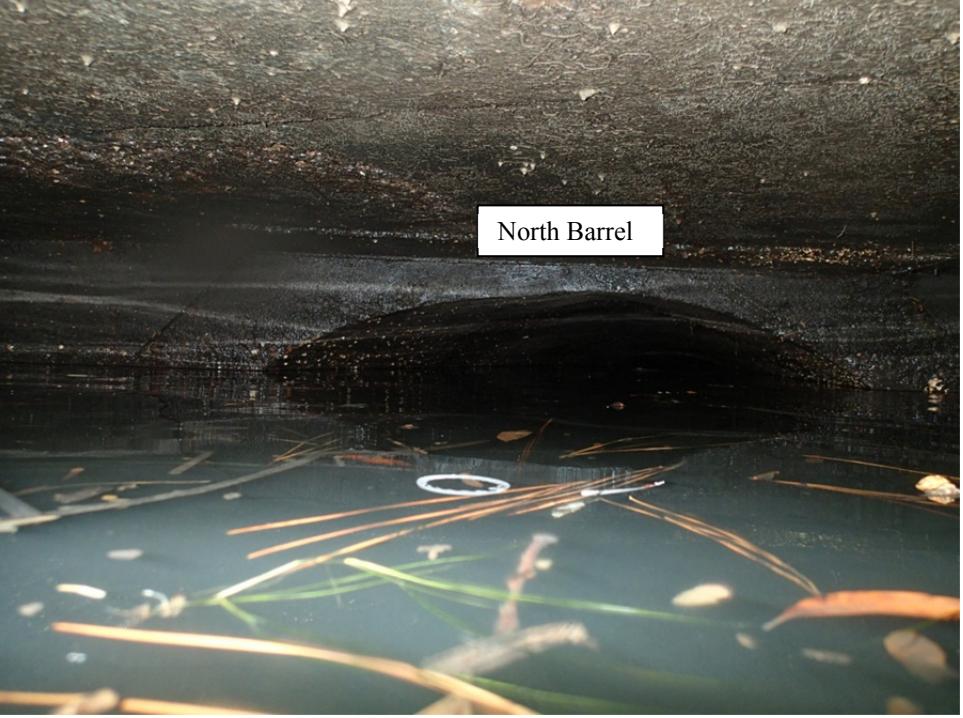
<p>North Barrel</p>	<p><b>Photo No.:</b> 9</p> <p><b>Location:</b> Looking west (downstream) at North Barrel entrance from underground concrete junction box at STA 6+06 N</p>

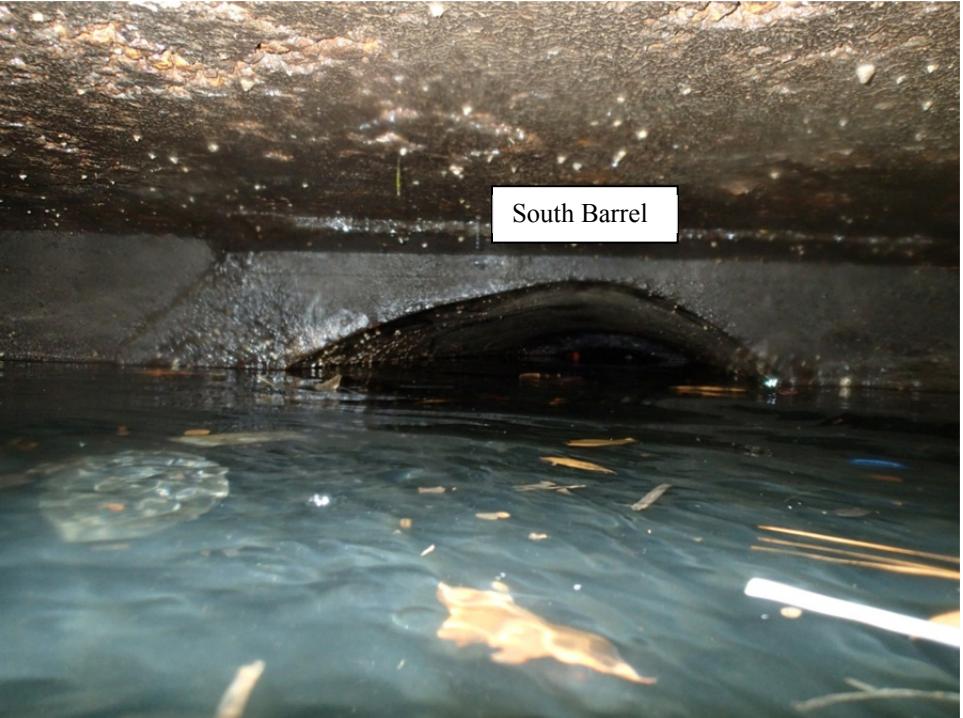
<p>South Barrel</p>	<p><b>No Action</b></p> <p><b>Photo No.:</b> 10</p> <p><b>Location:</b> Looking west (downstream) at South Barrel entrance from underground concrete junction box at STA 6+06 S</p>
	<p><b>Description:</b> South Barrel entrance from underground junction box</p> <p><b>No Action</b></p>

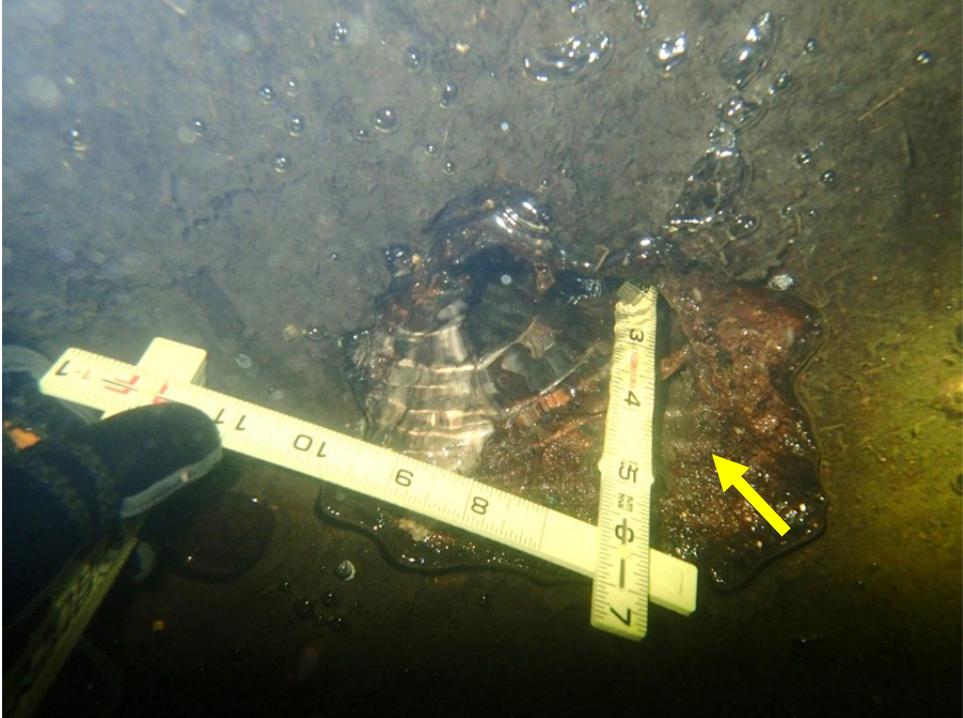
<p><b>Photo No.: 11</b></p> <p><b>Location:</b> South Barrel at STA 4+95 S</p> <p><b>Description:</b> Typical 5" diameter hole in top of barrel at midspan. Hole is sealed on exterior of pipe and appeared to have been used for installation purposes. No signs of additional sediment.</p> <p><b>No Action</b></p>

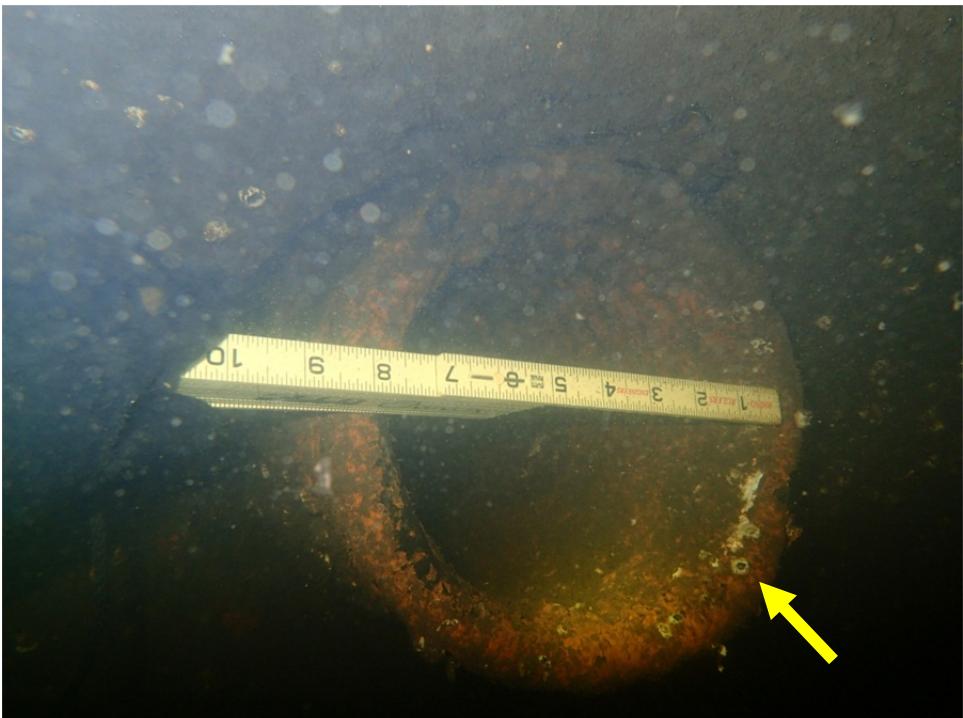
<p><b>Photo No.: 12</b></p> <p><b>Location:</b> Looking south in South Barrel at STA 5+05 S</p> <p><b>Description:</b> 8" diameter lateral ductile iron pipe that penetrates wall in South Barrel</p> <p><b>No Action</b></p>

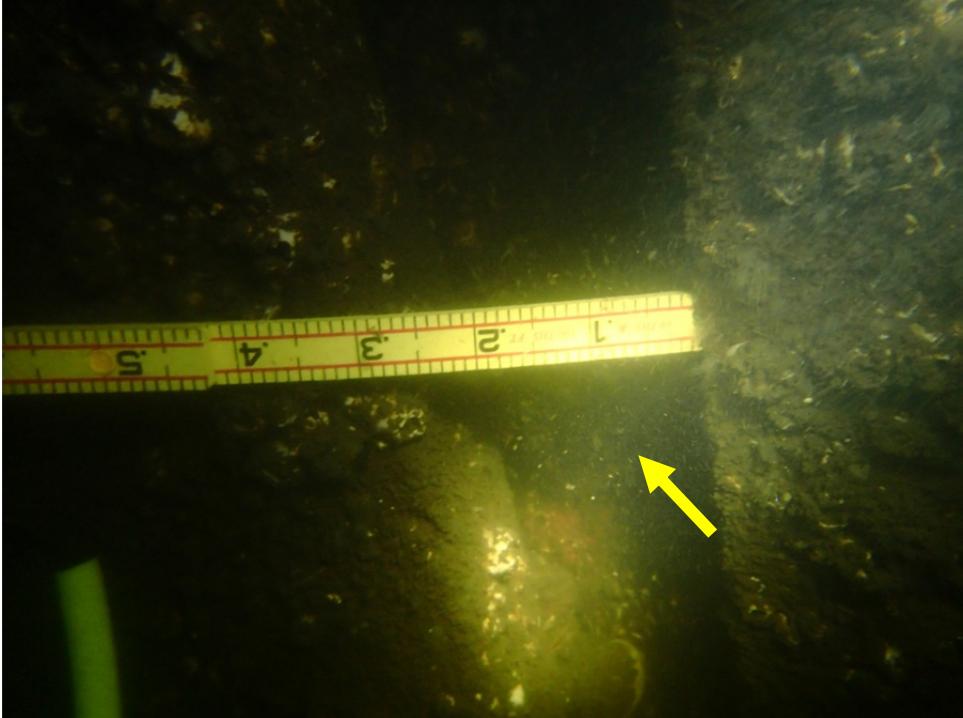
- Defect S2: Repair of a pipe joint in the South Barrel at STA 0+16 S, shown in Photo No. 13 in Appendix A. There is a 4" gap between the pipes at the joint location. Penetration up to 3" was achieved in the gap. The gap between the pipes at this joint has allowed soil to infiltrate

resulting in a void adjacent to and above the barrel. Evidence of this settlement can be seen from the topside where excessive settlement and cracking was noted in the sidewalk and a 2'-6" diameter x 1" deep sinkhole was noted in the roadway adjacent to the sidewalk. The topside deficiencies are shown in Photo Nos. 4 through 6 in Appendix A.

<p><b>Photo No.: 13</b></p> <p><b>Location:</b> South Barrel at STA 0+16 S</p> <p><b>Description:</b> Defect S2: 4" gap between pipes at joint. Penetration up to 3" was achieved in gap. Gap has allowed soil to infiltrate. Evidence of loss of soil on topside in Photo 4-6.</p> <p><b>Priority Repair</b></p>

- Install Internal Joint Seal with Pipe Grout	1	EA	\$2,500.00		\$2,500
<i>South Barrel Defect S2 - Station 0+16 S</i>					
<i>Option 1:</i>					
- Install Internal Joint Seal with Pipe Grout	1	EA	\$2,500.00		\$2,500
<i>South Barrel Defect S22 - Station 5+98 S</i>					
<i>Option 1:</i>

- Pavement	4	Tons	\$95.00		\$344
- New Sidewalk	75	SF	\$4.00		\$300
- New Curb & Gutter	15	LF	\$28.00		\$420
<i>South Barrel Defect S2 - Station 0+16 S</i>					
<i>Option 2:</i>

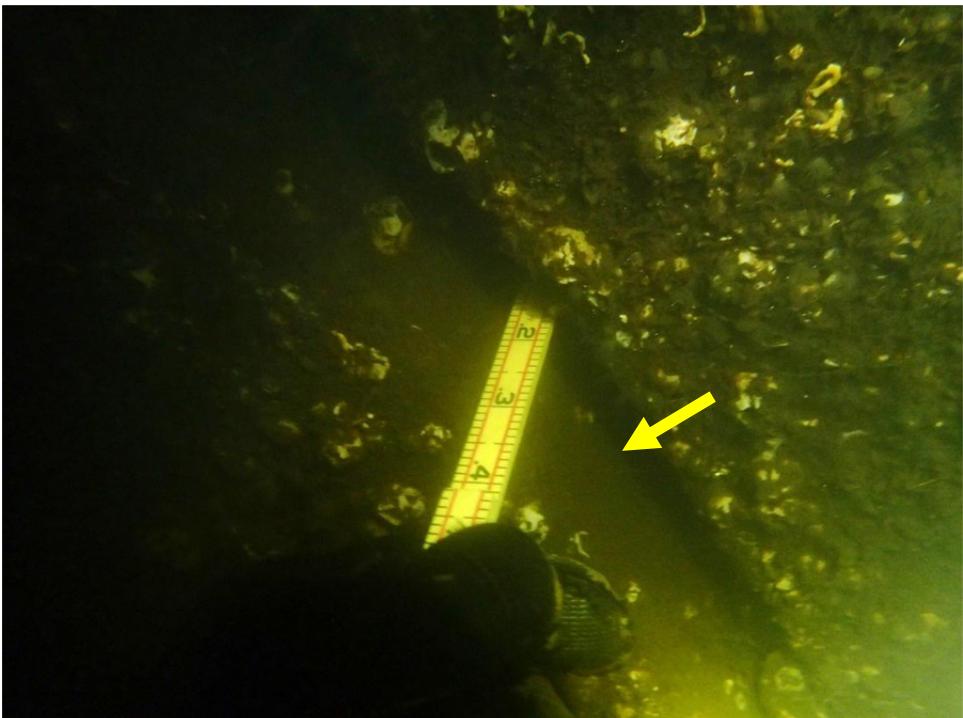
<p><b>Photo No.: 14</b></p> <p><b>Location:</b> South Barrel at STA 0+32 S</p> <p><b>Description:</b> Defect S4: 1-1/2" gap between pipes at joint. Downstream pipe invert at joint is 1" lower than the upstream invert (not shown in photo).</p> <p><b>Routine Repair</b></p>

- Install Internal Joint Seal with Pipe Grout	1	EA	\$2,500.00	\$2,500
<b>South Barrel Defect S3 - Station 0+24 S</b>				
- Install Internal Joint Seal with Pipe Grout	1	EA	\$2,500.00	\$2,500
<b>South Barrel Defect S4 - Station 0+32 S</b>

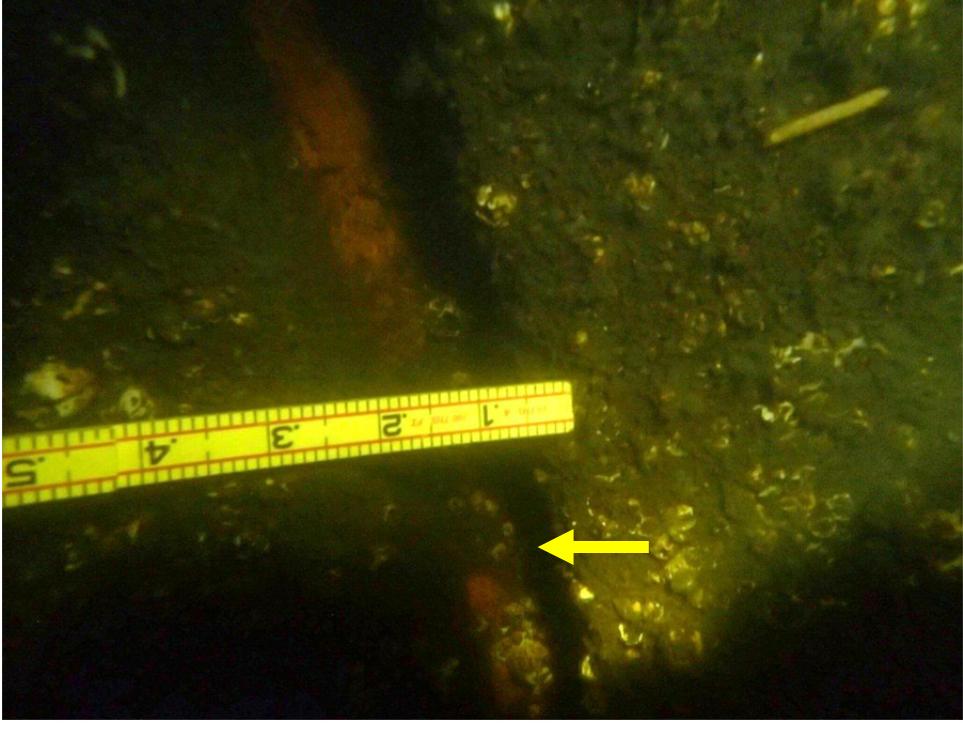
A photograph taken underwater showing a joint between two pipes. A yellow tape measure is placed horizontally across the joint. A yellow arrow points to the gap between the top of the upstream pipe and the bottom of the downstream pipe, indicating a 2-inch gap.	<p><b>Photo No.: 15</b></p> <p><b>Location:</b> South Barrel at STA 0+40 S</p> <p><b>Description:</b> Defect S5: 2" gap between pipes at top of joint. Downstream pipe invert at joint is 1" lower than upstream invert (not shown in photo).</p> <p><b>Routine Repair</b></p>

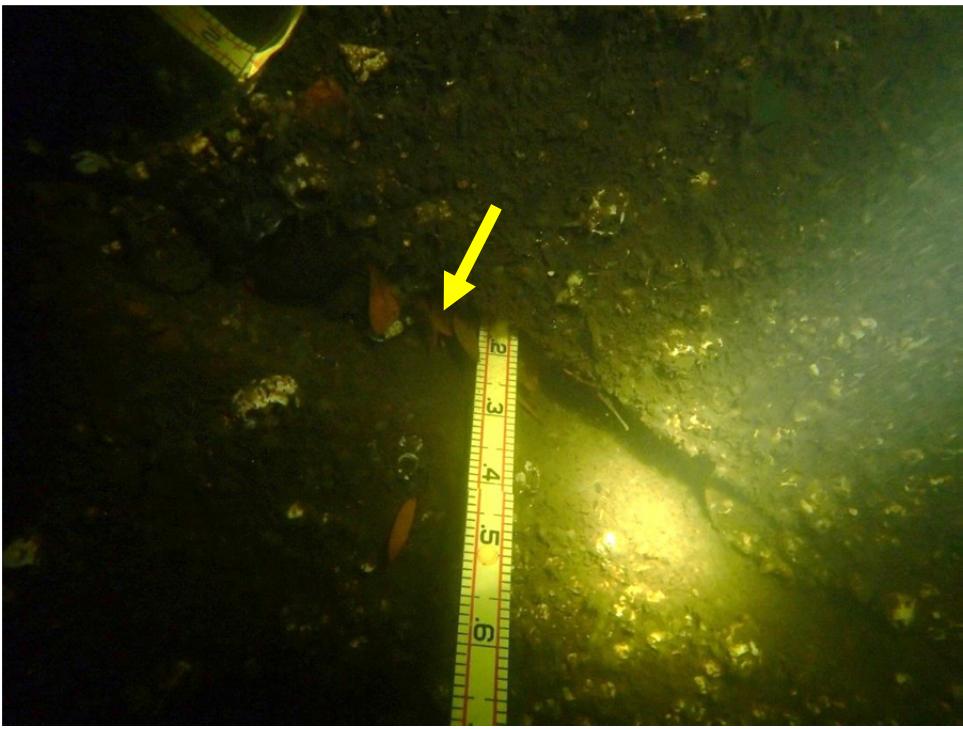
A photograph taken underwater showing a joint between two pipes. A yellow tape measure is placed vertically along the side of the upstream pipe. A yellow arrow points to the gap between the top of the upstream pipe and the bottom of the downstream pipe, indicating a 2-inch gap.	<p><b>Photo No.: 16</b></p> <p><b>Location:</b> South Barrel at STA 0+56 S</p> <p><b>Description:</b> Defect S7: 2" gap between pipes at top of joint. Downstream pipe invert at joint is 1" lower than upstream invert (not shown in photo).</p> <p><b>Routine Repair</b></p>

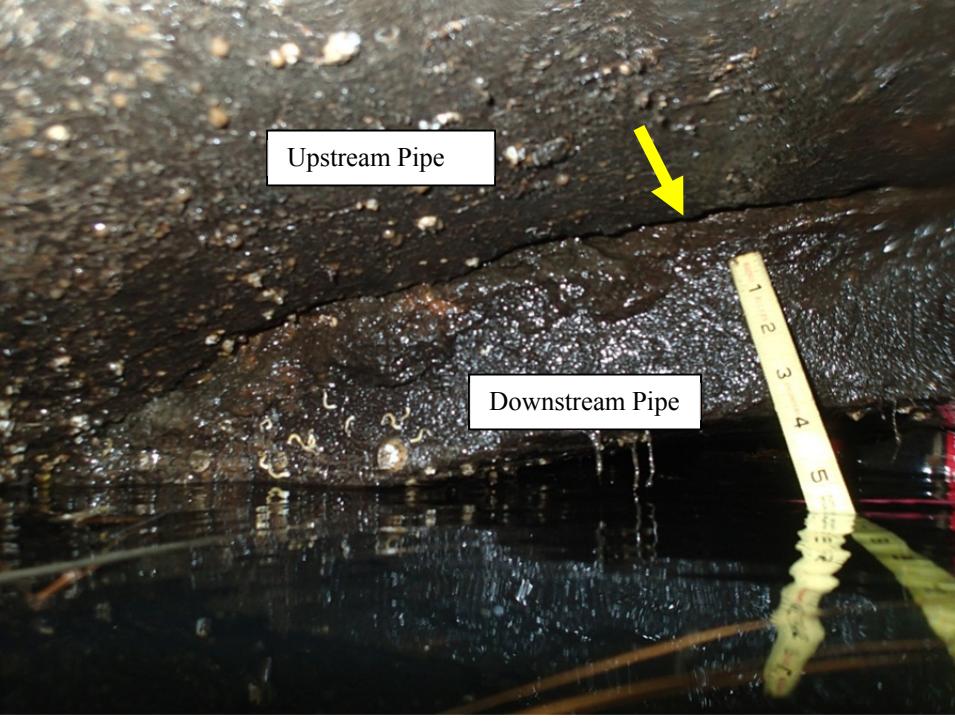
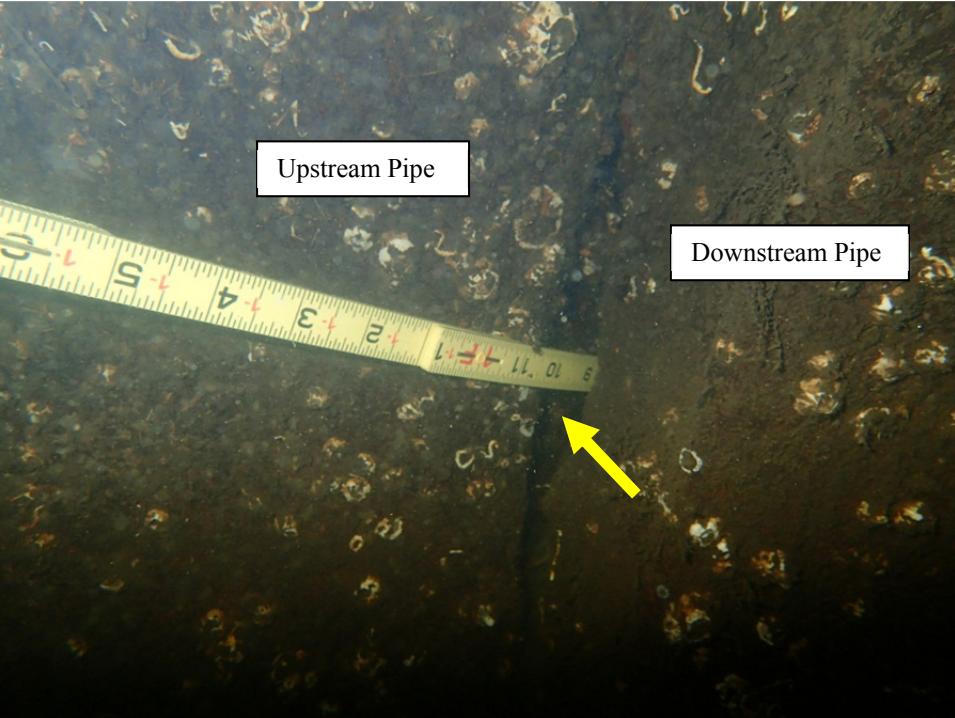
<p>Upstream Pipe</p> <p>Downstream Pipe</p>	<p><b>Photo No.: 17</b></p> <p><b>Location:</b> South Barrel at STA 5+98 S</p>

- Defect S22: Repair of a pipe joint in the South Barrel at STA 5+98 S, shown in Photo Nos. 17 through 18 in Appendix A. The downstream pipe invert at the joint is 4" lower than the upstream. Penetration up to 12" was achieved in the gap. The differential settlement of the pipes at this joint has allowed sediment to infiltrate resulting in a void adjacent to and above the barrel. No signs of a sinkhole were noted on the lawn above.

S22	5+98 S	The downstream pipe invert at the joint is 4" lower than the upstream. Penetration up to 12" was achieved in the gap. The differential settlement of the pipes at this joint has allowed soil to infiltrate, resulting in a void adjacent to and above the barrel. No signs of a sinkhole were noted on the lawn above.	<u>Option 1*:</u> Repair joint from inside of pipe by applying a joint filler or approved underwater grout.  <u>Option 2:</u> Excavate down to joint, re-set both pipes for proper alignment and re-seal joint.	17-18

<p>Upstream Pipe</p> <p>Downstream Pipe</p>	<p><b>Description:</b> Defect S22: Downstream pipe invert at joint is 4" lower than upstream invert. Differential settlement has allowed soil to infiltrate resulting in a void around culvert.</p> <p><b>Priority Repair</b></p> <p><b>Photo No.: 18</b></p> <p><b>Location:</b> South Barrel at STA 5+98 S</p> <p><b>Description:</b> Defect S22: Penetration up to 12" deep was achieved in gap at pipe joint. Differential settlement has allowed soil to infiltrate resulting in a void around culvert.</p> <p><b>Priority Repair</b></p>

- Excavation	59	CY	\$27.00		\$1,600
- Re-set Both Pipes at Joint for Proper Alignment	1	LS	\$3,000.00		\$3,000
- Install Internal Joint Seal with Pipe Grout	1	EA	\$2,000.00		\$2,000

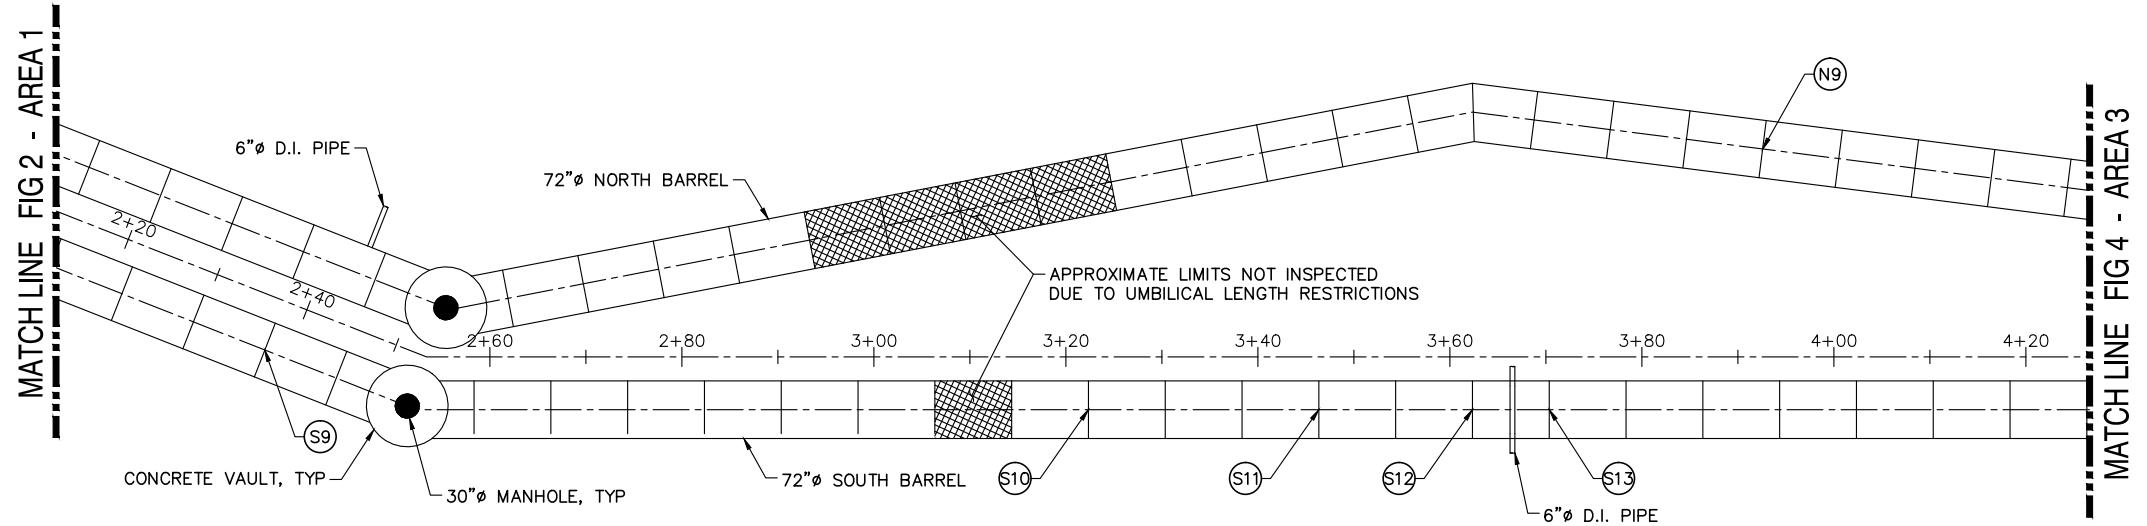
FIGURE C-3 – CULVERT PLAN VIEW – AREA 2

STATION	NOTE
3+92 N	(N9) 1/4" GAP BETWEEN PIPES AT JOINT

STATION	NOTE
2+38 S	(S9) UPSTREAM INVERT AT JOINT 1/2" LOWER THAN DOWNSTREAM
3+22 S	(S10) UPSTREAM INVERT AT JOINT 1" LOWER THAN DOWNSTREAM
3+46 S	(S11) UPSTREAM INVERT AT JOINT 1" LOWER THAN DOWNSTREAM
3+62 S	(S12) UPSTREAM INVERT AT JOINT 1-1/2" LOWER THAN DOWNSTREAM
3+70 S	(S13) UPSTREAM INVERT AT JOINT 1/2" LOWER THAN DOWNSTREAM
