# Hague Stormwater Evaluation and Improvement Concepts Report

City of Norfolk

*August 13, 2014*

moffatt & nichol

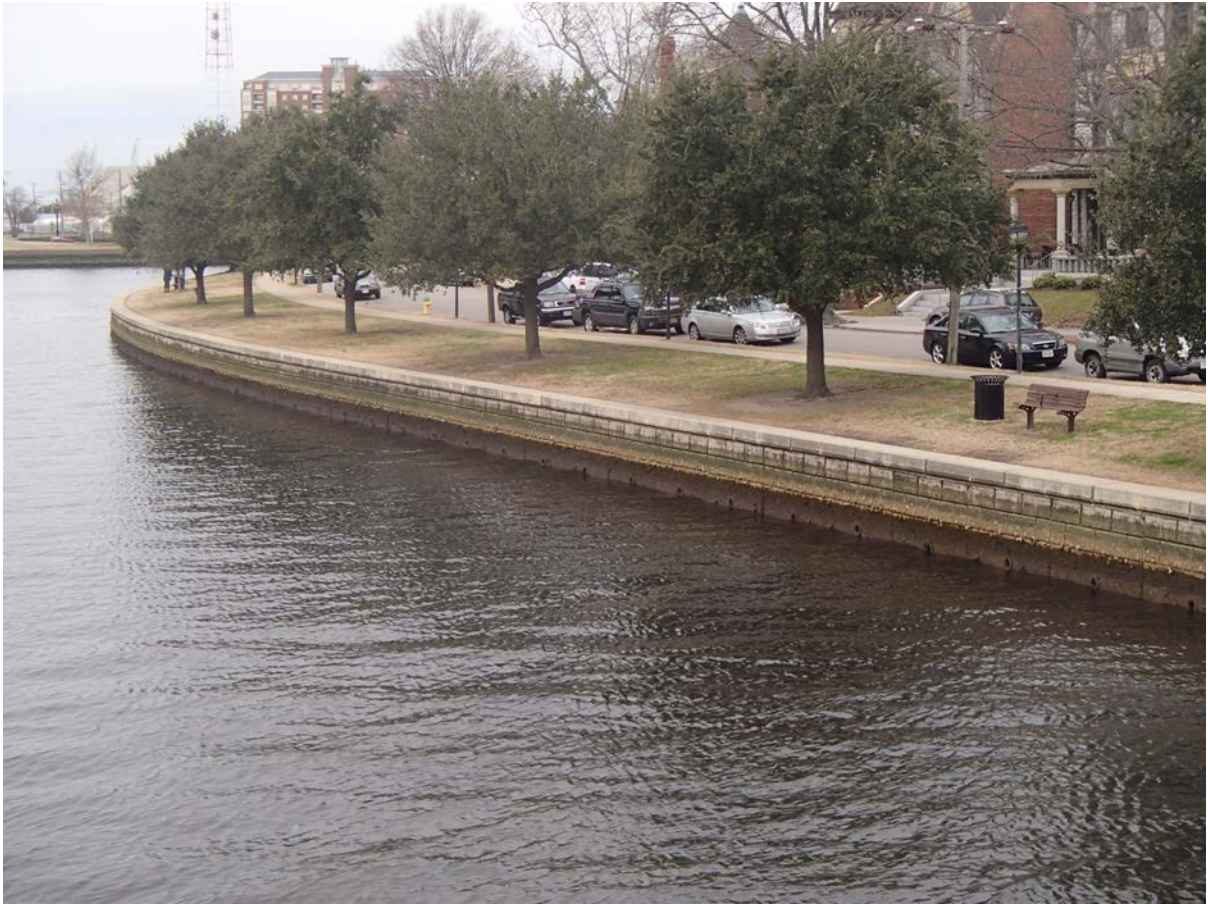
*Photo 1: Typical hardened shoreline along the Hague*

The Hague is a relatively shallow basin ranging from the mudline being exposed at low tide to -13 feet MLLW at the Brambleton Avenue Bridge. Much of the shoreline is hardened with concrete and stone bulkheads and/or relieving platforms. There is no significant wetland vegetation along the shoreline. Limited sediment sampling was completed to determine the physical and chemical characteristics of the sediments for alternatives involving dredging. In September 2013 (see Appendix C) 10 sediment core samples were taken within the Hague area. The physical characteristics indicate the bottom sediments are predominately silts and clays. Visual observations indicate material adjacent to outfalls contains some sandy material. Testing for chemical constituents in the sediments is based on protocols to determine alternatives for upland placement of dredged material. Samples for chemical testing involved compositing sediment samples into 5 groups based on areas within the Hague. Each composited sample was then tested for selected organic compounds and metals. This limited testing does indicate special handling may be required for dredged material for petroleum hydrocarbons in some areas, and is discussed in more detail below, with the data presented in Appendix C.

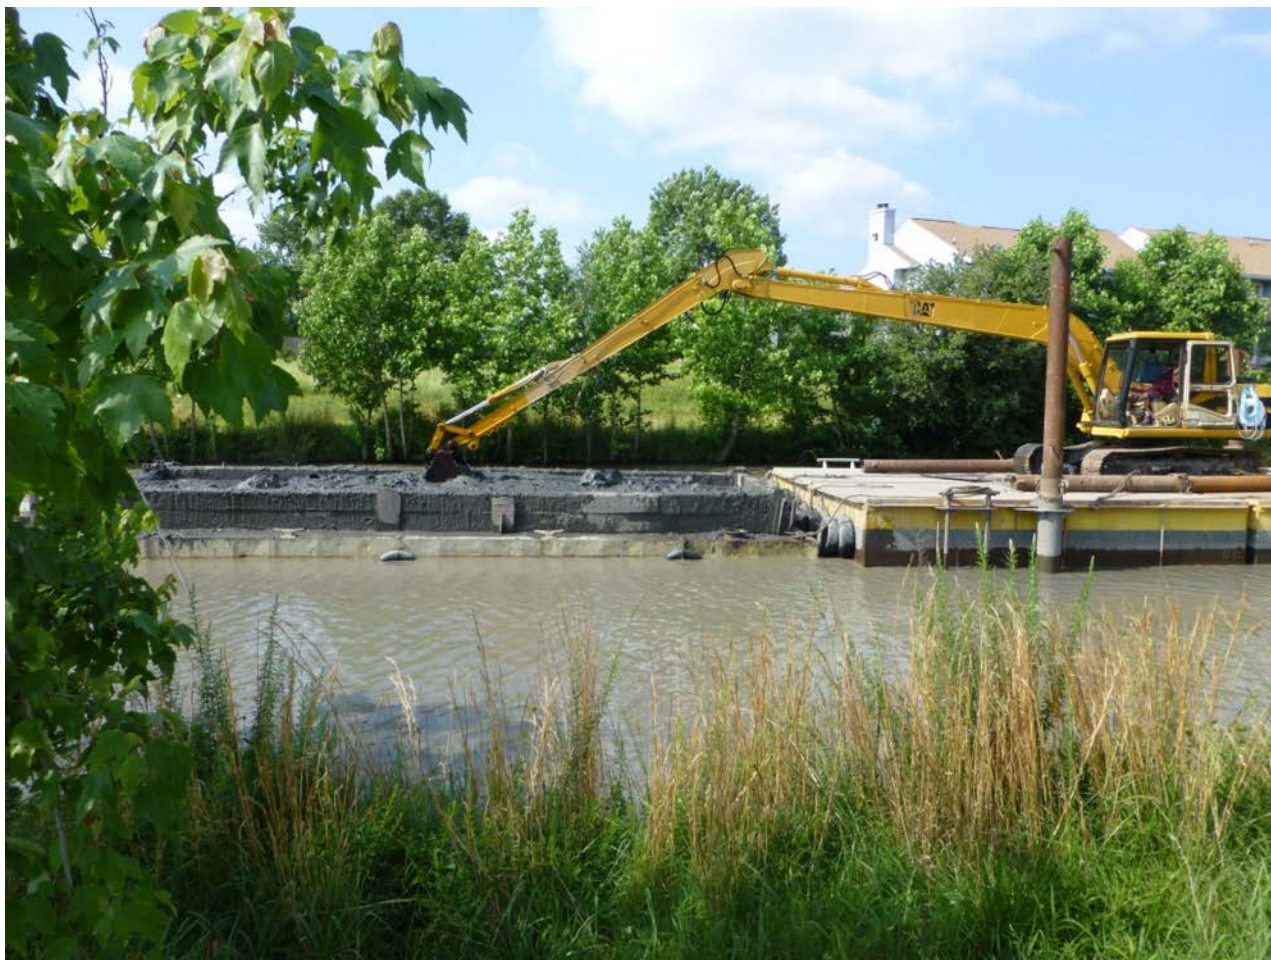
*Photo 2: Small mechanical dredging operation.*

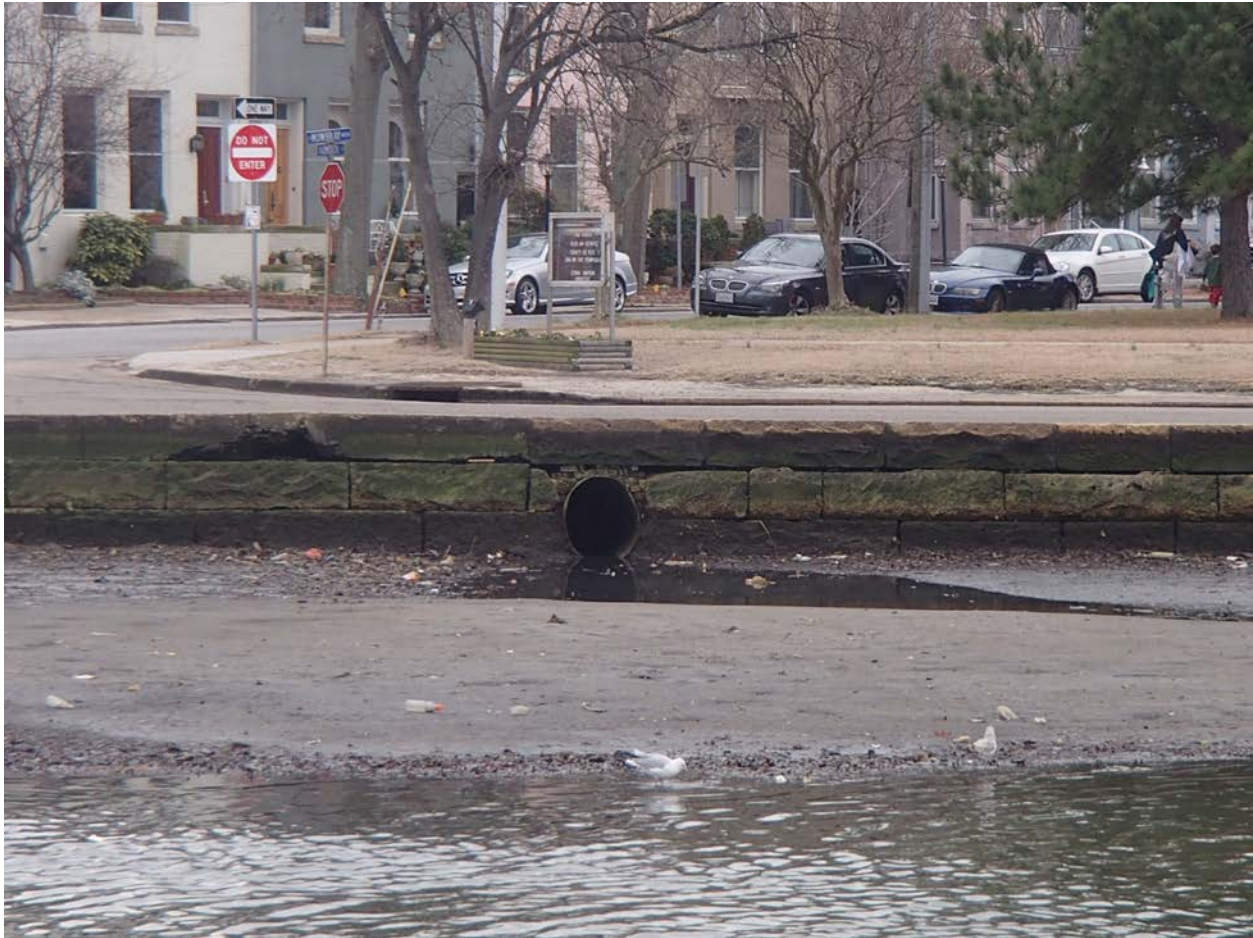
*Photo 3: Sediments (sandy) exposed at low tide adjacent to an outfall.*

Removing sediment built up from runoff through outfalls and overland is akin to maintenance activities in an upland stormwater detention basin or pond. In this case, areas adjacent to outfalls have provided an area for soil to settle out. This alternative will remove this sediment in the areas of outfalls and provide additional capacity for future settlement of solids.

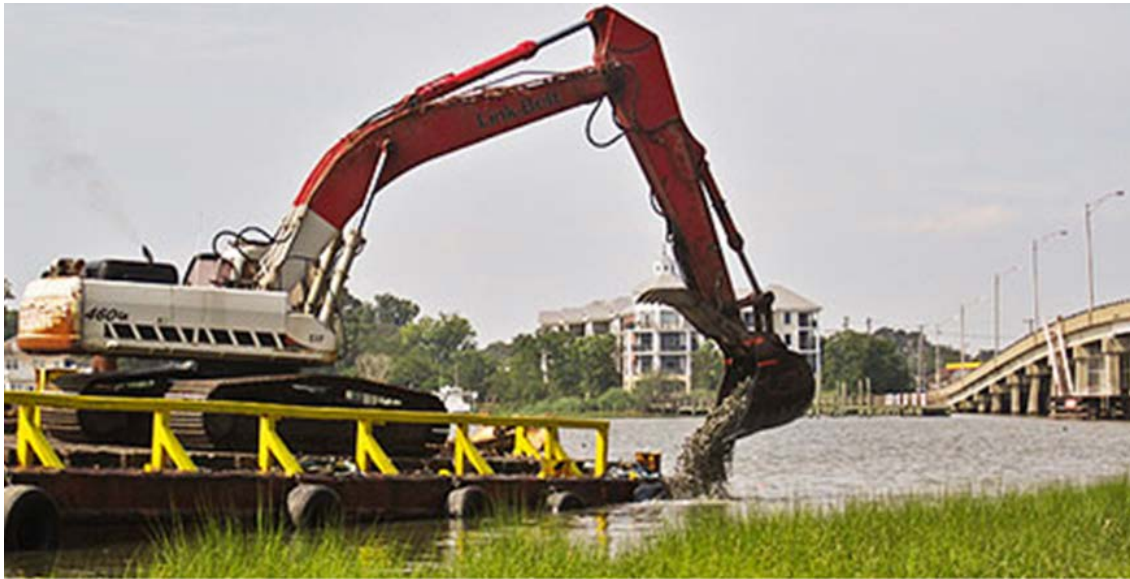
*Photo 5: Oyster reef construction on the Lafayette River (Picture taken from Chesapeake Bay Foundation website, cbf.org)*

Construction would involve use of oyster shell to build a 12 to 18-inch layer of shell on the exiting mudline. Alternative materials (such as stone or welk shell) have also been used to minimize the volume of required oyster shell. After shell placement the reefs are seeded with oyster spat (the larval stage of the oyster when it begins to develop a shell) on shell typically produced at a local hatchery. Best practice is to restore an oyster reef where there is evidence of prior reef and shell, or where the bottom is stable (sandy) so the shell does not settle into the bottom. In addition, oysters prefer high water circulation.

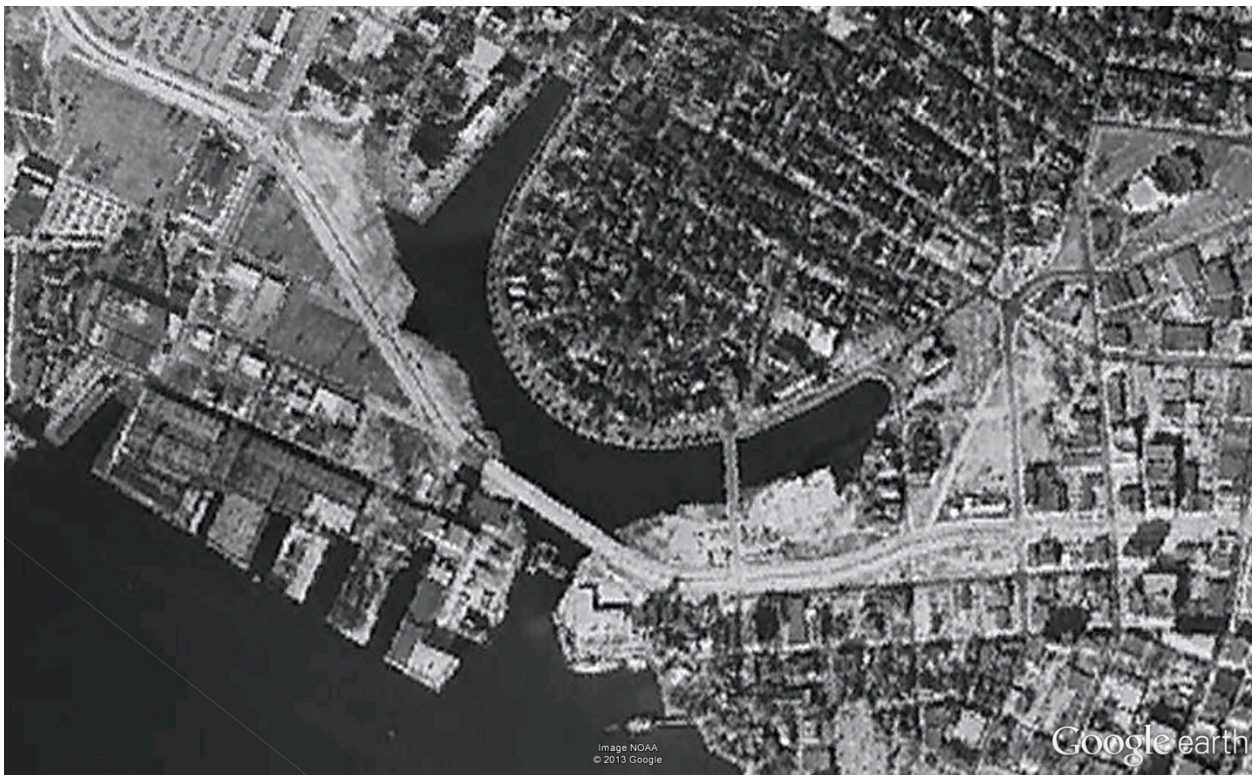
*Photo 6: Circa 1964 Aerial showing probable wetland fringe along southwestern shoreline of the Hague (source: Google Earth Professional)*

Creating or restoring wetlands improves water quality and provides ecosystem habitat. From observations of a historical chart, Smith Creek appears to have contained some fringe wetlands (see Photo 6 and Figure 1) prior to construction of the relieving platform that hardened the southwest Hague shoreline. Two concepts have been developed to create tidal wetlands within the Hague:

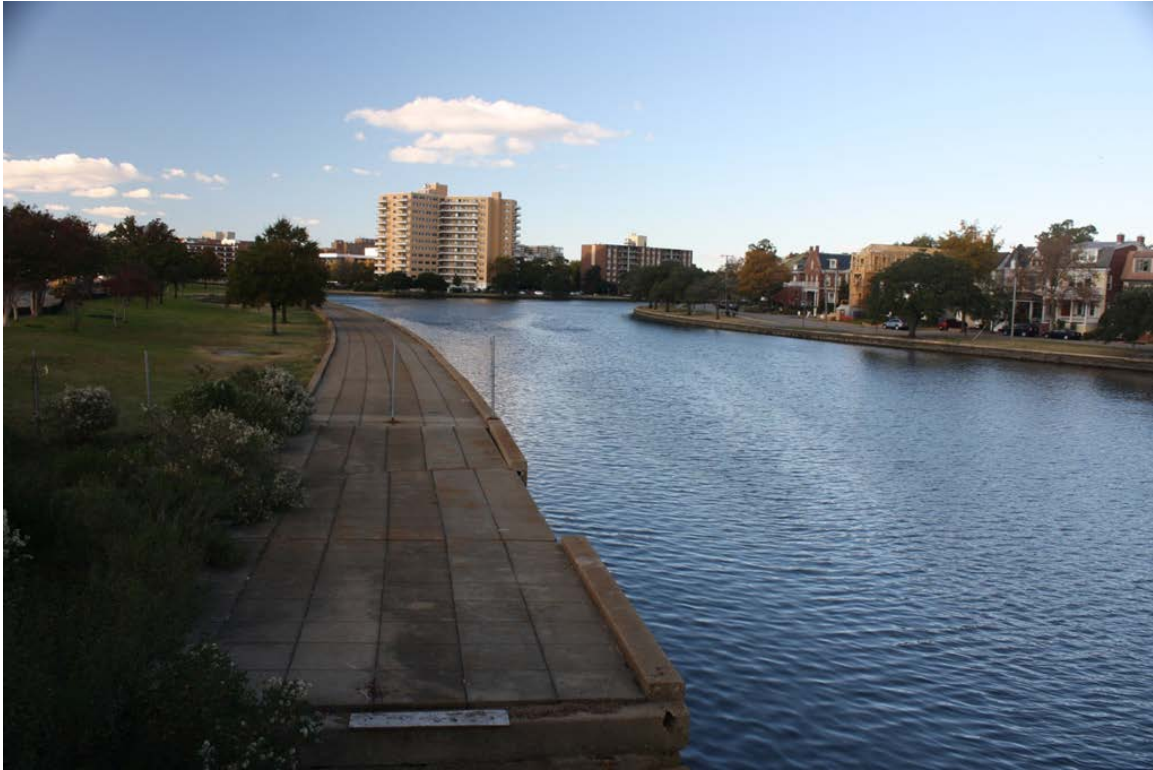
*Photo 7: Potential site for living shoreline fronting promenade west of the Brambleton Ave bridge*

Living shorelines use plants and sand fill, sometimes with stone or other structures to stabilize a shoreline while leaving a natural connection from upland to the water. This provides for shoreline erosion control, improved habitat for animals and fish, and beneficial filtration of stormwater as it passes through the wetlands. Wetlands provide for pollutant removal and nutrient uptake, and they reduce flow rates into the receiving body (refer to <http://ccrm.vims.edu/livingshorelines/index.html>). The concept developed for this project option would include a living shoreline adjacent to the shoreline along Brambleton Avenue, the area shown in Photo 7.

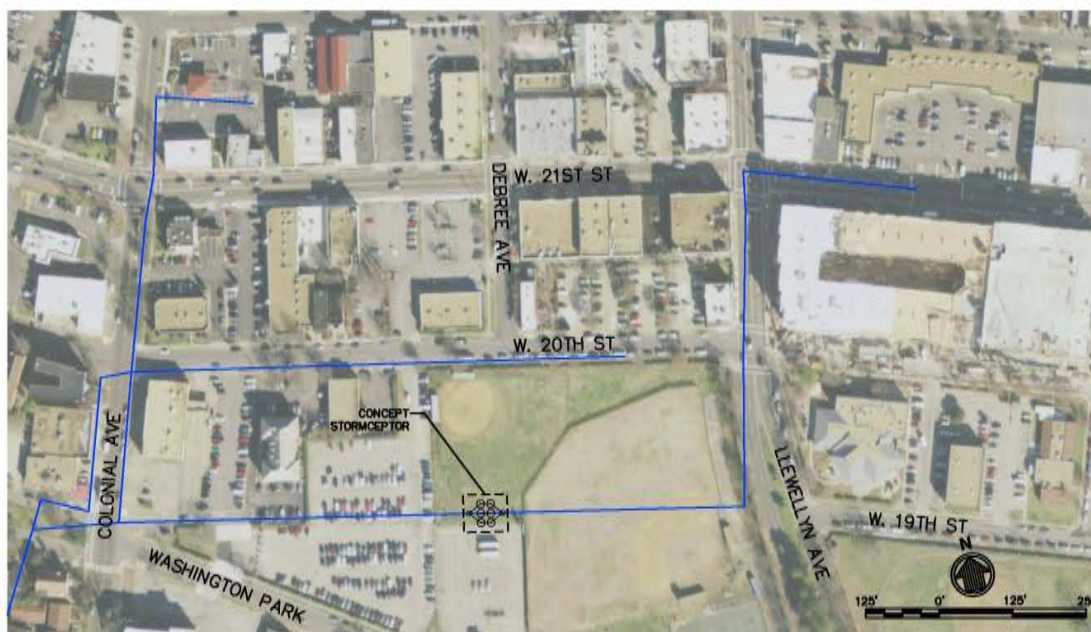
Figure 11: Concept example – Maury High School

This concept constructs an underground Rinker Stormceptor hydrodynamic separator BMP in the baseball field area north of Maury High School to treat runoff from approximately 17.9 acres dense development (93% impervious) prior to its eventual discharge through outfall D143000. See Figure 11 and Figure 12 for concept plan and details.

Based on the drainage size, the structure needs to be sized to provide treatment to 10.47 cfs with the ability to handle (i.e. bypass) up to approximately 75 cfs (10-year peak flow rate). This corresponds to 3 Stormceptor STC 16000s units. [Each STC 16000s unit is capable of treating 7 acres of developed urban land (CN=93)].

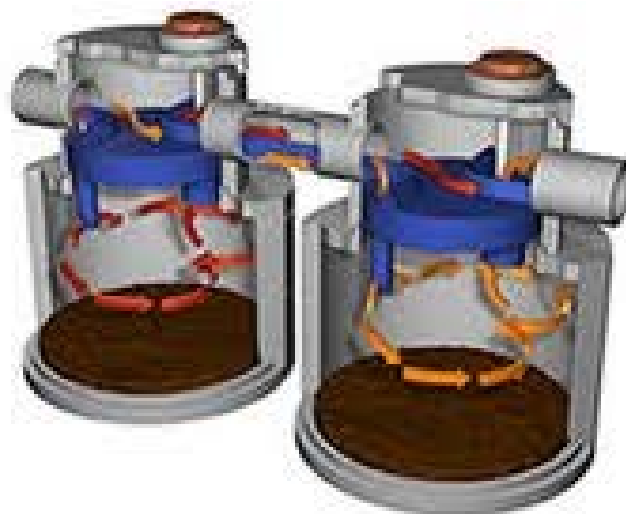
*Figure 12: Typical Stormceptor 16000s unit*

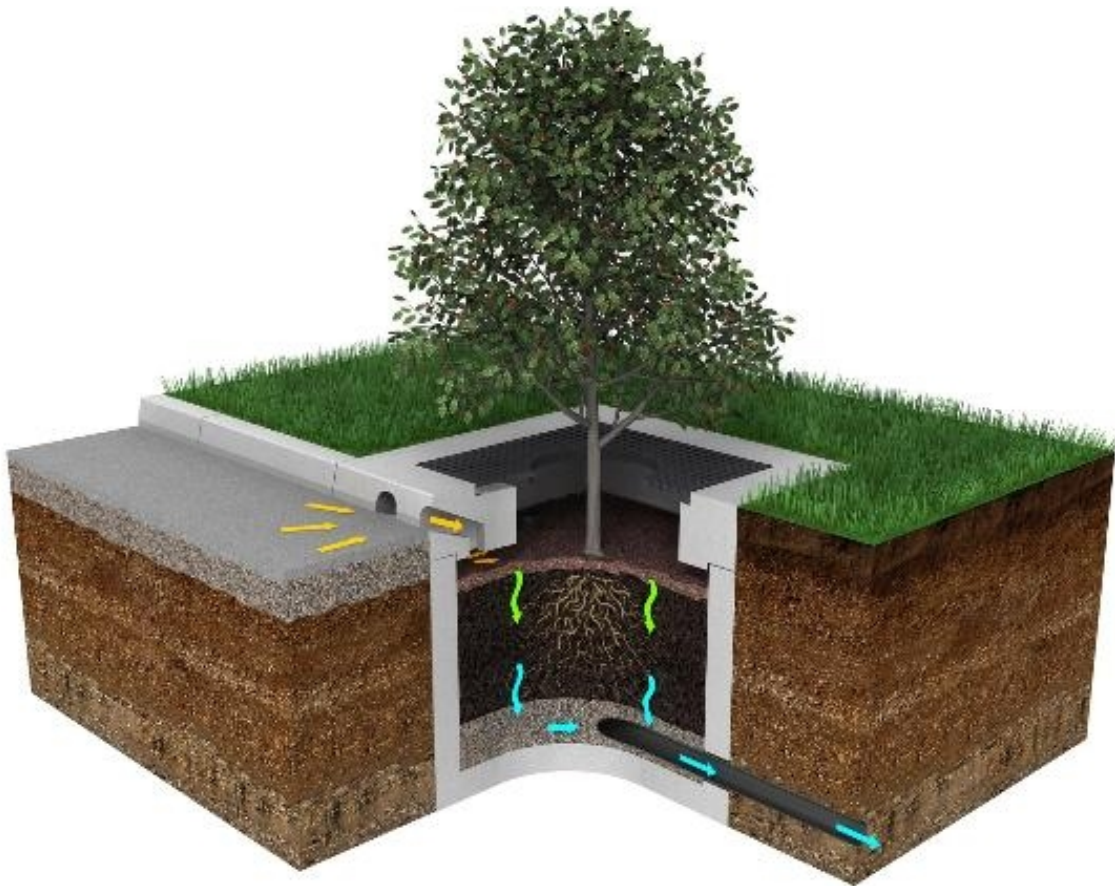
*Figure 15: Typical Filterra retrofit*

Treatment effectiveness and cost projection is based on replacement of inlet structure that drains a 1/2-acre urban area with a Filterra System. State guidelines establish a minimum required Filterra bed size as a percentage (0.33%) of the contributing impervious area. Therefore, for a 1/2 urban drainage area, the minimum required Filterra area would be approximately 72 ft<sup>2</sup>, could be 2 standard 6-ft by 6-ft units, or a custom unit designed for specific site constraints. See Figure 15 for typical detail.

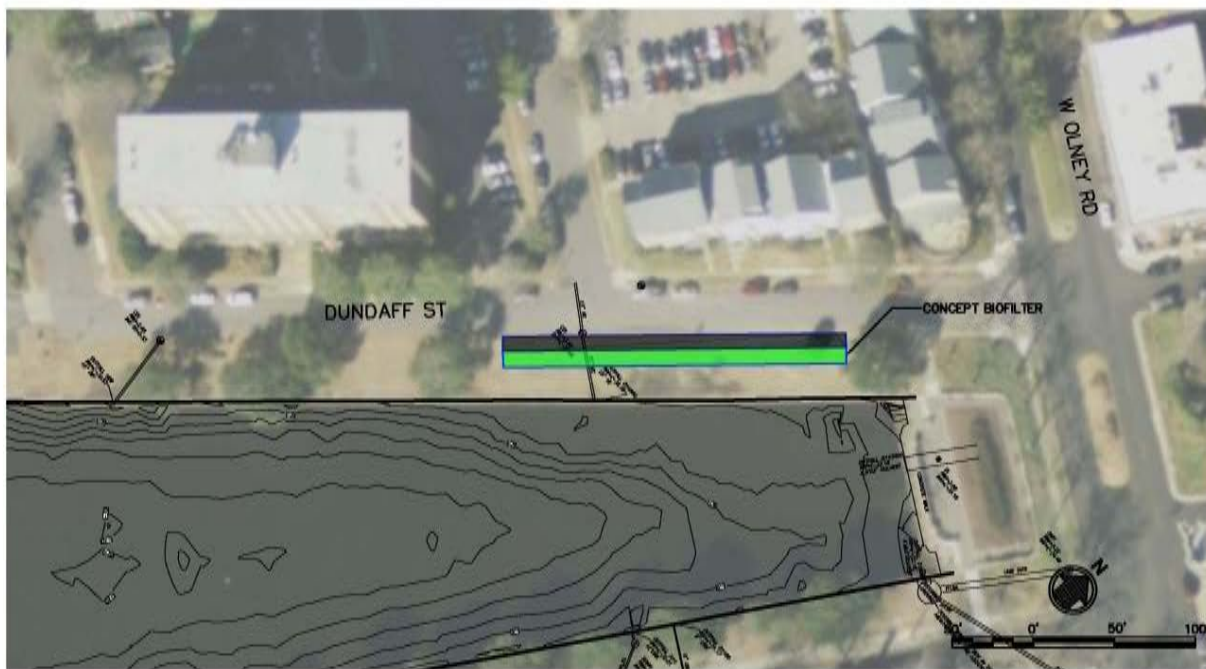
*Figure 16: Concept plan for Dundaff Street biofilter*

Based on WSDOT guidelines and using the TR-55 peak runoff for a 1" storm event, a 10-ft wide strip along the full length of the 205-ft site would be able to treat the incoming runoff.

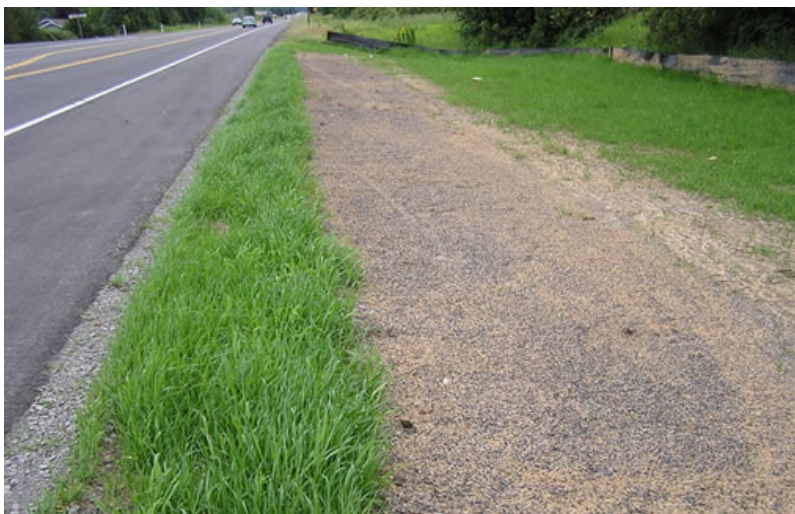
*Figure 17: Sample site-developed biofilter concept*

Biofilters may also be designed as landscape areas where space permits but temporary storage of runoff is not desired (i.e. bioretention). Concept Example #2 is based on construction of a biofilter area adjacent to Dundaff Street and is intended to capture runoff that discharges through systems H09 and D14860. See Figure 16 and Figure 17 for concept plan and typical section.

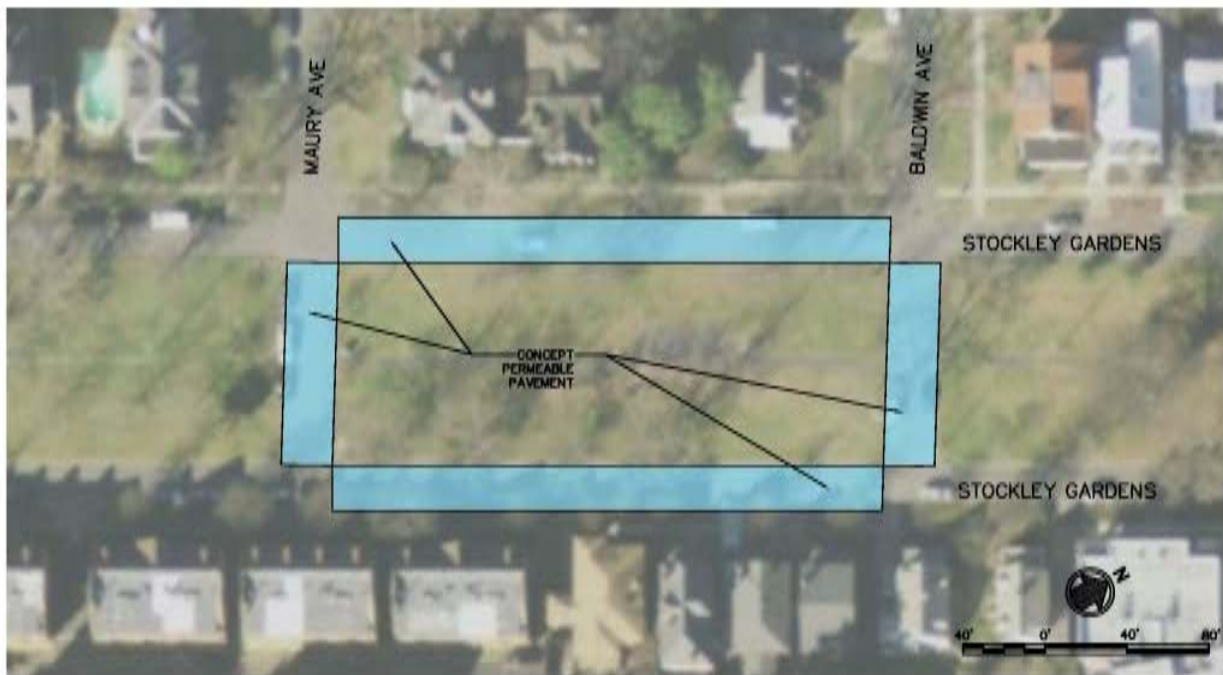
Figure 18: Stockley Gardens permeable pavement concept plan

Stockley Gardens is a candidate location for permeable pavement construction due to its relatively light and truck-free traffic exposure. Within this example, a 270-foot long block, plus two 100-foot long cross segments are converted to pervious pavement (both directions of travel – approximately 25-feet wide each way), resulting in .39-acres of roadway plus 1.00-acre and 0.45-acres contributing impervious and pervious area, respectively (total drainage area 1.84-acres). Figure 18 and Figure 19 illustrate the concept plan and pavement section.

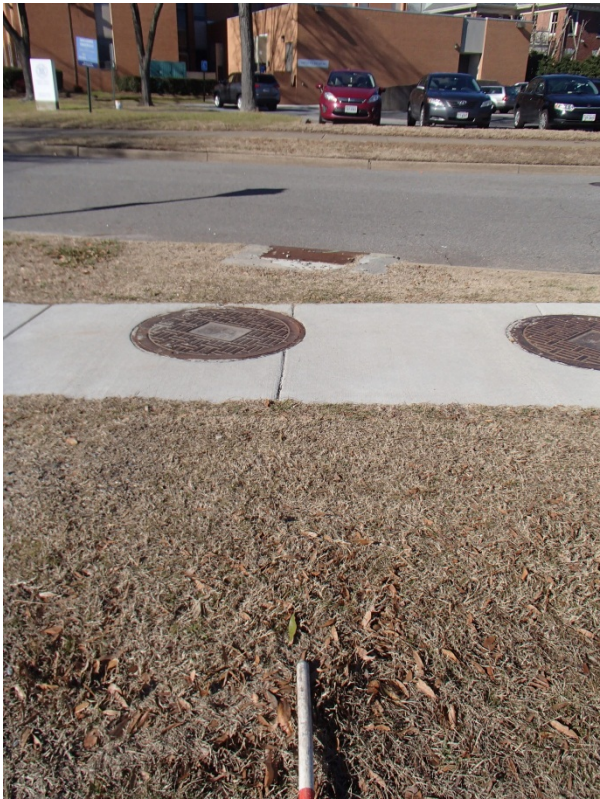
| | <p><b>Photo No.: B-1</b></p> <p><b>Location:</b></p> <p>Outfall E141-View at Top of Outfall</p> <p><b>Description:</b></p> <p>No Deficiencies Noted</p> <p><b>1/13/2014</b></p> |

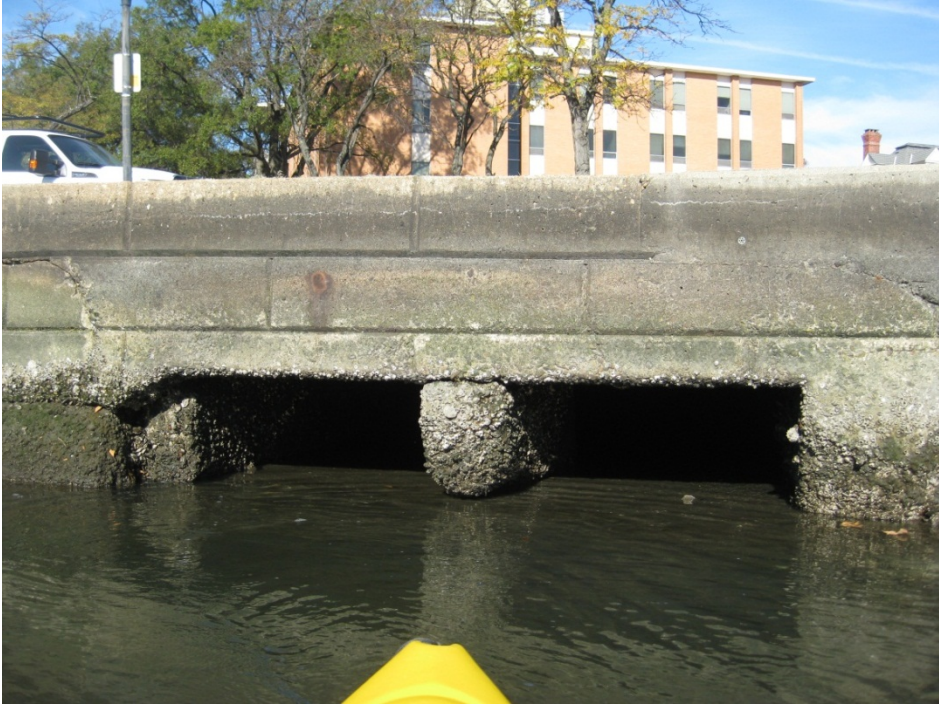
| | <p><b>Photo No.: B-2</b></p> <p><b>Location:</b></p> <p>Outfall E141-Elevation View</p> <p><b>Description:</b></p> <p>3.5'x2' Box Culvert(L)<br/>4'x2' Box Culvert(R)</p> <p><b>11/11/2013</b></p> |

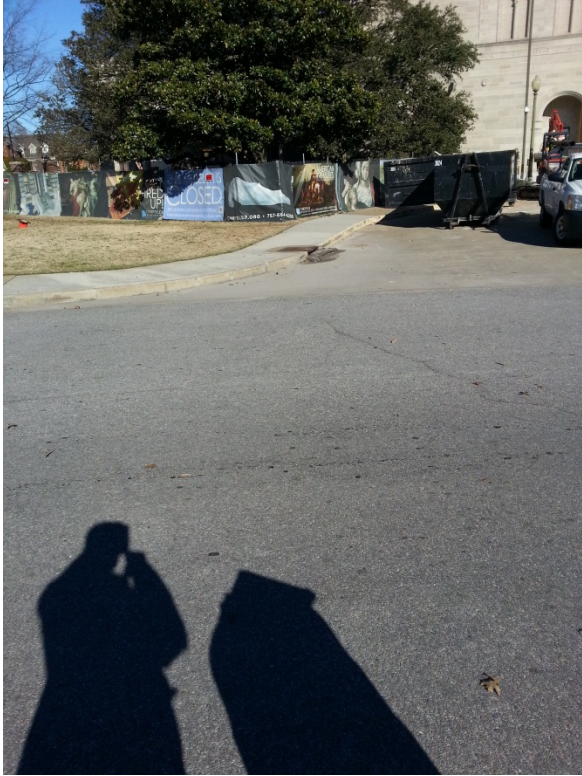
| | <b>Photo No.: B-3</b> |

| | <b>Location:</b><br>Outfall E147007-View<br>at Top of Outfall |
| | <b>Description:</b><br>No Deficiencies Noted |

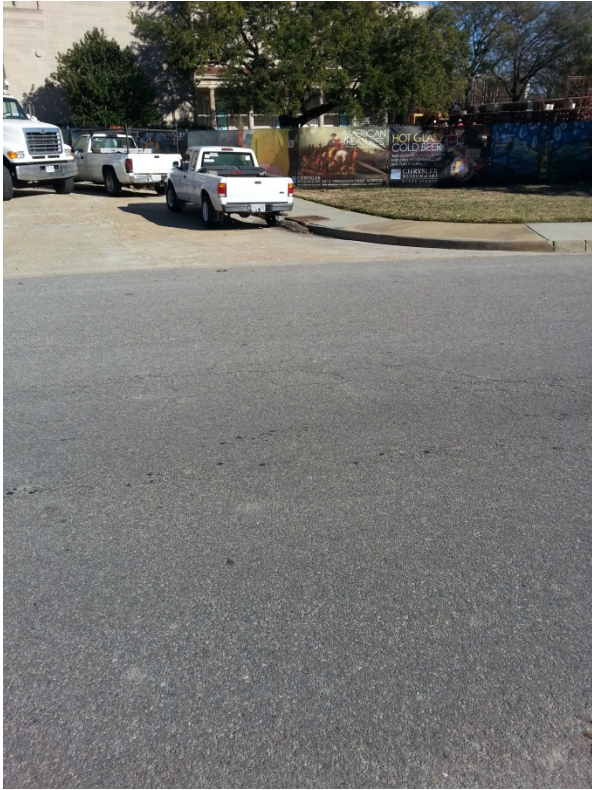
| | <b>Photo No.: B-5</b> |

| | <b>Location:</b><br><br>Outfall<br>E143250 (L) &<br>E143699 (R) -View at<br>Top of Outfall |
| | <b>Description:</b><br><br>No Deficiencies Noted |

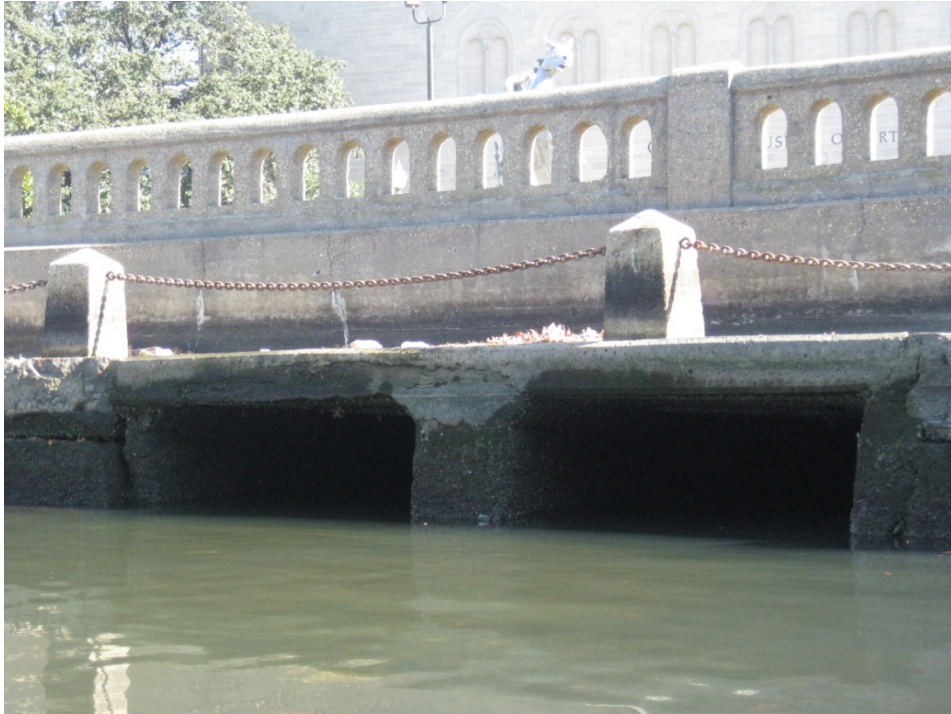
| | <b>Photo No.: B-6</b> |

| | <b>Location:</b><br><br>Outfall<br>E143250 (L) &<br>E143699 (R) -Elevation<br>View |
| | <b>Description:</b><br><br>6.5'x3.5' Culvert(L)<br>6'x4' Culvert (R) |

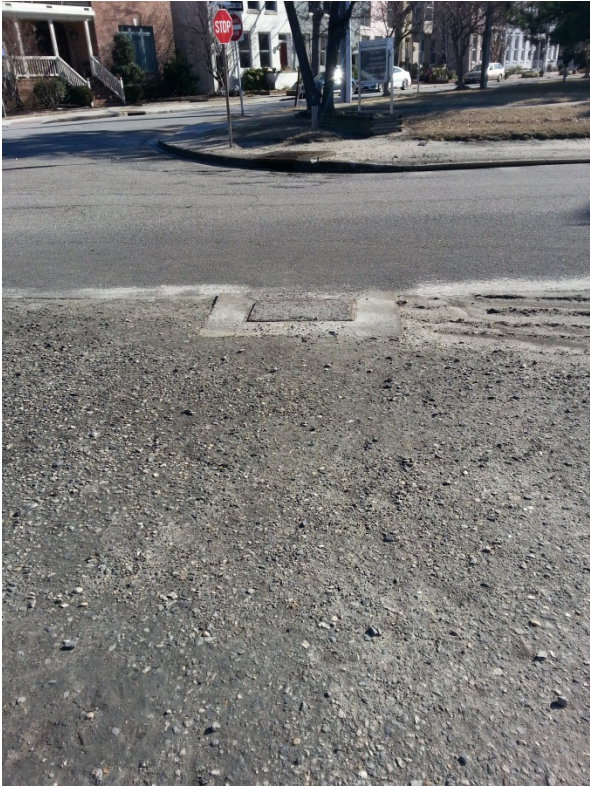
| | <b>Photo No.: B-7</b> |

| | <b>Location:</b><br>Outfall E145200-View<br>at Top of Outfall |
| | <b>Description:</b><br>No Deficiencies Noted |

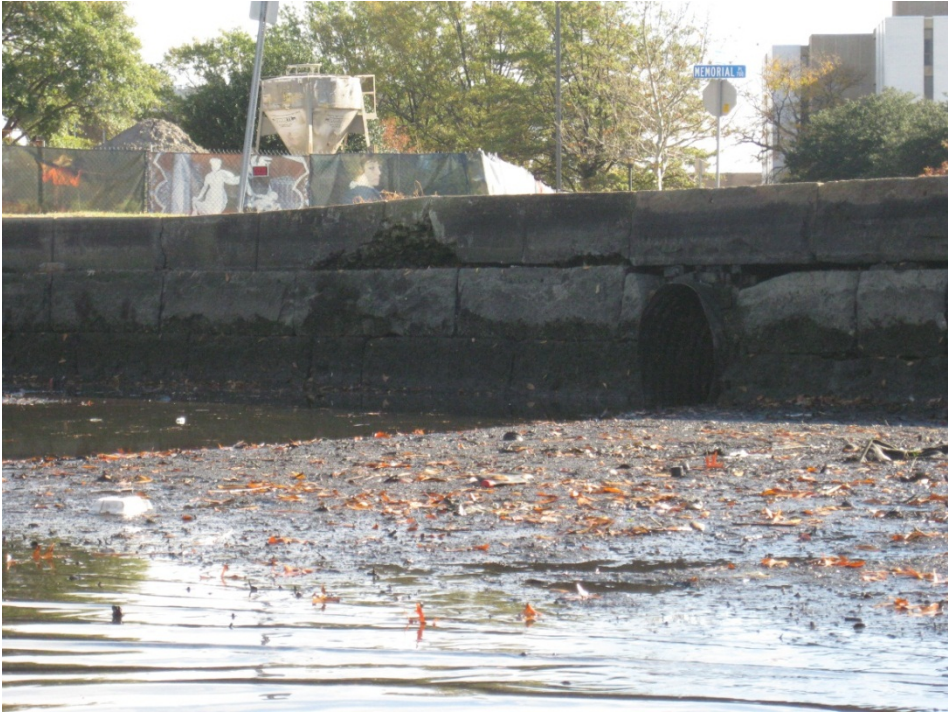
| | <b>Photo No.: B-8</b> |

| | <b>Location:</b><br>Outfall E145200-<br>Elevation View |
| | <b>Description:</b><br>30" CMP |

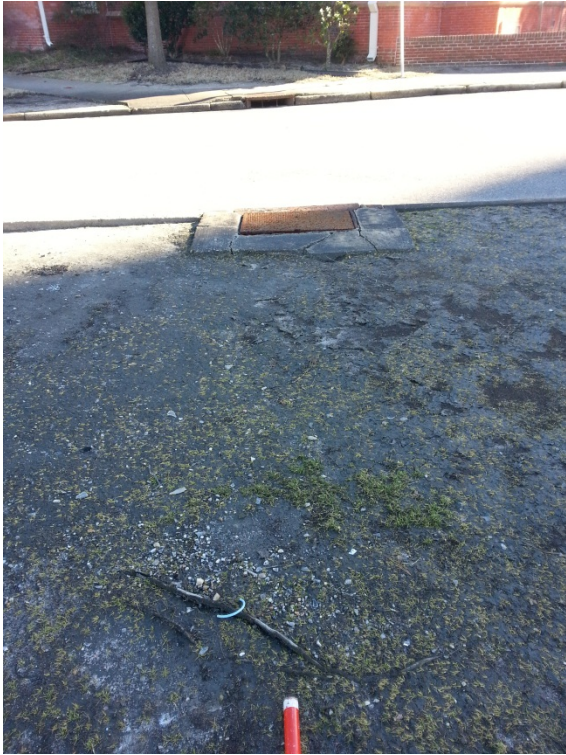
| | <b>Photo No.: B-9</b> |

| | <b>Location:</b><br>Outfall E145211-View<br>at Top of Outfall |
| | <b>Description:</b><br>No Deficiencies Noted |

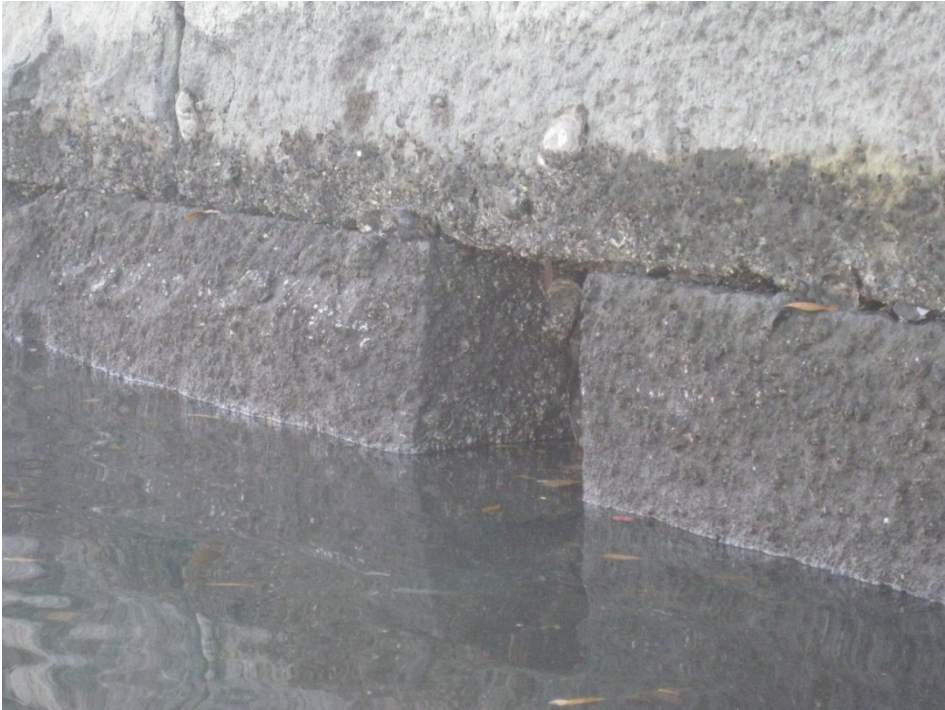
| | <b>Photo No.: B-10</b> |

| | <b>Location:</b><br>Outfall E145211-<br>Elevation View |
| | <b>Description:</b><br>12" Conc. |

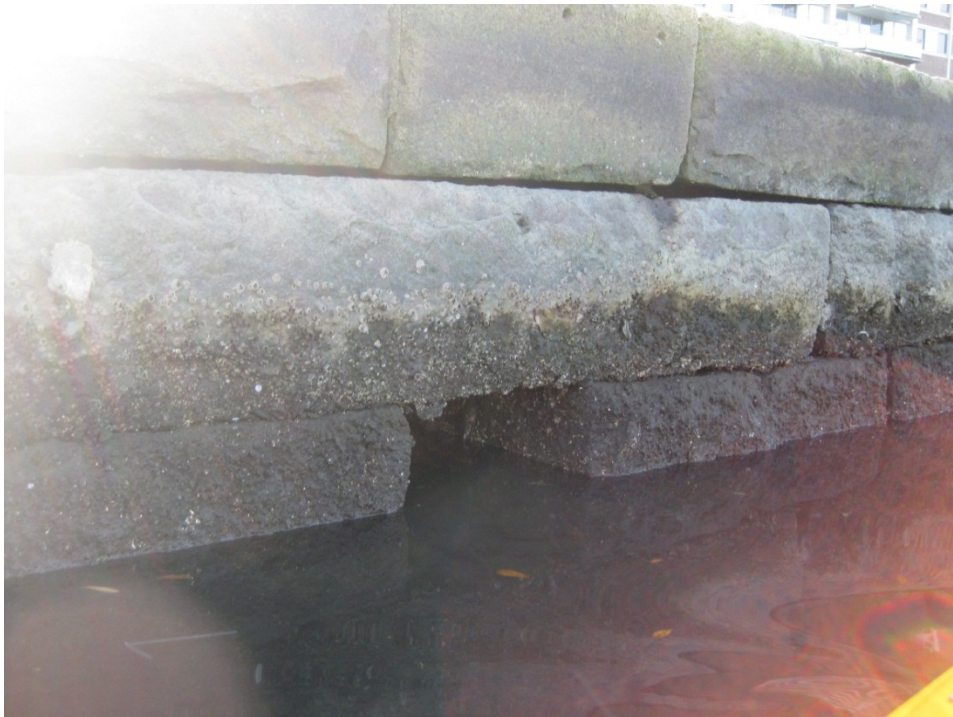
| | <b>Photo No.: B-11</b> |

| | <b>Location:</b><br><br>Unknown outfall west<br>of E145211-Elevation<br>View |
| | <b>Description:</b><br><br>Unknown if Pipe is in<br>service. |

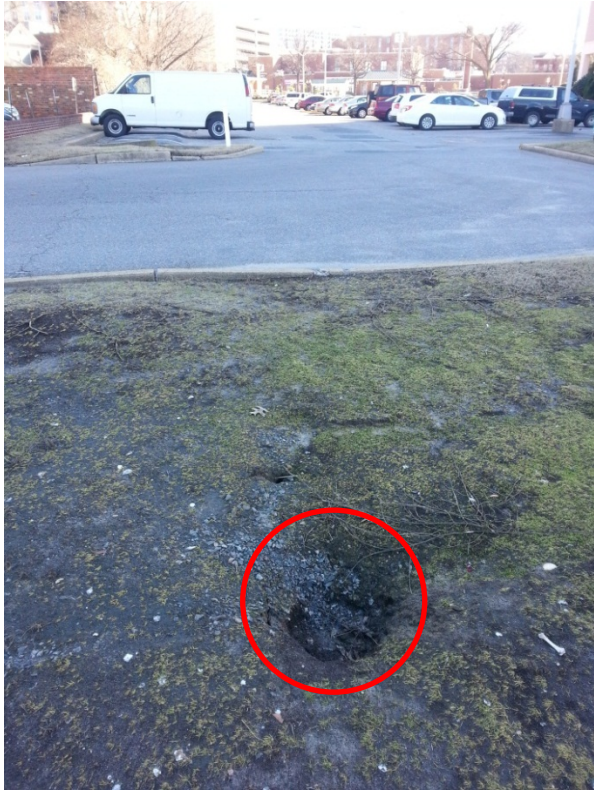
| | <b>Photo No.: B-12</b> |

| | <b>Location:</b><br>Outfall E14330-View at Top of Outfall |
| | <b>Description:</b><br>Settlement of 1'Dia. x 1'D along length of culvert |

| Outfall | Size | Deficiencies Noted |
|---|---|---|
| E14330 | 5 ft x 3.5 ft culvert | Repairs needed: Separated joint – excavate, realign, wrap pipe, and backfill. |

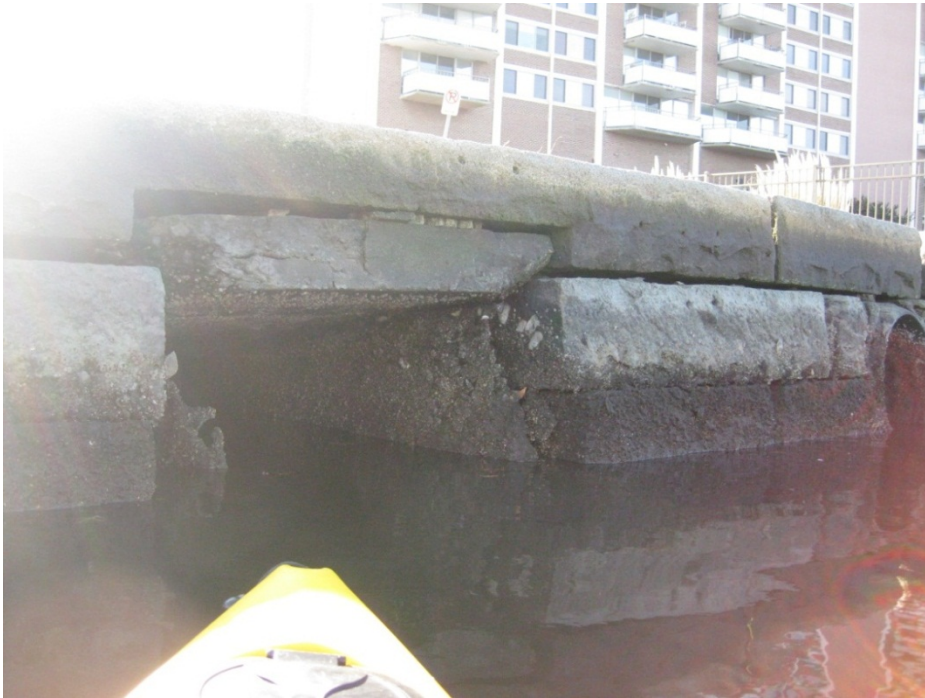
| | <b>Photo No.: B-13</b> |

| | <b>Location:</b><br>Outfall E14330-Elevation View |
| | <b>Description:</b><br>5'x3.5' Culvert |

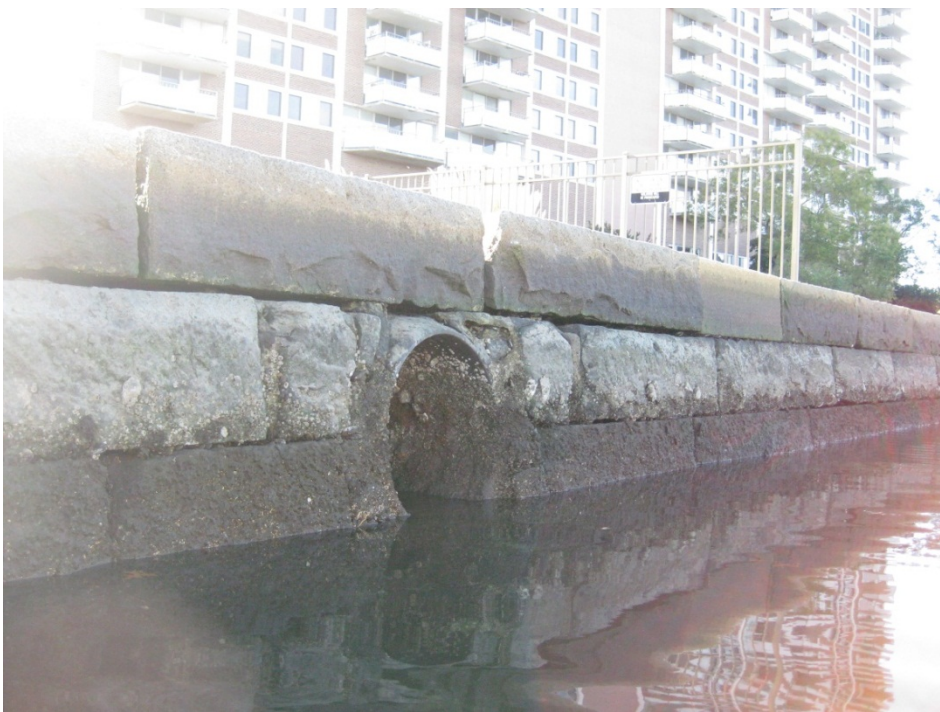
| | <b>Photo No.: B-14</b> |

| | <b>Location:</b><br><br>Outfall E14310-<br>Elevation View |
| | <b>Description:</b><br><br>30" DIP |

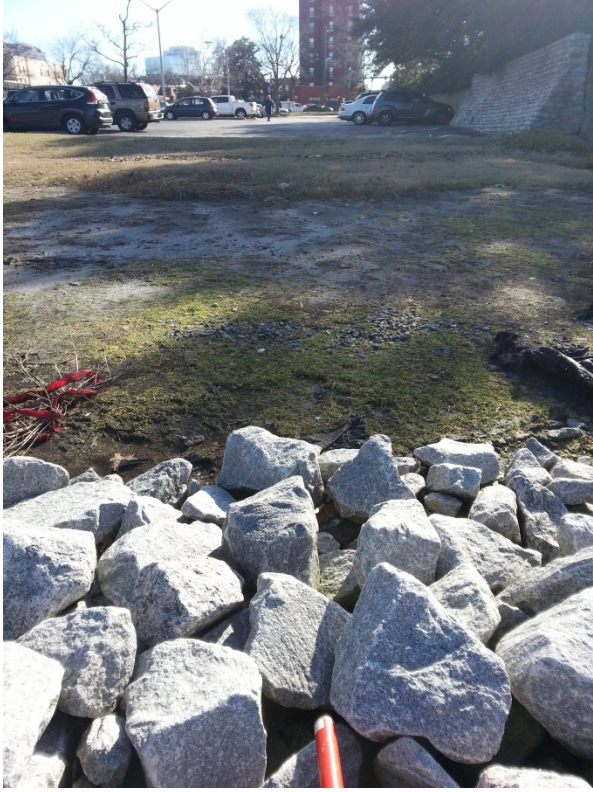
| | <p><b>Photo No.: B-15</b></p> <p><b>Location:</b><br/>Unnumbered Outfall (Report Designation H34), west of E14310-View at Top of Outfall</p> <p><b>Description:</b><br/>-Rip Rap placed behind Retaining wall<br/><br/><i>Not in Picture:</i><br/>-Settlement of 4'W x 2'L x up to 4"D along length of pipe.<br/>-Settlement behind structure 8'W x up to 4'L x 8"D likely from vehicles.</p> <p><b>1/13/2014</b></p> |

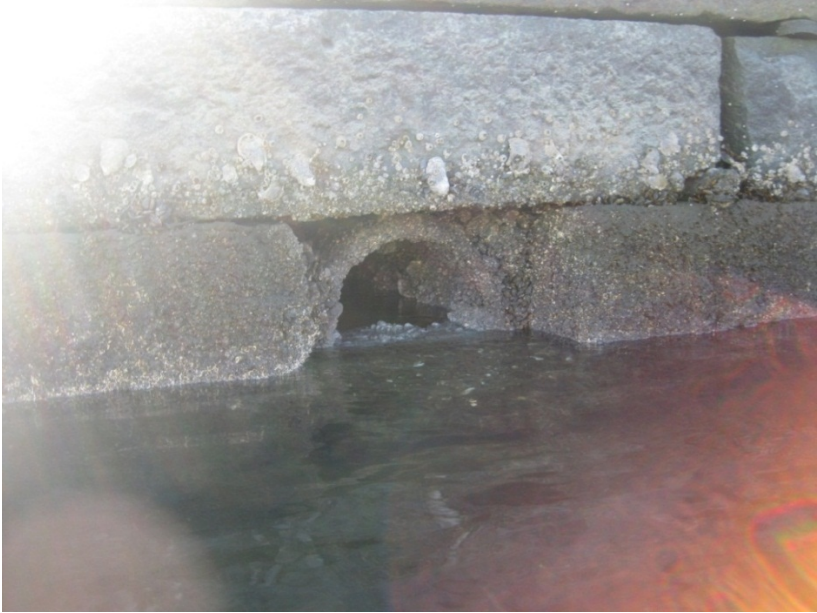
| | <p><b>Photo No.: B-16</b></p> <p><b>Location:</b><br/>Outfall H34</p> <p><b>Description:</b><br/>24" Conc.</p> <p><b>11/11/2013</b></p> |

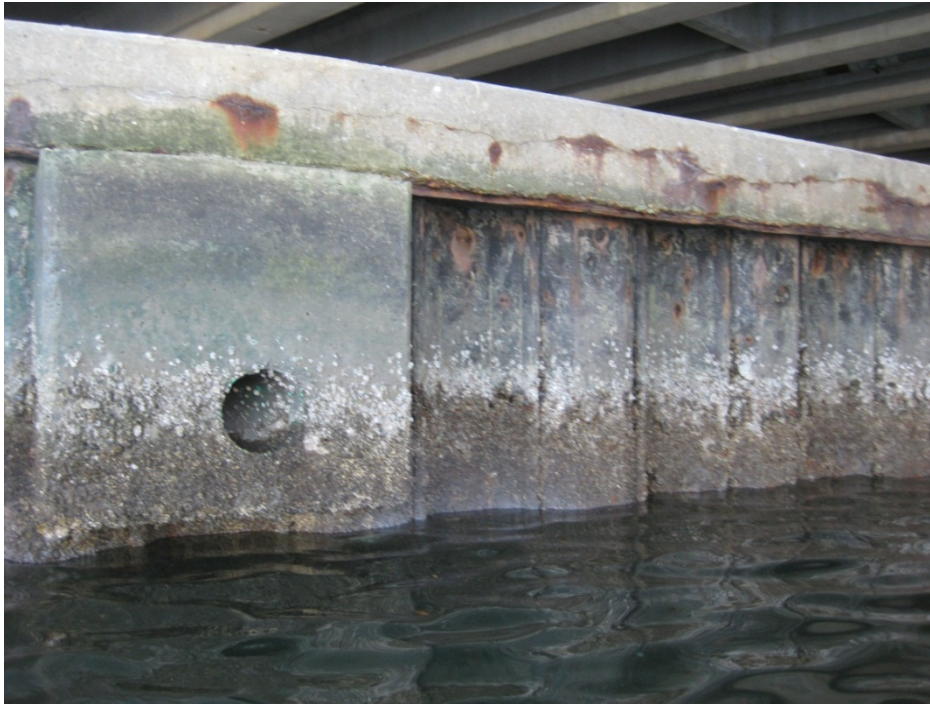
**Photo No.: B-17****Location:**

Unnumbered Outfall  
(Report Designation  
H38), under westbound  
Brambleton Ave  
Bridge-Elevation View

No Deficiencies Noted  
(12" PVC)

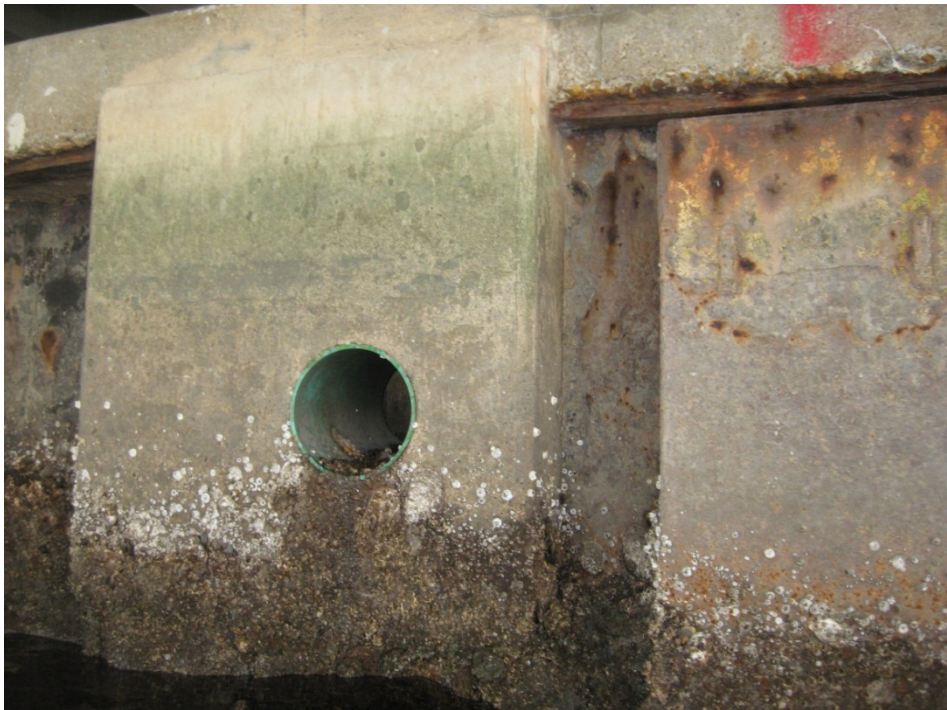
| | <b>Photo No.: B-18</b> |

| | <b>Location:</b><br><br>Unnumbered Outfall<br>(Report Designation<br>H39), under eastbound<br>Brambleton Ave<br>Bridge-Elevation View |
| | <b>Description:</b><br><br>No Deficiencies Noted<br>(12" PVC) |

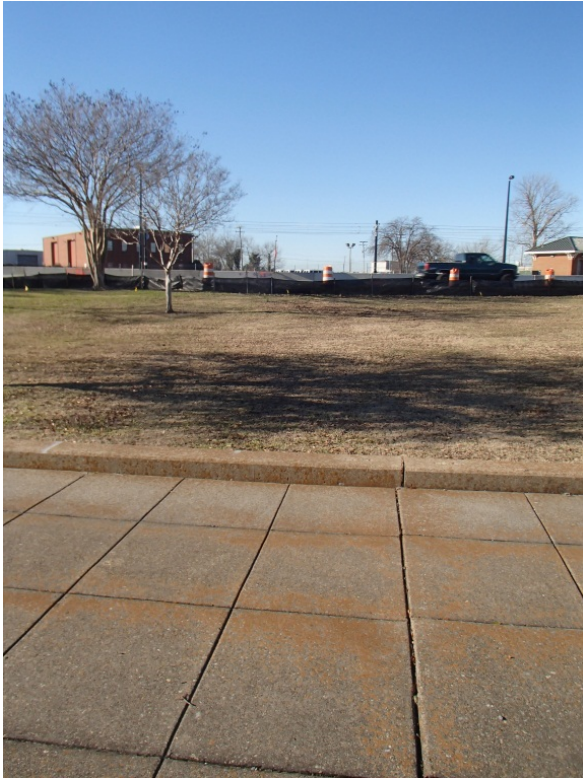
| | <b>Photo No.: B-19</b> |

| | <b>Location:</b><br><br>Outfall D14171-View<br>at Top of Outfall<br><br>(Outfall is under<br>relieving platform and<br>is not visible.) |
| | <b>Description:</b><br><br>No Deficiencies Noted<br>(15" Conc. Pipe) |
