# Hague Stormwater Evaluation and Improvement Concepts Report

City of Norfolk

*August 13, 2014*

moffatt & nichol

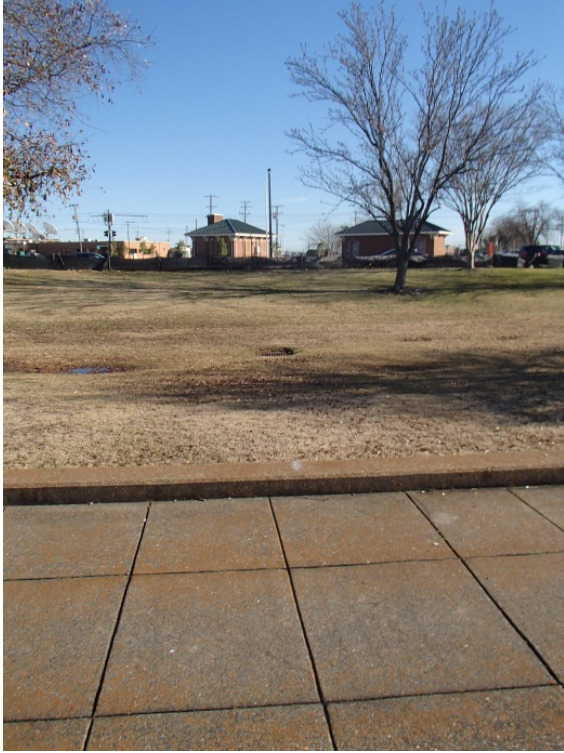
| | <b>Photo No.: B-20</b> |

| | <b>Location:</b><br><br>Outfall D14165-View at<br>Top of Outfall<br><br>(Outfall is under<br>relieving platform and is<br>not visible.) |
| | <b>Description:</b><br><br>Non Observed<br>(15" Conc. Pipe) |

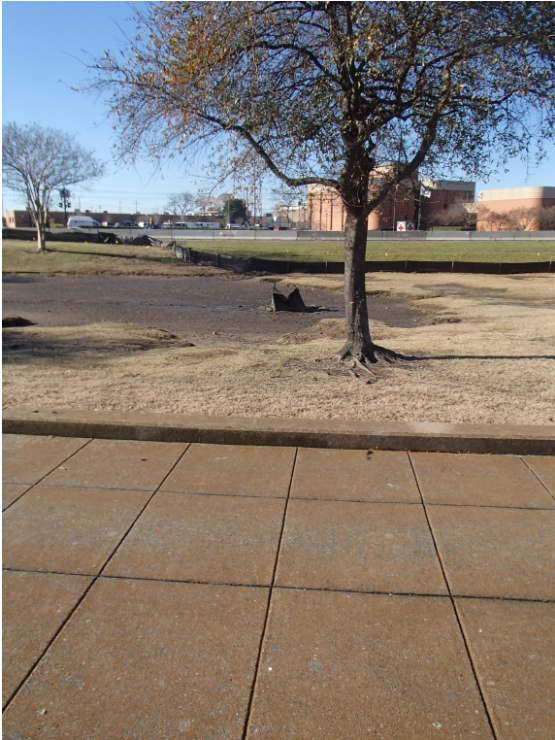
| | <b>Photo No.: B-21</b> |

| | <b>Location:</b><br><br>Outfall D14158-View<br>at Top of Outfall<br><br>(Outfall is under<br>relieving platform and<br>is not visible.) |
| | <b>Description:</b><br><br>No Deficiencies Noted<br>(12" Pipe) |

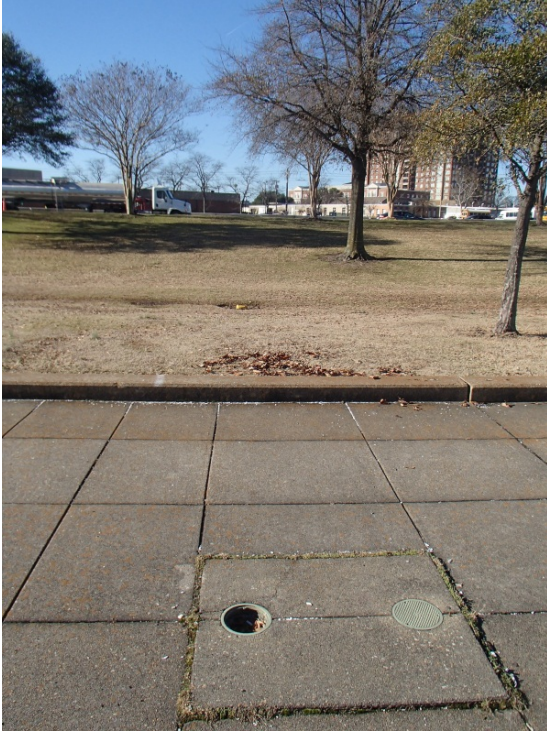
| | <b>Photo No.: B-22</b> |

| | <b>Location:</b><br><br>Outfall D14153-View<br>at Top of Outfall<br><br>(Outfall is under<br>relieving platform and<br>is not visible.) |
| | <b>Description:</b><br><br>No Deficiencies Noted<br>(15" Iron Pipe) |

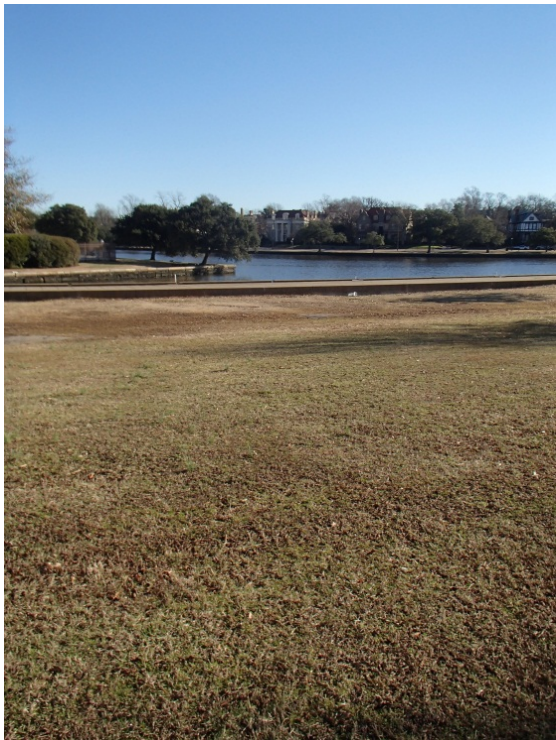
| | <b>Photo No.: B-23</b> |

| | <b>Location:</b><br><br>Outfall D14149-View<br>at Top of Outfall<br><br>(Outfall is under<br>relieving platform and<br>is not visible.) |
| | <b>Description:</b><br><br>No Deficiencies Noted<br>(18" RCP) |

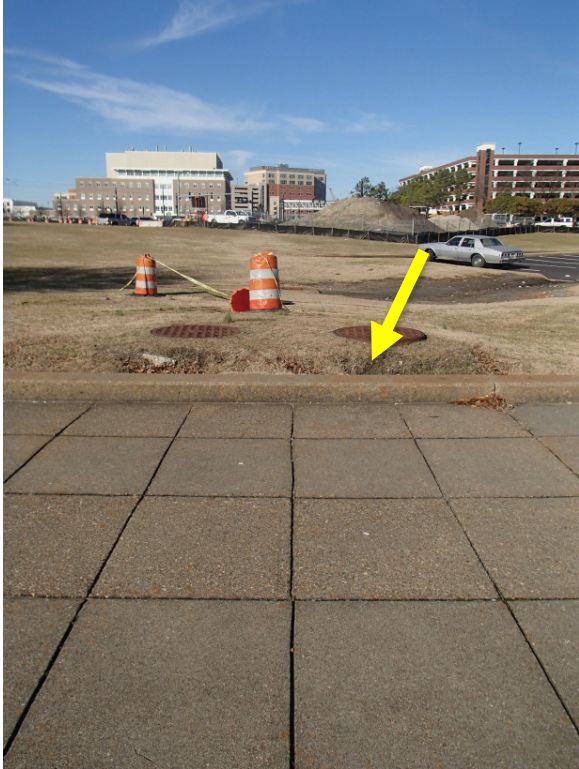
| | <p><b>Photo No.: B-24</b></p> <p><b>Location:</b></p> <p>Outfall D14240-View at Top of Outfall Looking west</p> <p>(Outfall is under relieving platform and is not visible.)</p> <p><b>Description:</b></p> <ul style="list-style-type: none"><li>-Settlement east of Structure 12'W x 4'L x up to 1'D</li><li><i>Not in Picture:</i></li><li>-Pipe Joist Disc. at Structure</li></ul> <p><b>1/13/2014</b></p> |

| Outfall | Size | Deficiencies Noted |
|---|---|---|
| D14240 | 5 ft x 3 ft culvert | Further investigation needed: CCTV pipe to verify no joint separation or failure. |

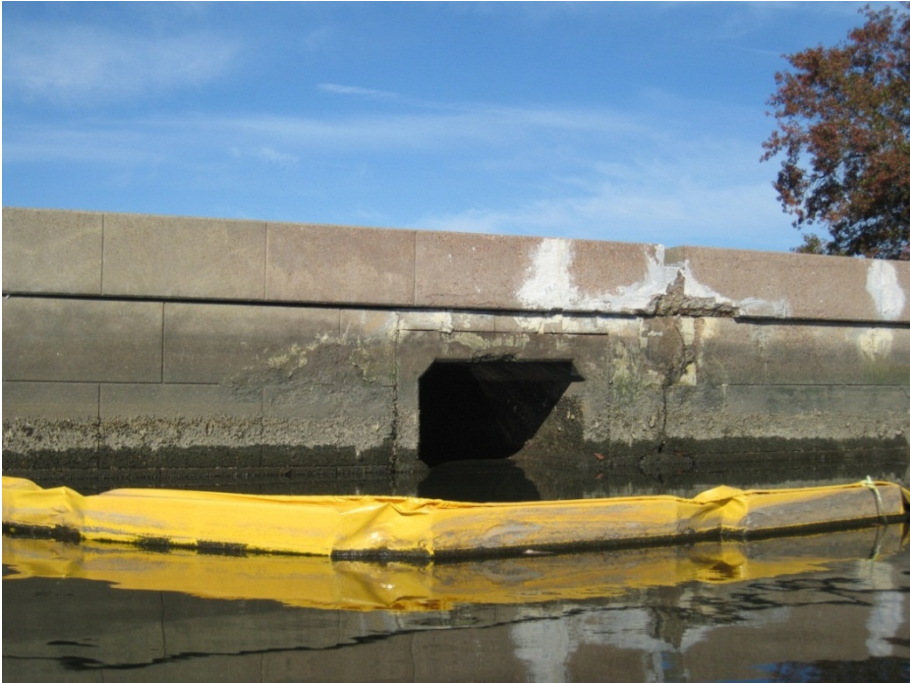
| | <p><b>Photo No.: B-25</b></p> <p><b>Location:</b></p> <p>Outfall D14240-Elevation View</p> <p><b>Description:</b></p> <p>5'x3' Culvert</p> <p><b>11/11/2013</b></p> |

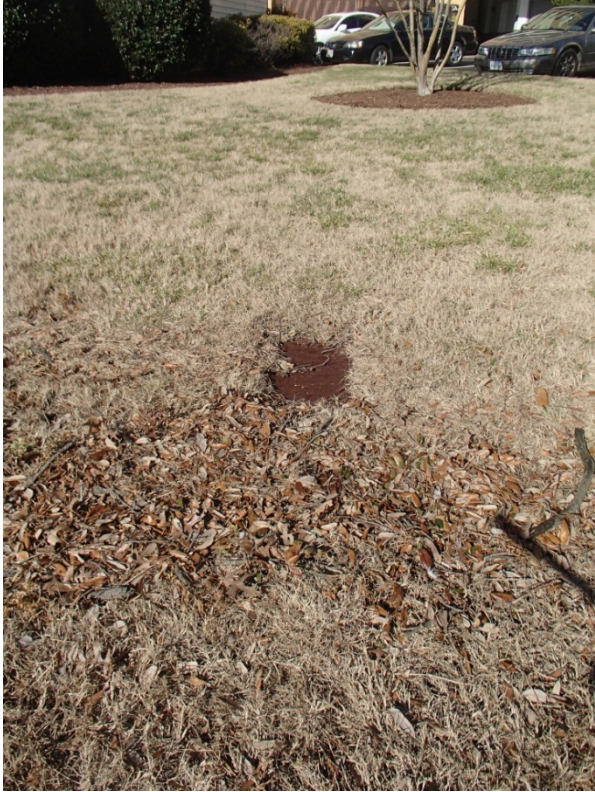
| | <p><b>Photo No.: B-26</b></p> <p><b>Location:</b><br/>Unnumbered Outfall<br/>(Report Designation<br/>H07), east of D14240-<br/>View at Top of Outfall</p> <p><b>Description:</b><br/>No Deficiencies Noted</p> <p><b>1/13/2014</b></p> |

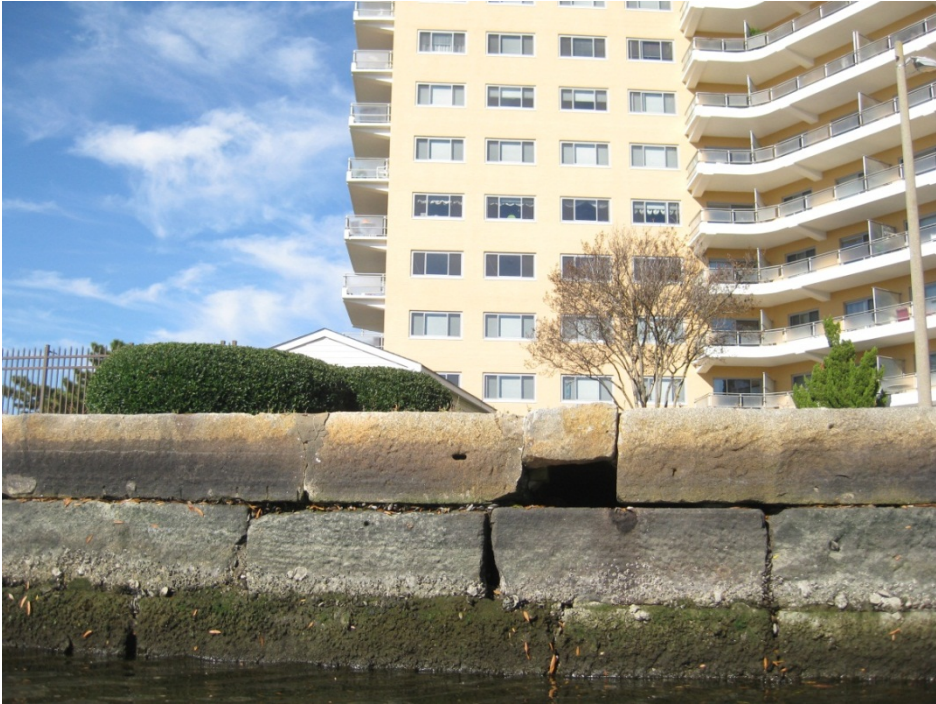
| | <p><b>Photo No.: B-27</b></p> <p><b>Location:</b><br/>Outfall H07-Elevation<br/>View</p> <p><b>Description:</b><br/>18" RCP</p> <p><b>11/11/2013</b></p> |

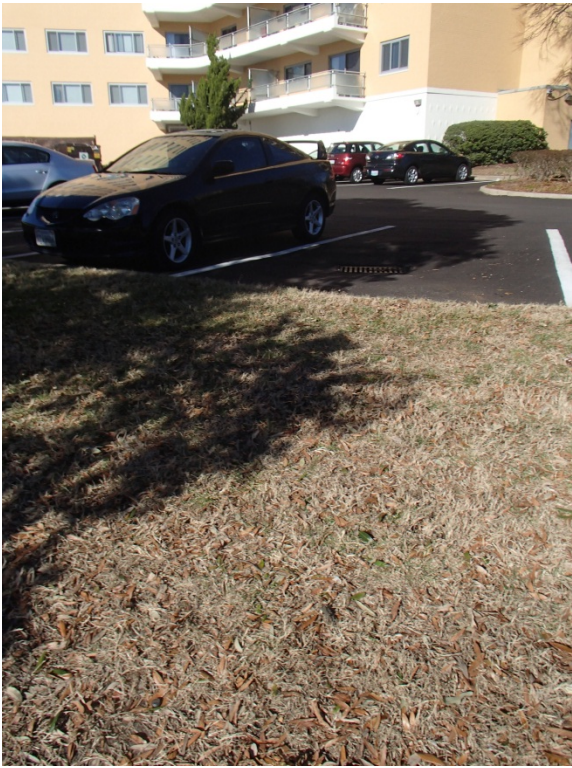
| | <b>Photo No.: B-28</b> |

| | <b>Location:</b><br><br>Unnumbered Outfall<br>(Report Designation<br>H08), east of H07-View<br>at Top of Outfall |
| | <b>Description:</b><br><br>12" Conc. Pipe |

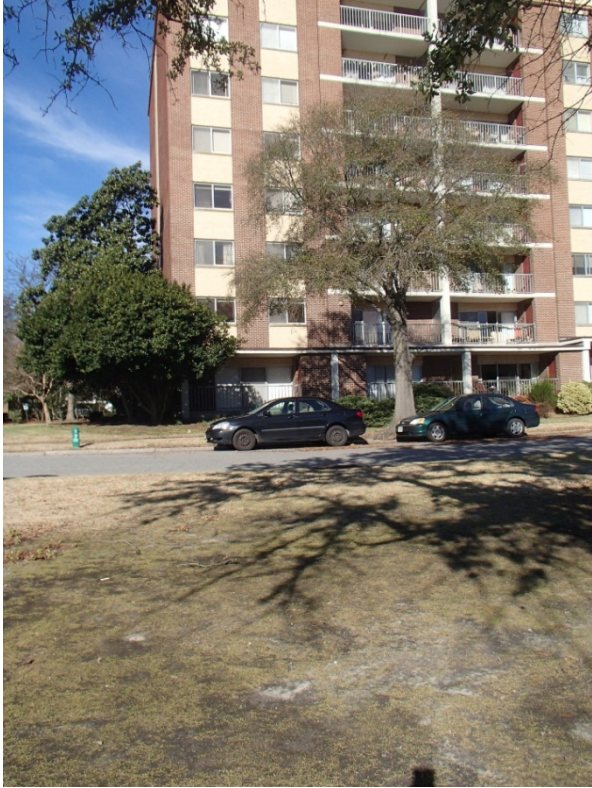
| | <p><b>Photo No.: B-29</b></p> <p><b>Location:</b><br/>Unnumbered Outfall<br/>(Report Designation<br/>H09), east of H08-View<br/>at Top of Outfall</p> <p><b>Description:</b><br/>No Deficiencies Noted</p> <p><b>1/13/2014</b></p> |

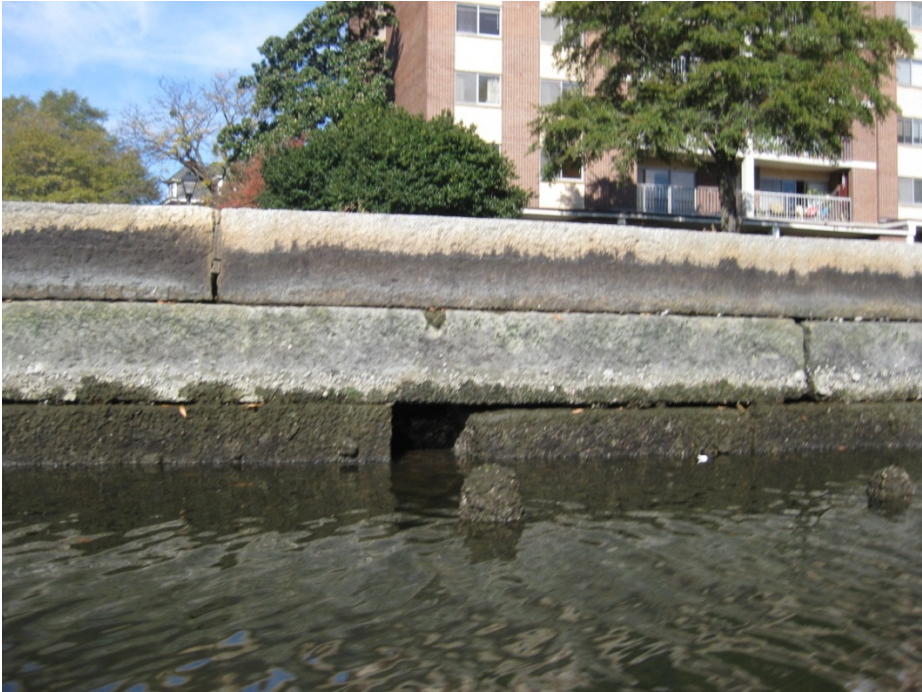
| | <p><b>Photo No.: B-30</b></p> <p><b>Location:</b><br/>Outfall H09-Elevation<br/>View</p> <p><b>Description:</b><br/>15" DIP</p> <p><b>11/11/2013</b></p> |

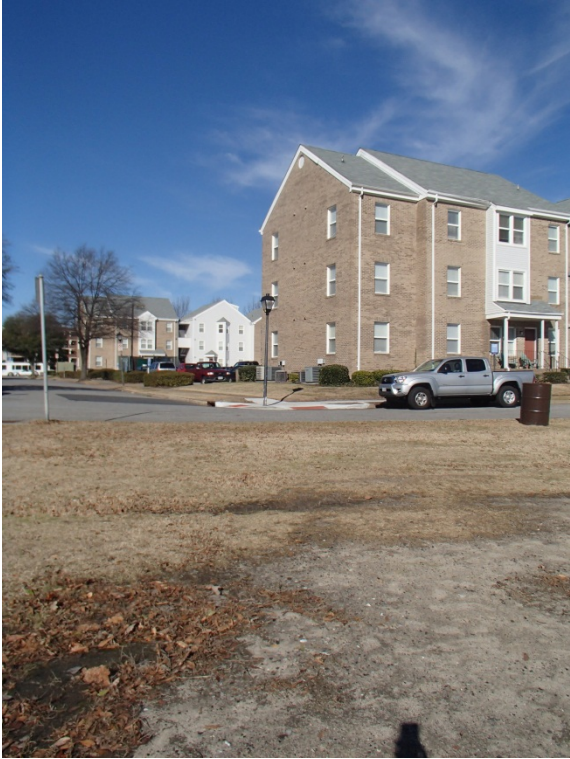
| | <b>Photo No.: B-31</b> |

| | <b>Location:</b><br><br>Outfall D14860-View<br>at Top of Outfall |
| | <b>Description:</b><br><br>Stone Fill Placed Along<br>Length of Pipe 15'<br>Lx6'W |

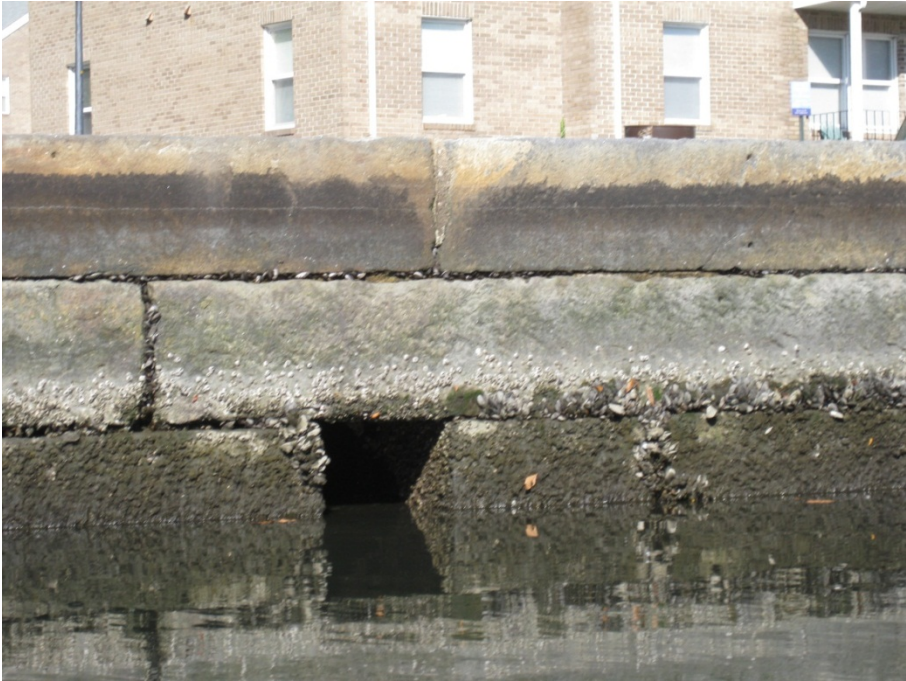
| | <b>Photo No.: B-32</b> |

| | <b>Location:</b><br><br>Outfall D14860-<br>Elevation View |
| | <b>Description:</b><br><br>15" VC |

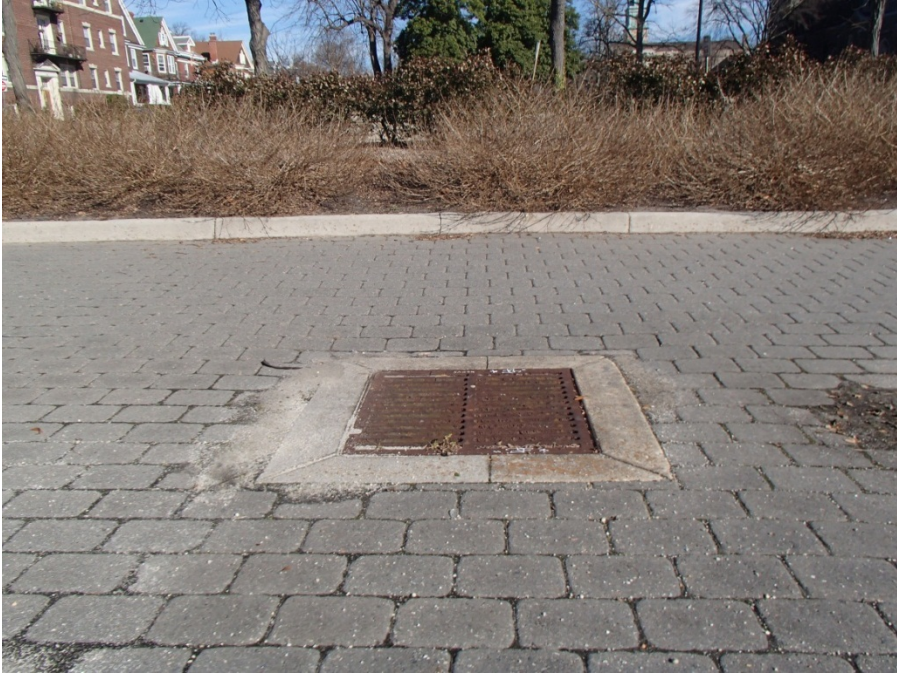
| | <b>Photo No.: B-33</b> |

| | <b>Location:</b><br>Outfall D143000-View<br>at Top of Outfall |
| | <b>Description:</b><br>No Deficiencies Noted |

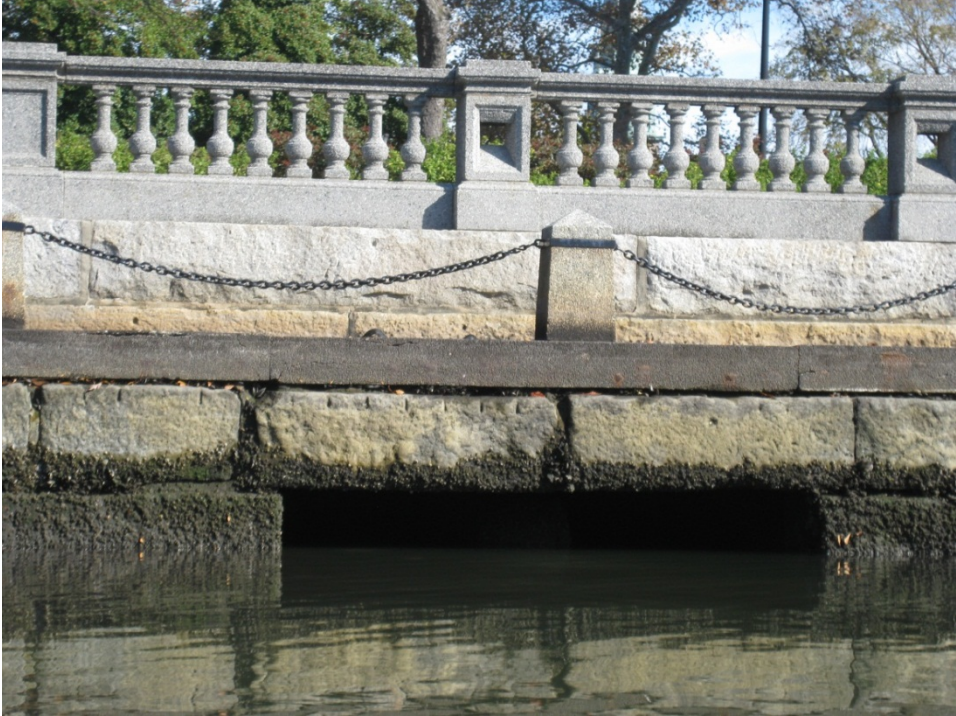
| | <b>Photo No.: B-34</b> |

| | <b>Location:</b><br>Outfall D143000-<br>Elevation View |
| | <b>Description:</b><br>8.5'x3' Conc. Culvert |

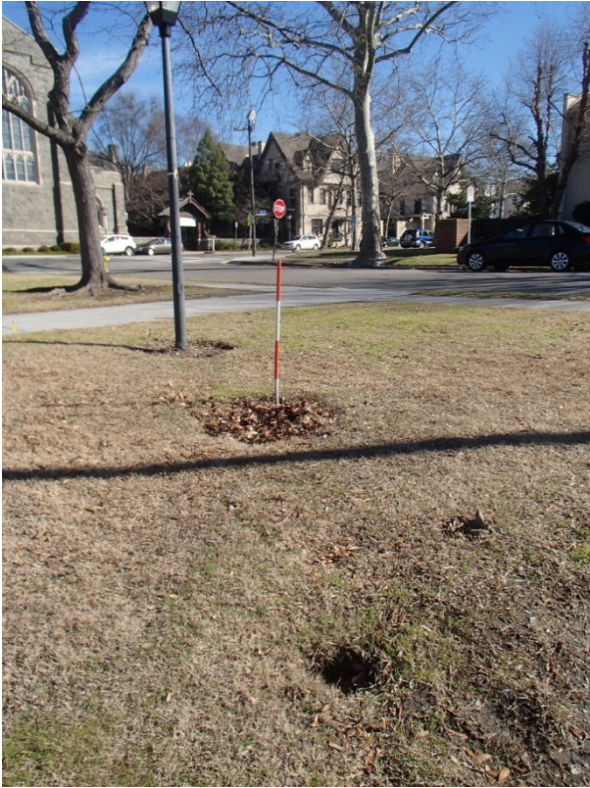
| | <p><b>Photo No.: B-35</b></p> <p><b>Location:</b><br/>Outfall D1486-View at Top of Outfall</p> <p><b>Description:</b><br/>2- Areas of settlement along length of pipe- 8" Dia x 1'D &amp; 4"Dia x 6"D</p> <p><b>1/13/2014</b></p> |

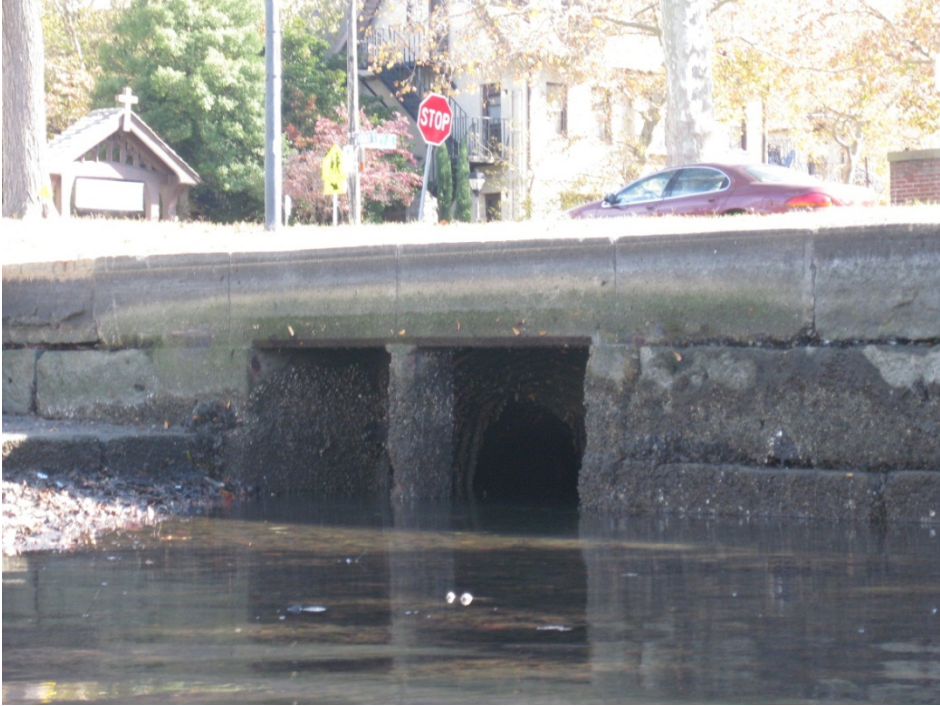
| | <p><b>Photo No.: B-36</b></p> <p><b>Location:</b><br/>Outfall D1486- Elevation View</p> <p><b>Description:</b><br/>4'x8.5' Culvert</p> <p><b>11/11/2013</b></p> |

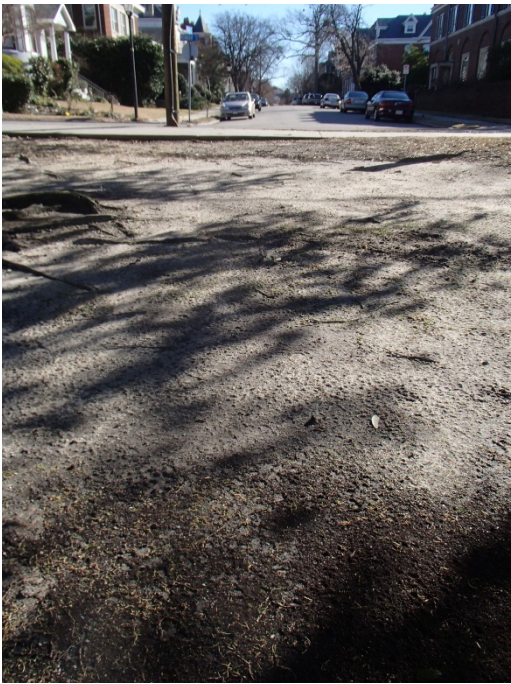
| | <b>Photo No.: B-37</b> |

| | <b>Location:</b><br>Outfall D1489-View at Top of Outfall |
| | <b>Description:</b><br>No Deficiencies Noted |

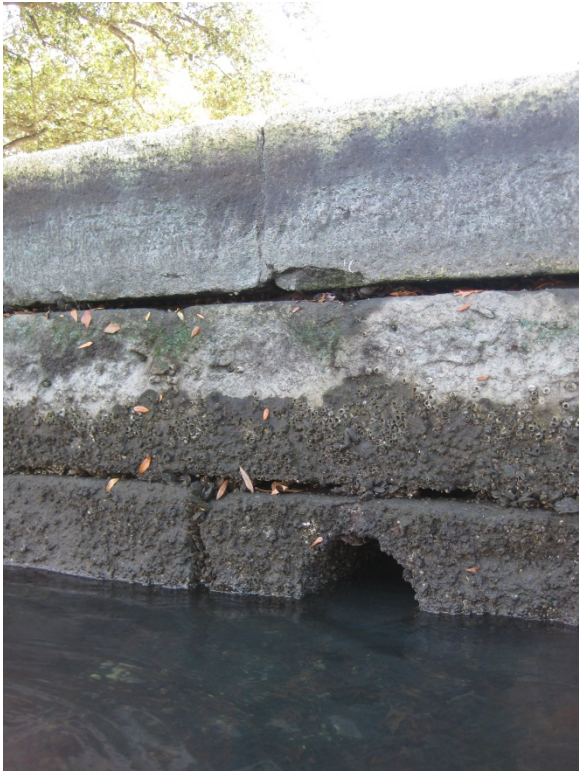
| | <b>Photo No.: B-38</b> |

| | <b>Location:</b><br>Outfall D1489-Elevation View |
| | <b>Description:</b><br>8" Pipe |

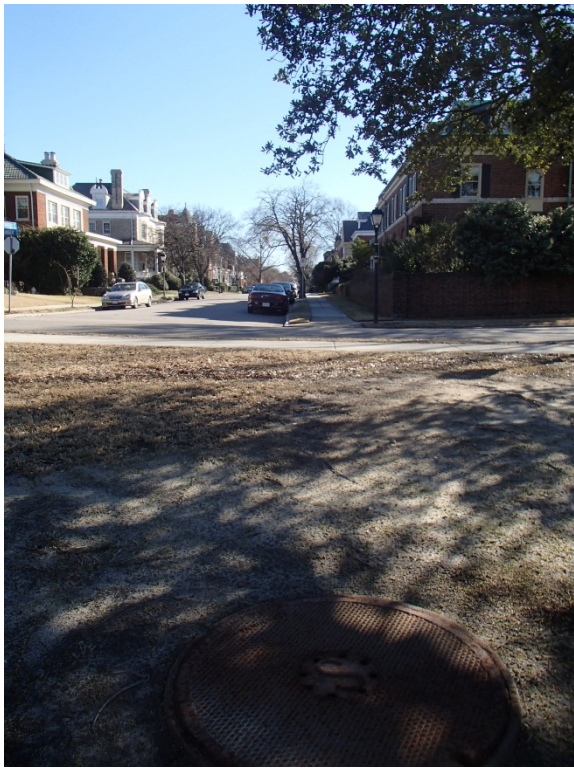
| | <b>Photo No.: B-39</b> |

| | <b>Location:</b><br>Outfall D1491-View at Top of Outfall |
| | <b>Description:</b><br>No Deficiencies Noted |

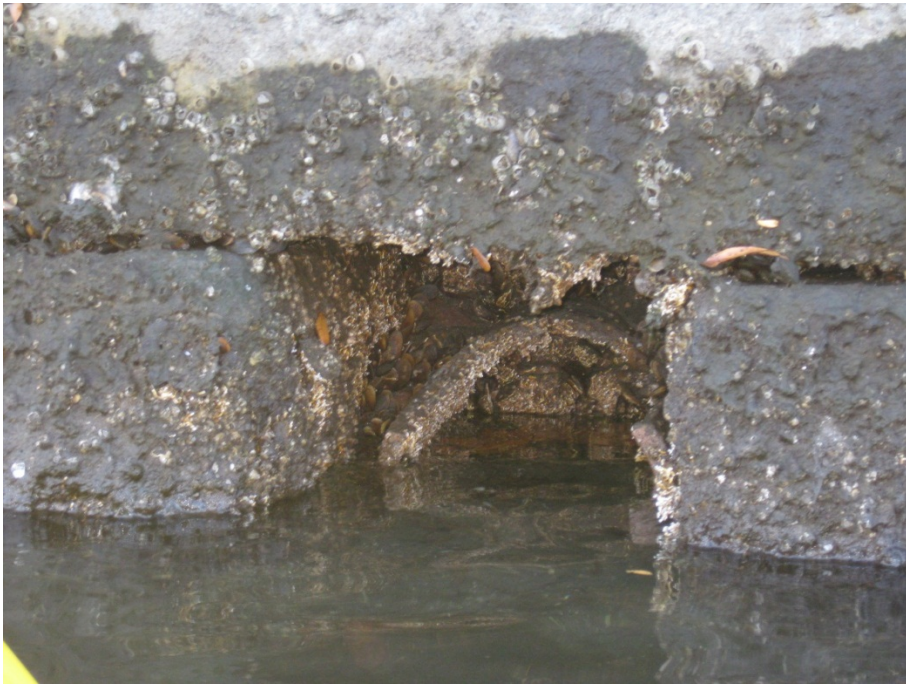
| | <b>Photo No.: B-40</b> |

| | <b>Location:</b><br>Outfall D1491-Elevation View |
| | <b>Description:</b><br>12" Pipe (appears to be sealed) |

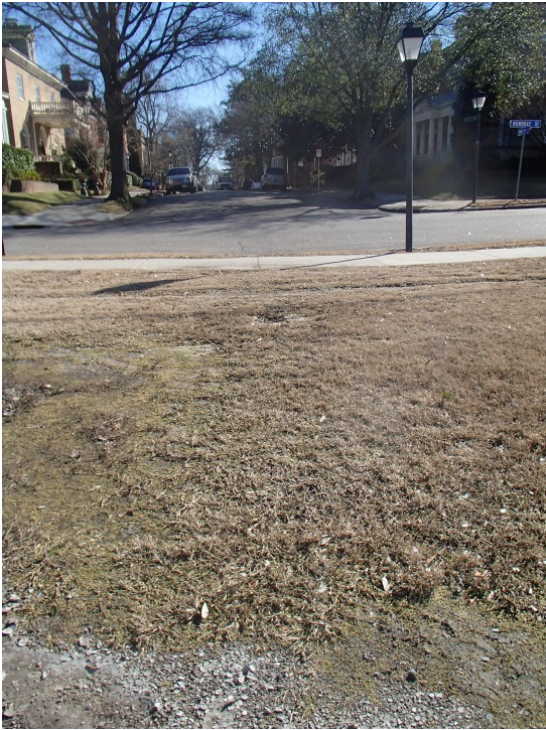
| | <b>Photo No.: B-41</b> |

| | <b>Location:</b><br>Outfall D1496-View at Top of Outfall |
| | <b>Description:</b><br>-Fill along bulkhead at pipe.<br><i>Not in Picture:</i><br>-Settlement 10" Dia x up to 3"D<br>-Erosion on either side of sidewalk along pipe<br>Approx. 10SF |

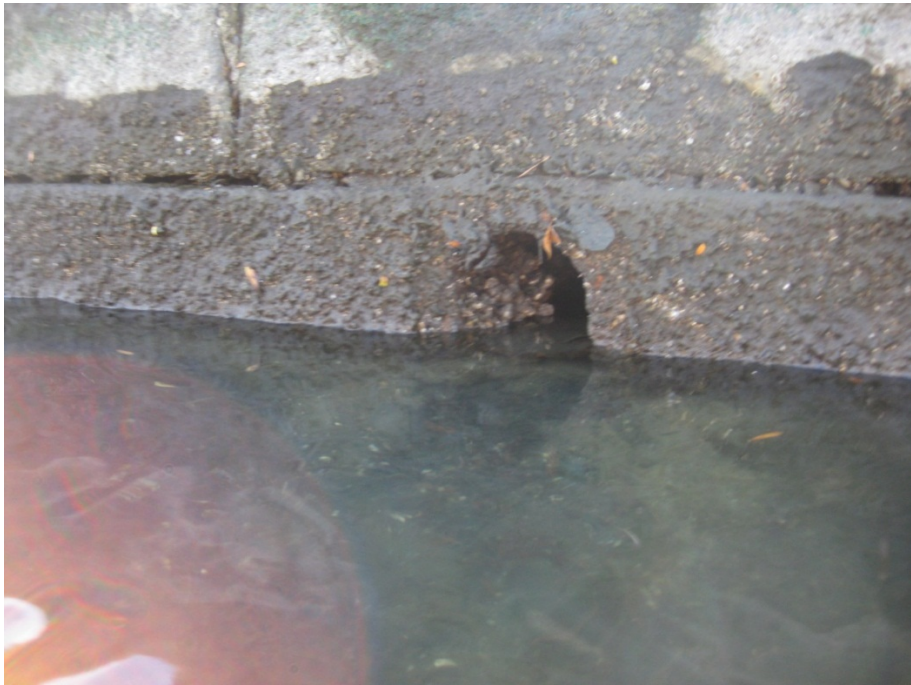
| | <b>Photo No.: B-42</b> |

| | <b>Location:</b><br>Outfall D1496-Elevation View |
| | <b>Description:</b><br>12" RCP |

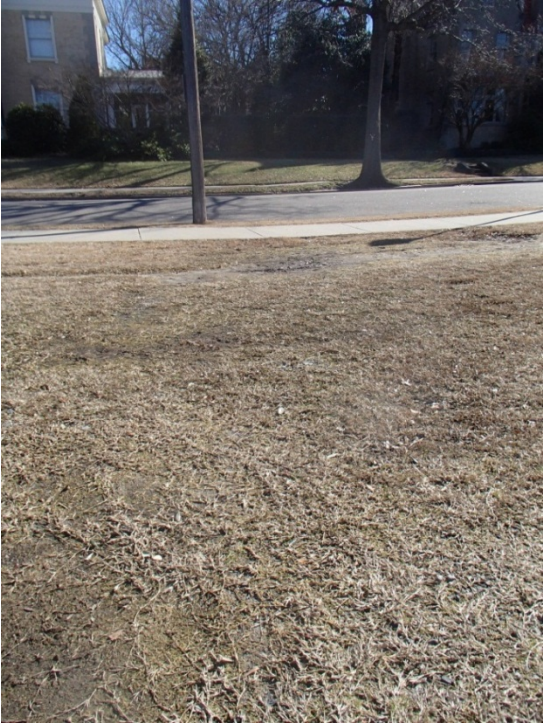
| | <b>Photo No.: B-43</b> |

| | <b>Location:</b><br>Outfall D14101-View<br>at Top of Outfall |
| | <b>Description:</b><br>No Deficiencies Noted |

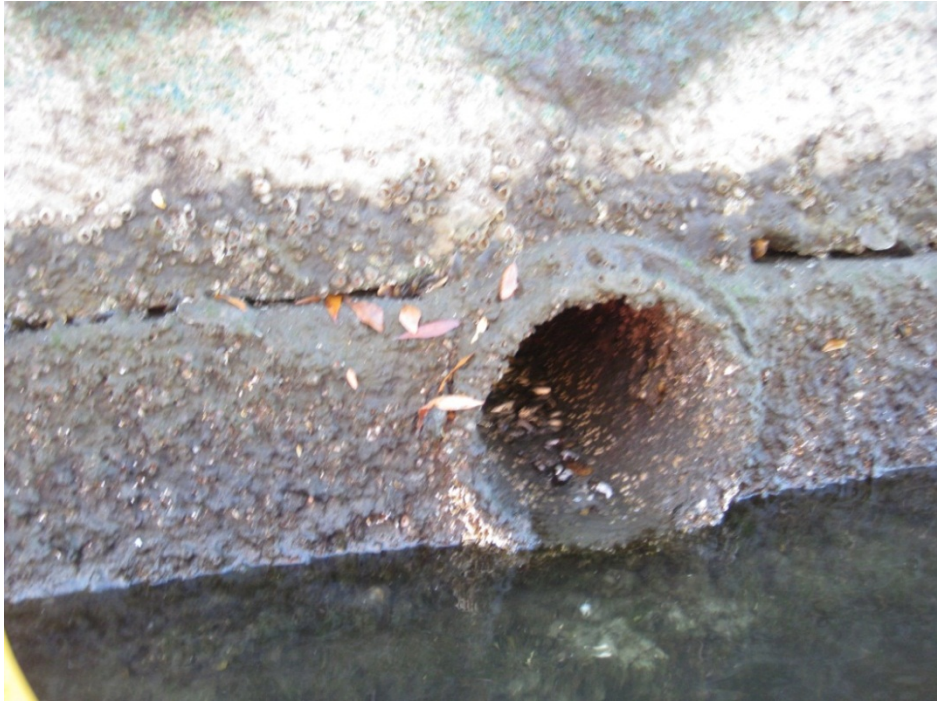
| | <b>Photo No.: B-44</b> |

| | <b>Location:</b><br>Outfall D14101-<br>Elevation View |
| | <b>Description:</b><br>12" DIP |

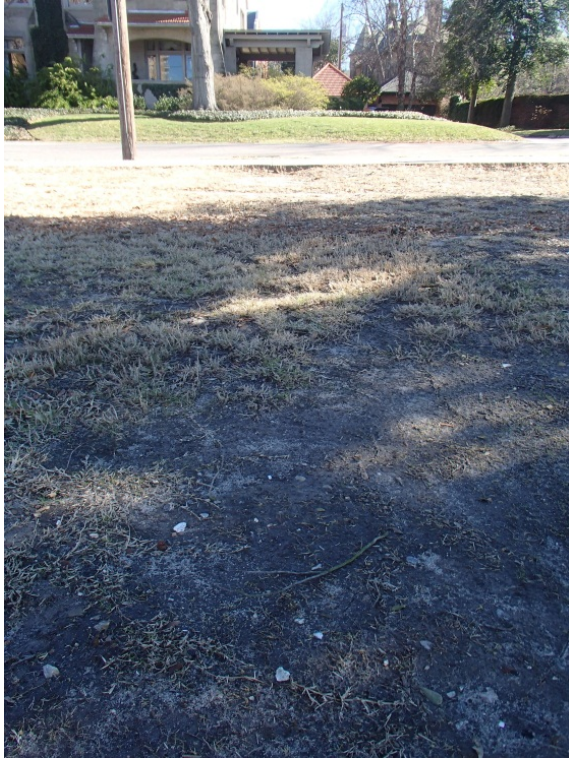
| | <b>Photo No.: B-45</b> |

| | <b>Location:</b><br>Outfall D14104-View<br>at Top of Outfall |
| | <b>Description:</b><br>Erosion on west side of<br>sidewalk 4'wx3"D |

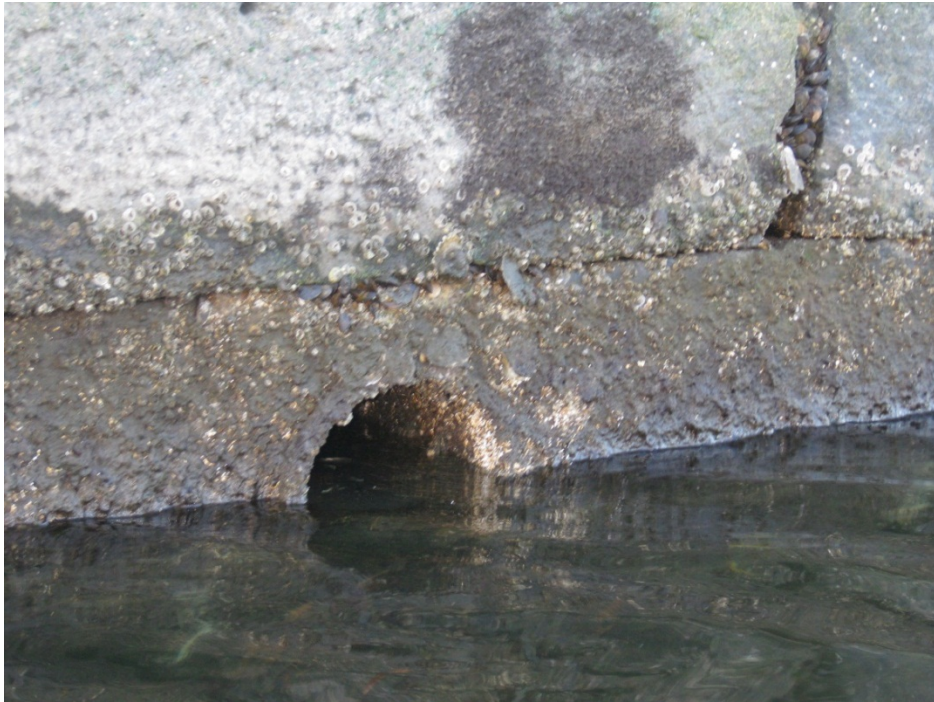
| | <b>Photo No.: B-46</b> |

| | <b>Location:</b><br>Outfall D14104-<br>Elevation View |
| | <b>Description:</b><br>12" DIP |

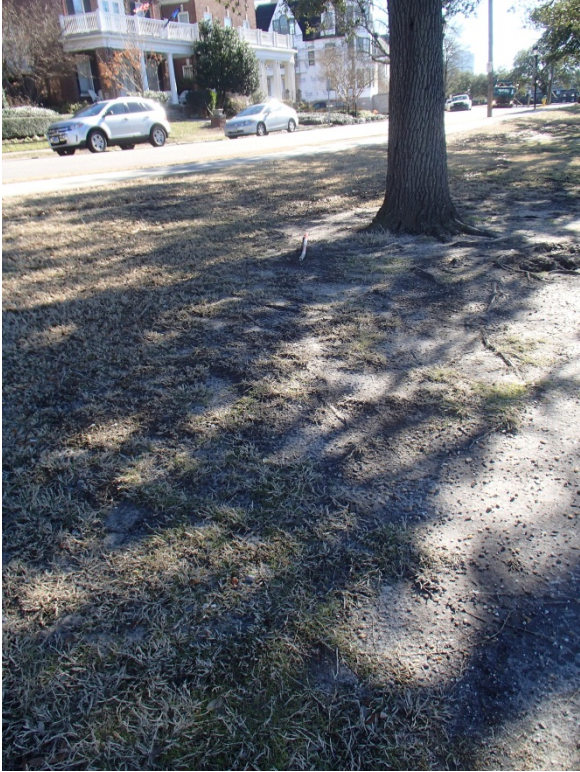
| | <p><b>Photo No.: B-47</b></p> <p><b>Location:</b><br/>Outfall D14107-View<br/>at Top of Outfall</p> <p><b>Description:</b><br/>No Deficiencies Noted</p> <p><b>1/13/2014</b></p> |

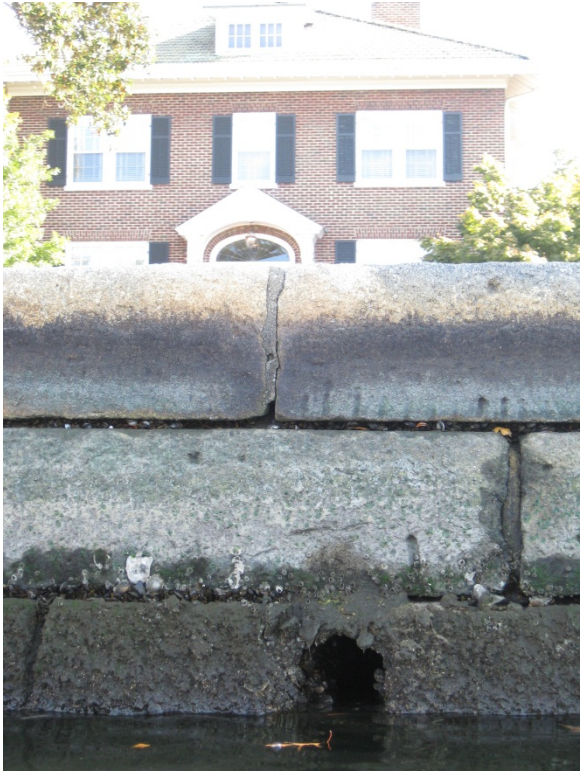
| | <p><b>Photo No.: B-48</b></p> <p><b>Location:</b><br/>Outfall D14107-<br/>Elevation View</p> <p><b>Description:</b><br/>12" Iron</p> <p><b>11/11/2013</b></p> |

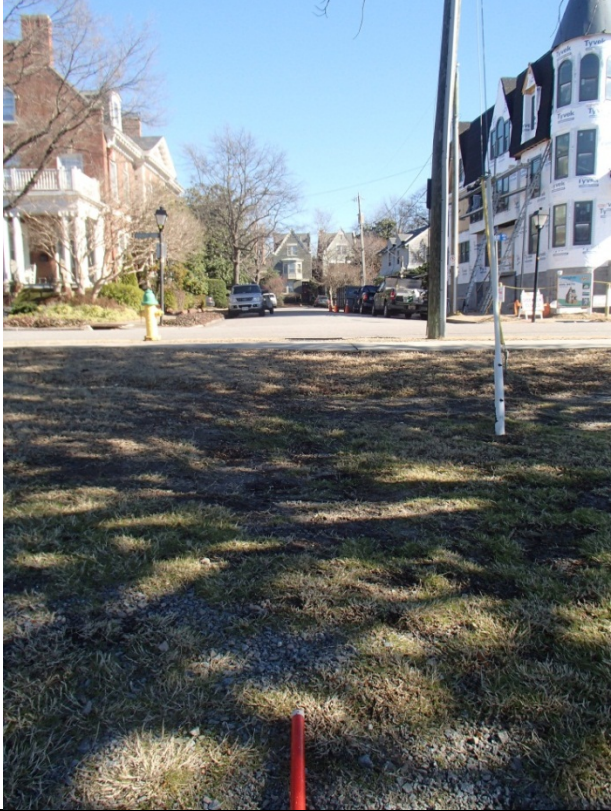
| | <b>Photo No.: B-49</b> |

| | <b>Location:</b><br>Outfall D14110-View<br>at Top of Outfall |
| | <b>Description:</b><br><i>Not in Picture:</i><br>10'L x 4"W area along<br>pipe where stone has<br>been placed |

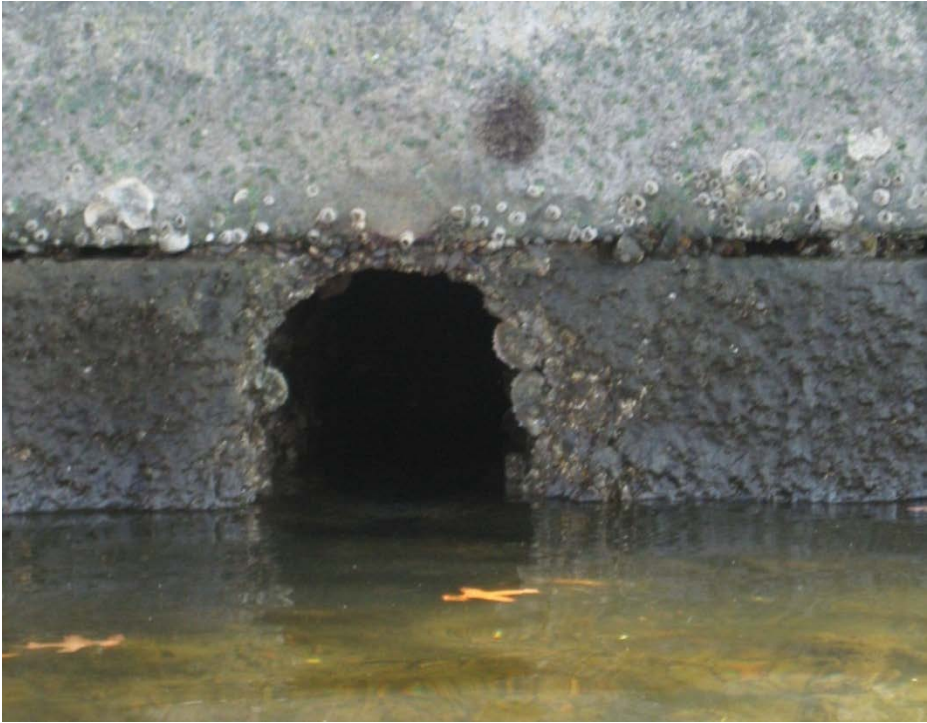
| | <b>Photo No.: B-50</b> |

| | <b>Location:</b><br>Outfall D14110-<br>Elevation View |
| | <b>Description:</b><br>15" PVC |

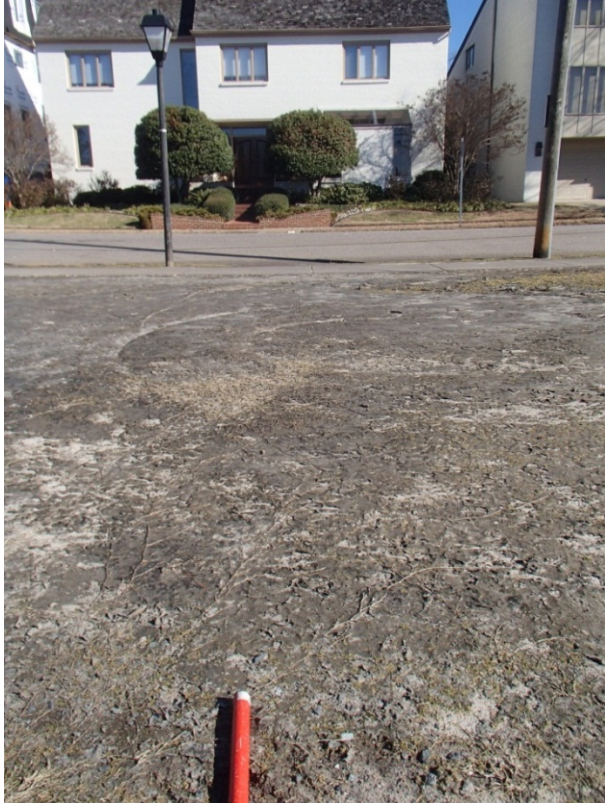
| | <b>Photo No.: B-51</b> |

| | <b>Location:</b><br>Outfall D14116-View<br>at Top of Outfall |
| | <b>Description:</b><br>No Deficiencies Noted |

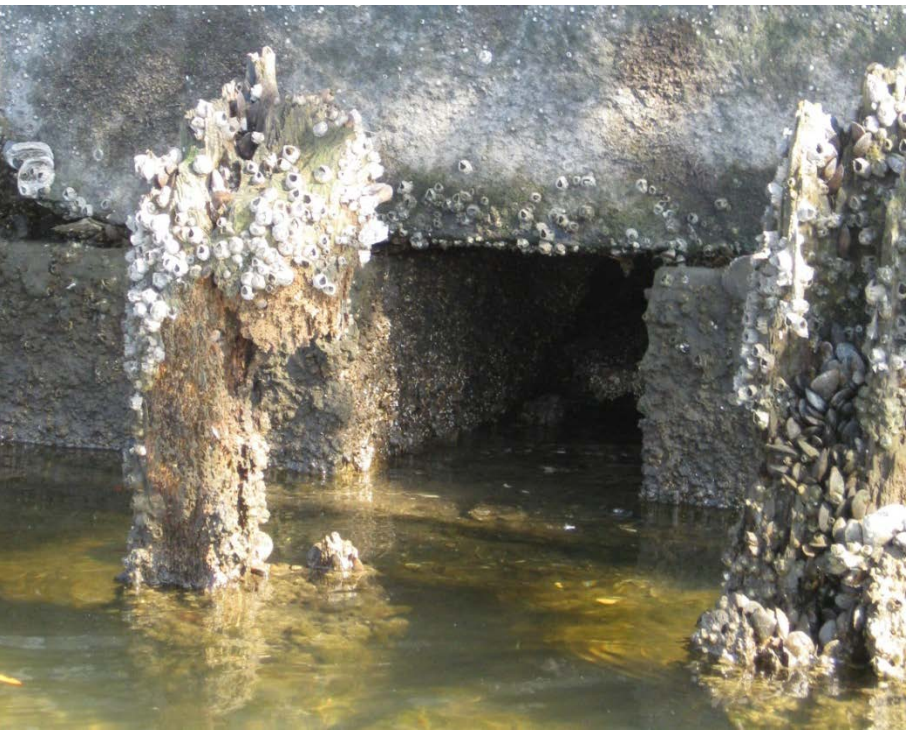
| | <b>Photo No.: B-52</b> |

| | <b>Location:</b><br>Outfall D14116-<br>Elevation View |
| | <b>Description:</b><br>12" PVC |

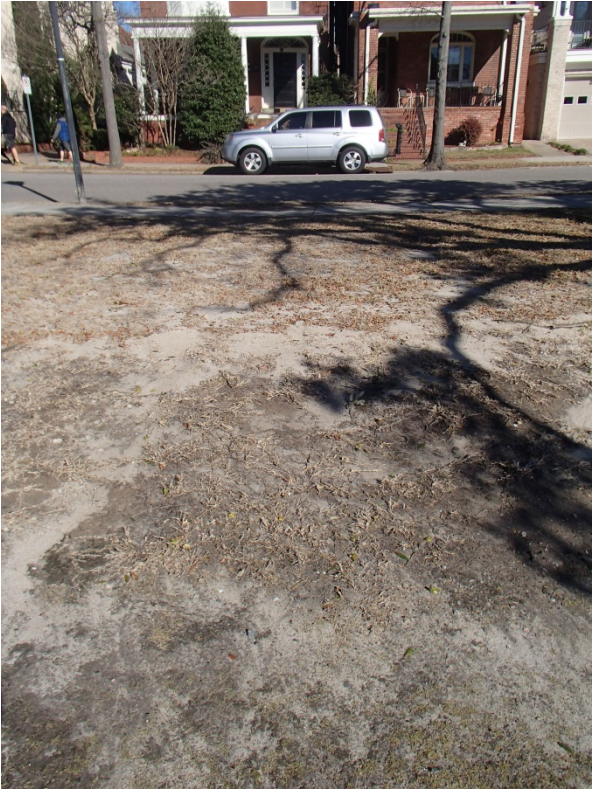
| | <b>Photo No.: B-53</b> |

| | <b>Location:</b><br>Outfall D14121-View<br>at Top of Outfall |
| | <b>Description:</b><br>No Deficiencies Noted |

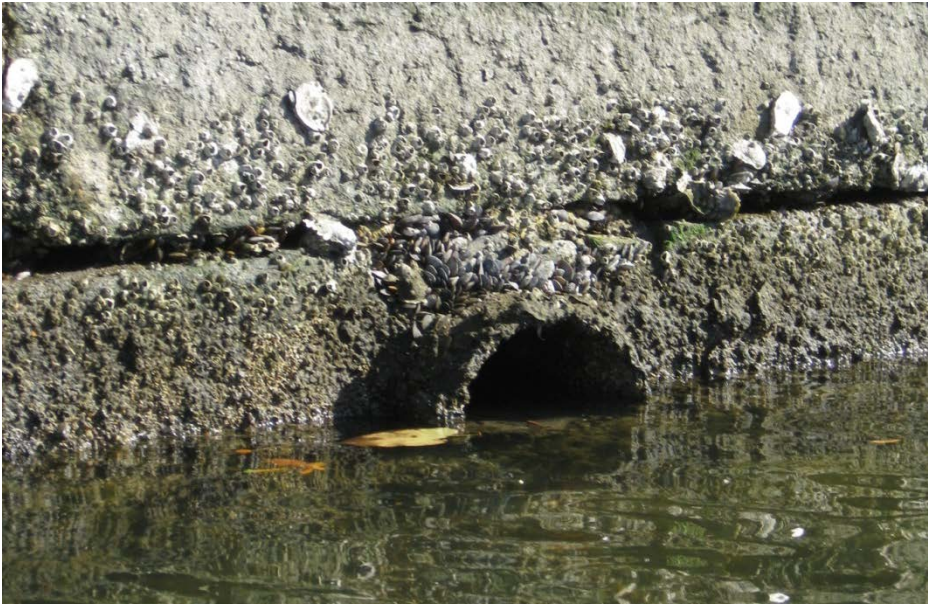
| | <b>Photo No.: B-54</b> |

| | <b>Location:</b><br>Outfall D14121-<br>Elevation View |
| | <b>Description:</b><br>12" DIP |

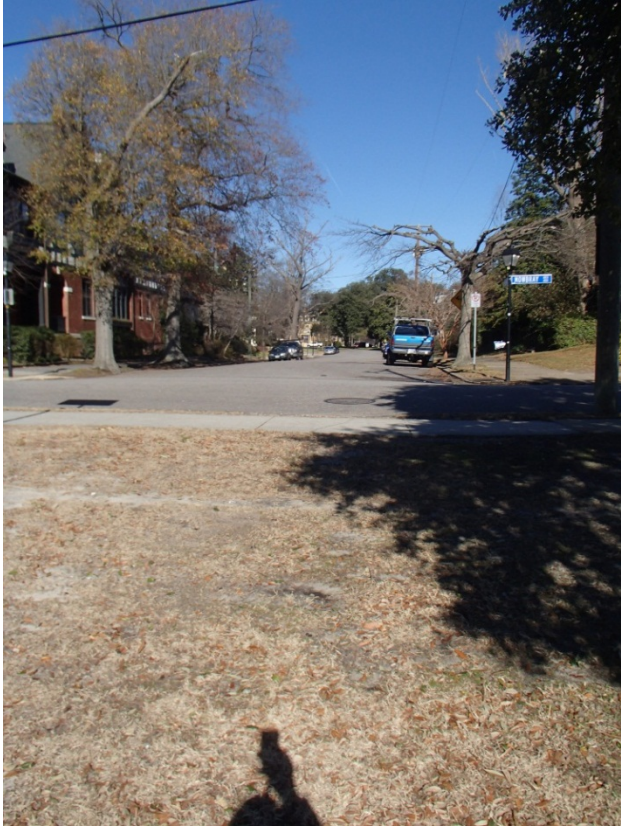
| | <b>Photo No.: B-55</b> |

| | <b>Location:</b><br>Outfall D14124-View<br>at Top of Outfall |
| | <b>Description:</b><br>No Deficiencies Noted |

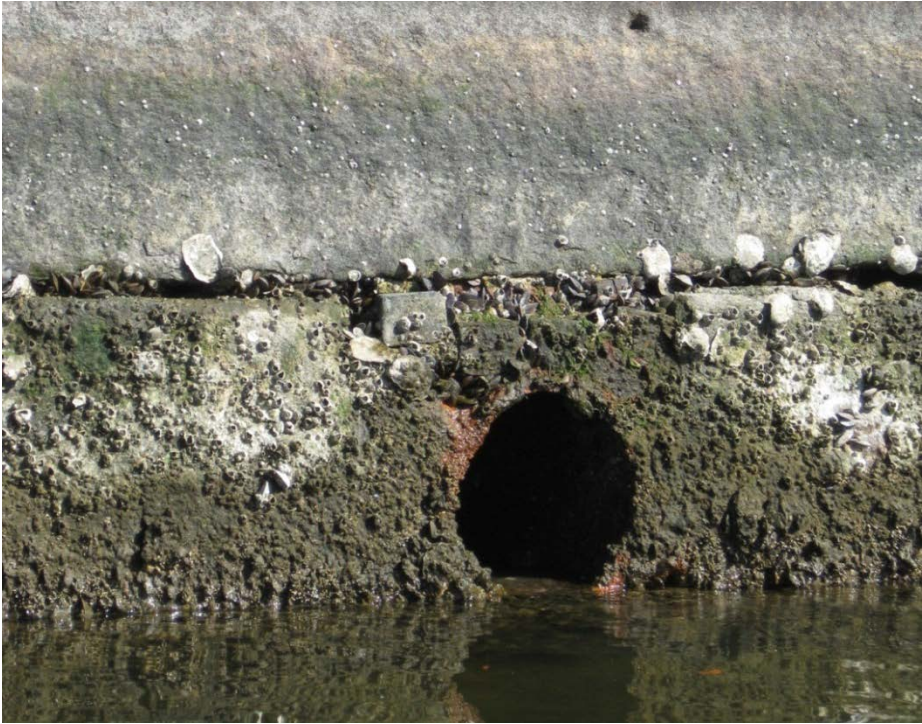
| | <b>Photo No.: B-56</b> |

| | <b>Location:</b><br>Outfall D14124-<br>Elevation View |
| | <b>Description:</b><br>12" DIP |

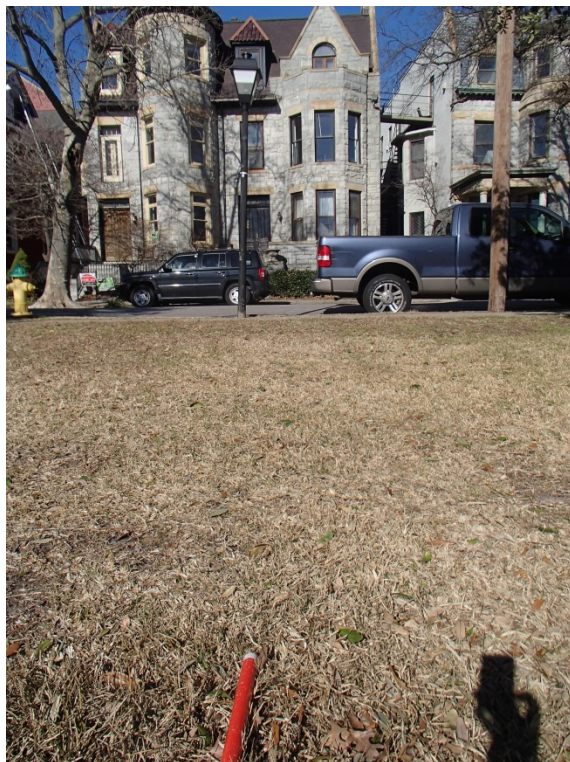
**Photo No.: B-57****Location:**

Outfall D14130-View  
at Top of Outfall

Settlement  
6'Lx3.5'Wx3"D East  
of pipe(12" PVC)

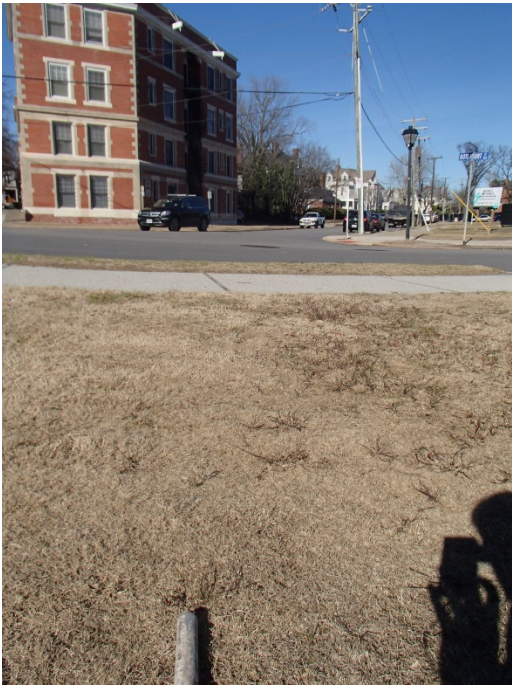
| | <b>Photo No.: B-58</b> |

| | <b>Location:</b><br>Outfall D14200-View<br>at Top of Outfall |
| | <b>Description:</b><br>No Deficiencies Noted<br>(36" RCP) |

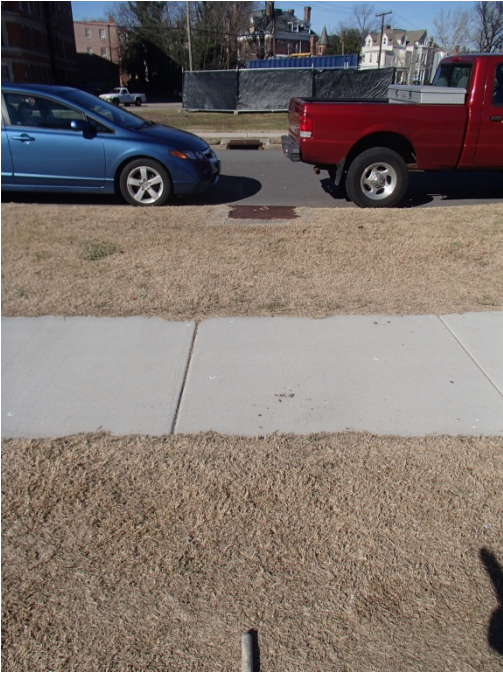
| | <b>Photo No.: B-59</b><br><br><b>Location:</b><br>Outfall D1482-View at Top of Outfall<br><br><b>Description:</b><br>No Deficiencies Noted<br><br><b>1/13/2014</b> |

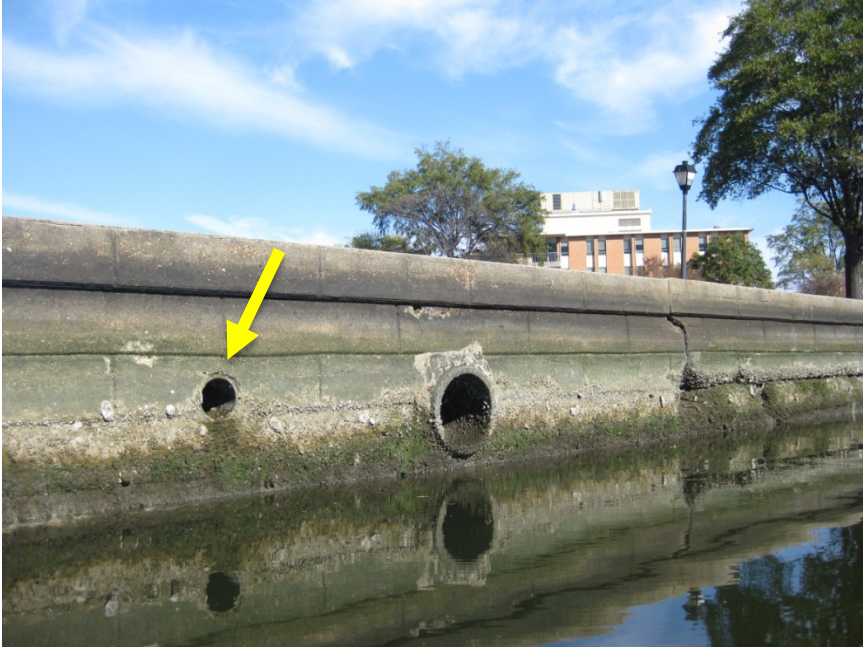
| | <b>Photo No.: B-60</b><br><br><b>Location:</b><br>Outfall D1482-Elevation View<br><br><b>Description:</b><br>15"RCP<br><br><b>11/11/2013</b> |

| Outfall | Size | Deficiencies Noted |
|---|---|---|
| D1482 | 15" pipe | Repairs needed at outfall: Excavate, realign, wrap pipe and backfill. |
