# Hague Stormwater Evaluation and Improvement Concepts Report

City of Norfolk

*August 13, 2014*

moffatt & nichol

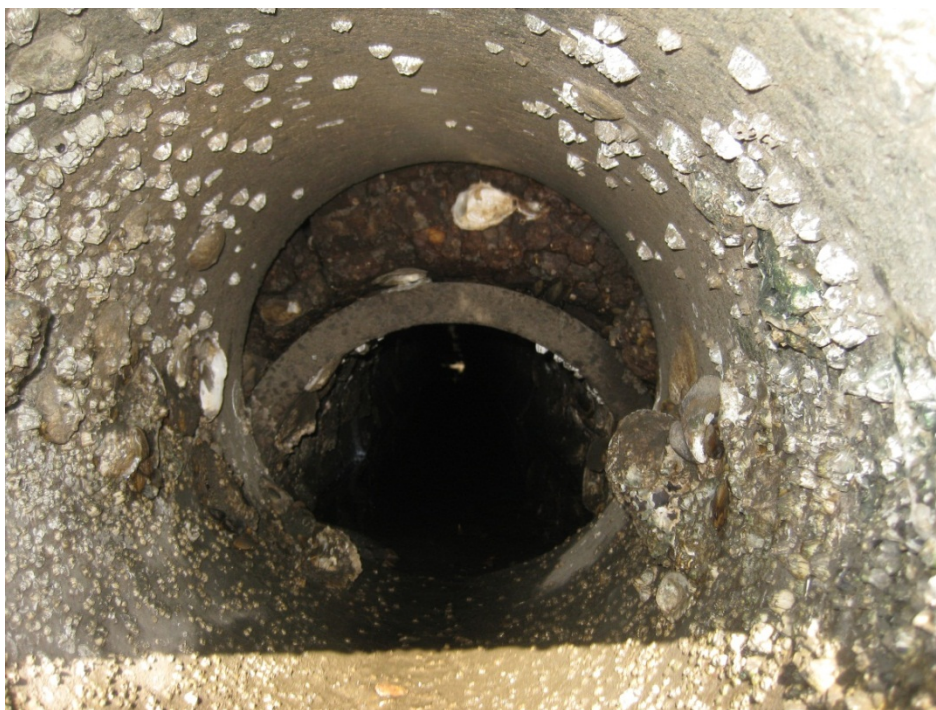
**Photo No.: B-61****Location:**

Outfall D1482-  
Elevation View

| Outfall | Size | Deficiencies Noted |
|---|---|---|
| D1482 | 15" pipe | Repairs needed at outfall: Excavate, realign, wrap pipe and backfill. |

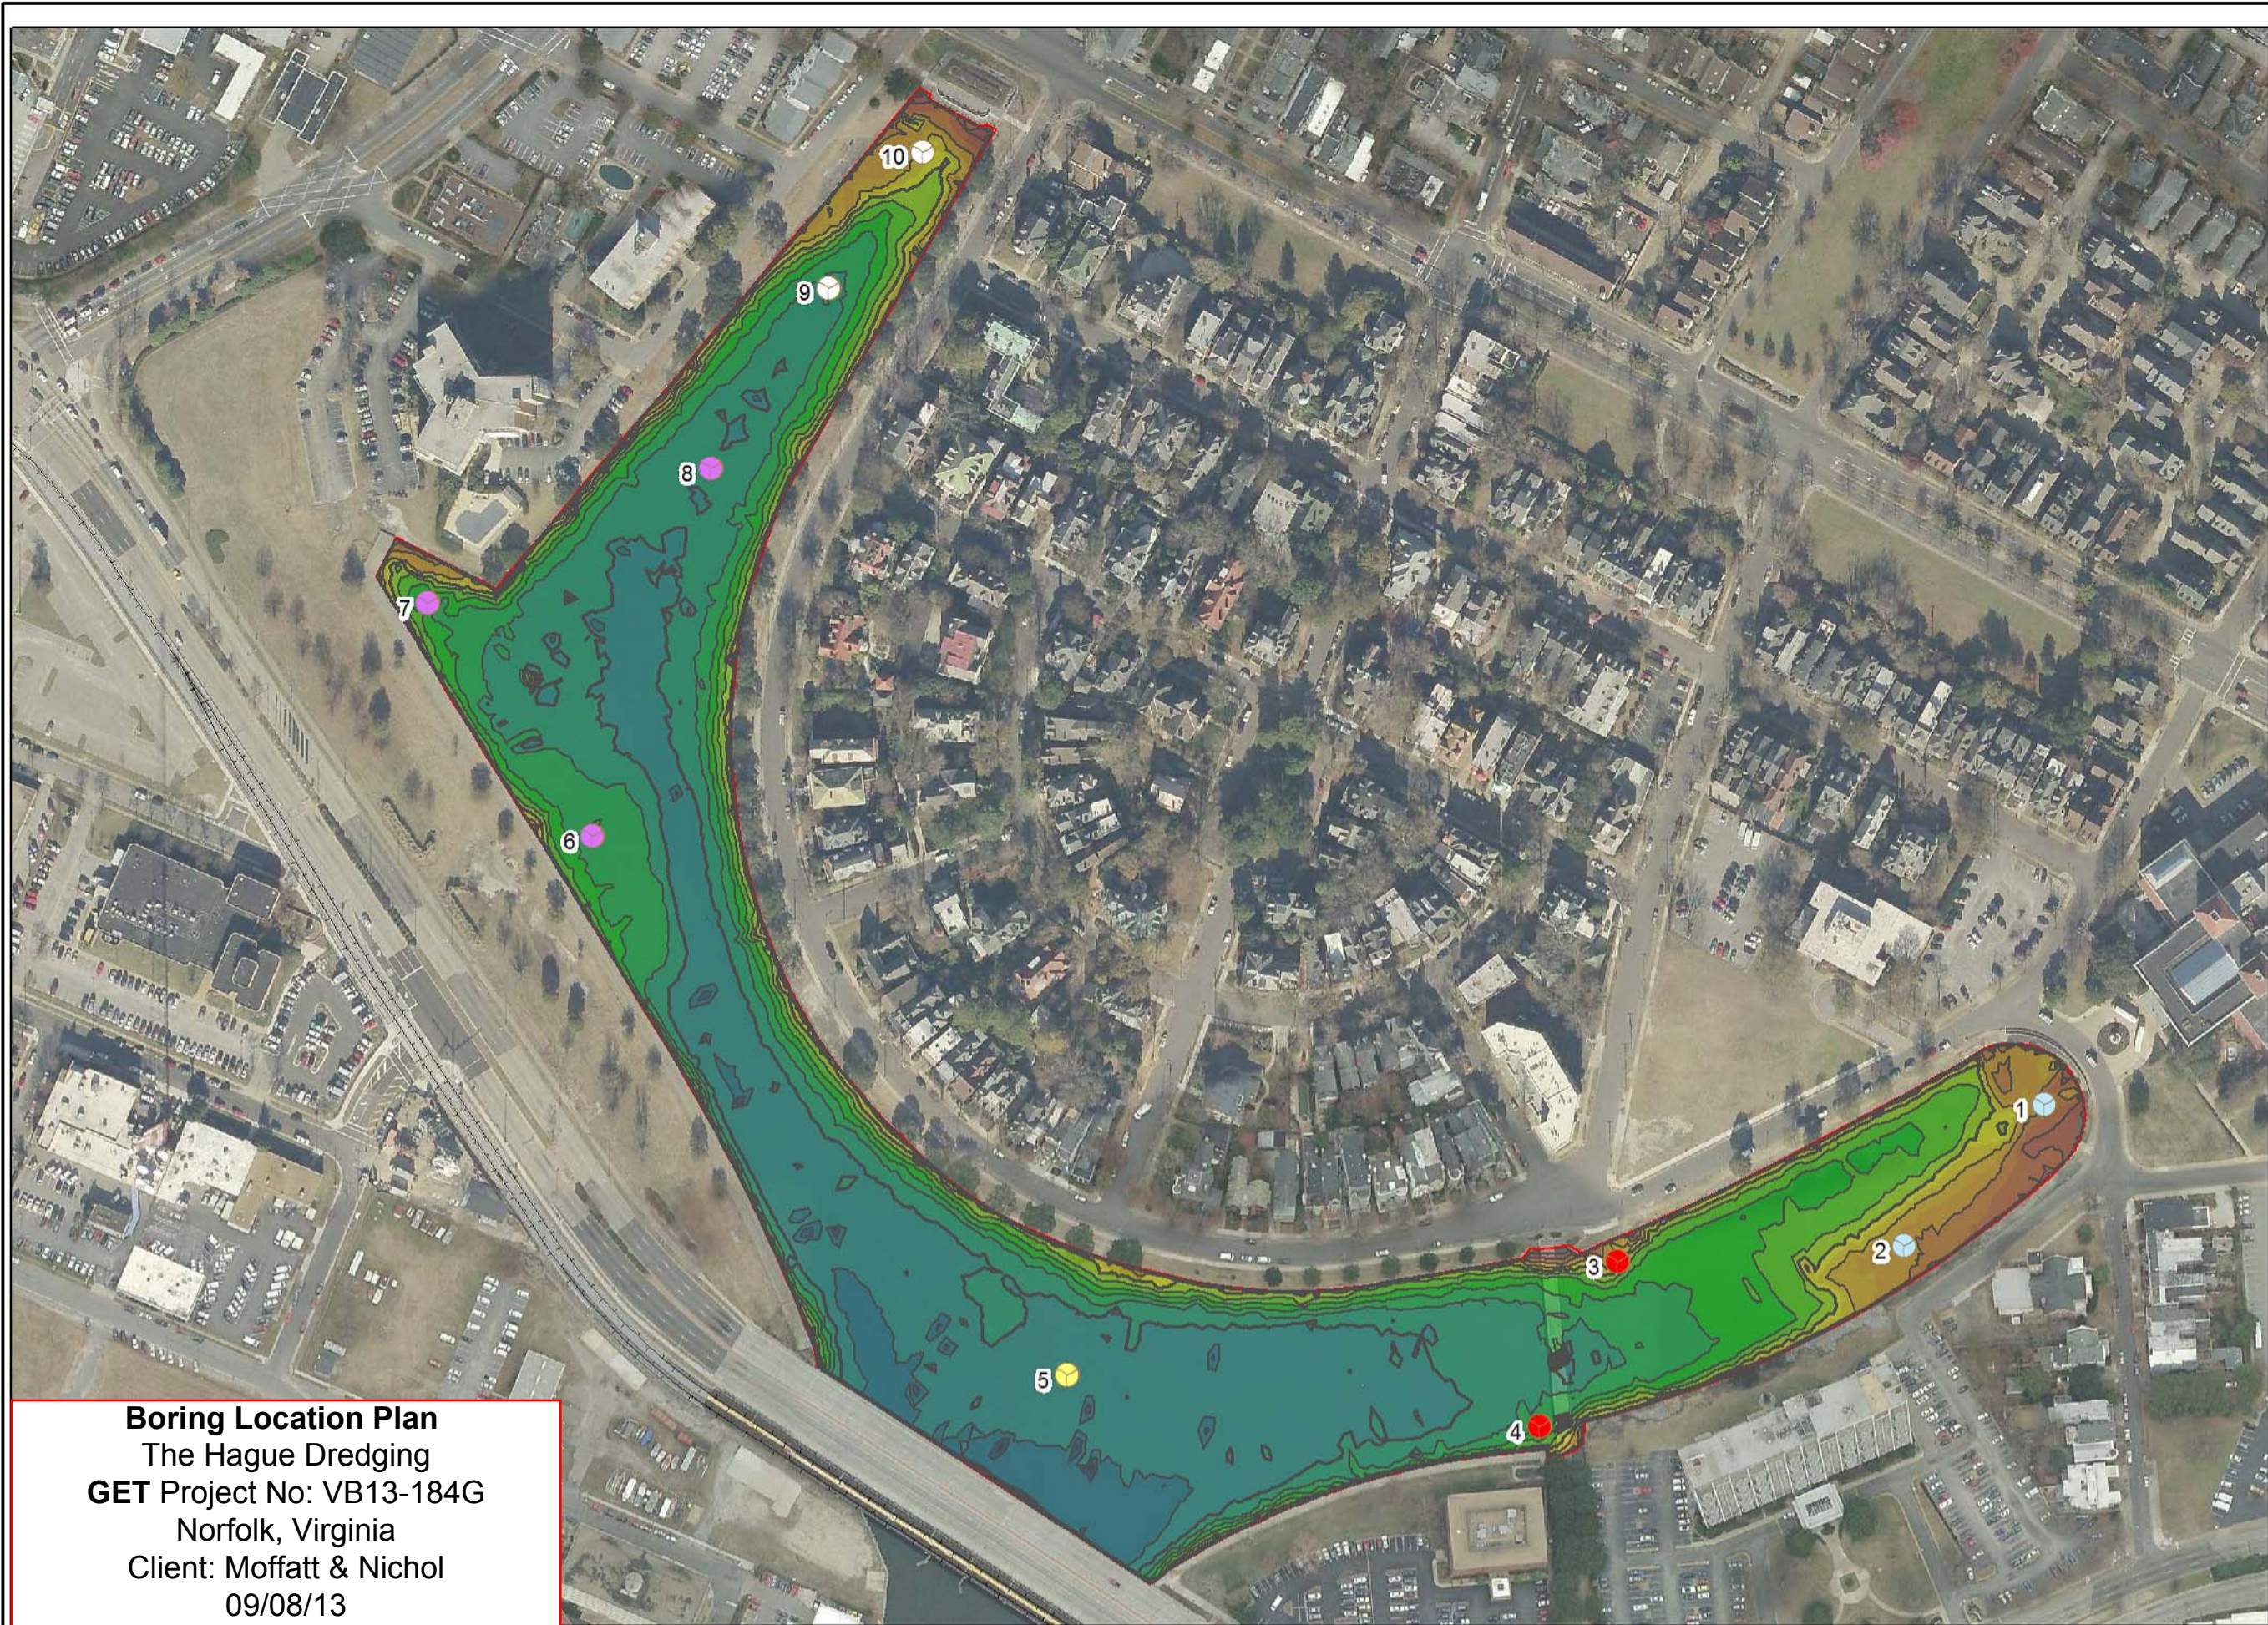
**APPENDIX II**  
**BORING LOCATION PLAN**

**Boring Location Plan**  
The Hague Dredging  
**GET** Project No: VB13-184G  
Norfolk, Virginia  
Client: Moffatt & Nichol  
09/08/13

In order to explore the general subsurface soil types, ten (10) 3-inch diameter sediment samples, designated as H-1 through H-10, were advanced within the existing body of water with the use of a Vibecore-D sediment sampler. The tube samples were obtained at depths ranging from approximately 2 to 12 feet below the current water elevation (from the mud line elevation to depths of approximately 6 feet below the mud line). A composite sample was created in the field at each of the boring locations. The composite soil samples were sealed in glass jars to prevent moisture loss and returned to the laboratory for classification and environmental testing.
