# NORFOLK

RE: VPDES Permit VA0088650

Please find enclosed the FY18 VPDES Annual Report for the City of Norfolk, submitted in accordance with Part I.E of the above referenced MS4 Phase I permit.

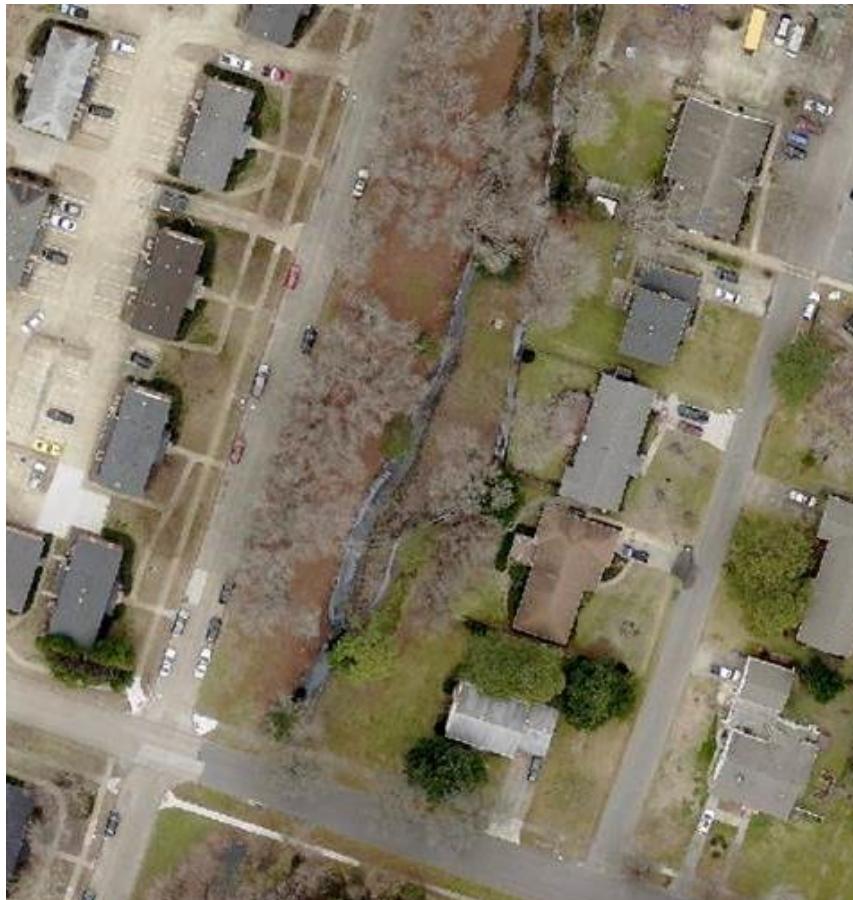
2015: Before Construction - Two Eroded Channels

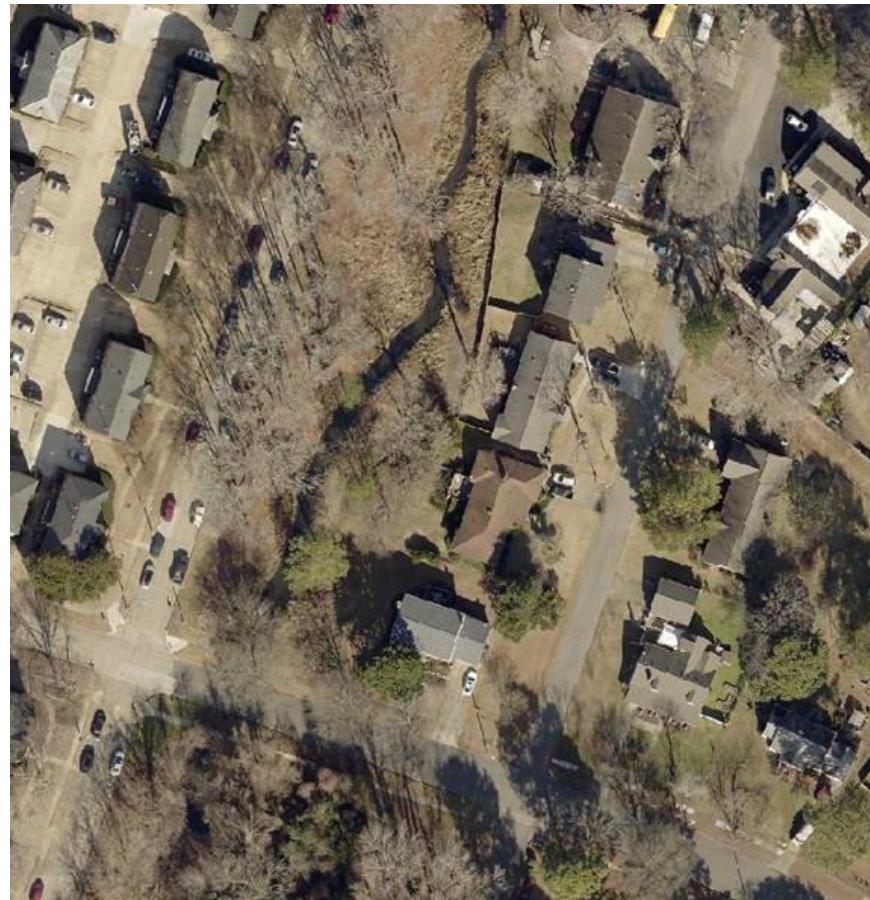
2018: After Construction - Single Restored Channel

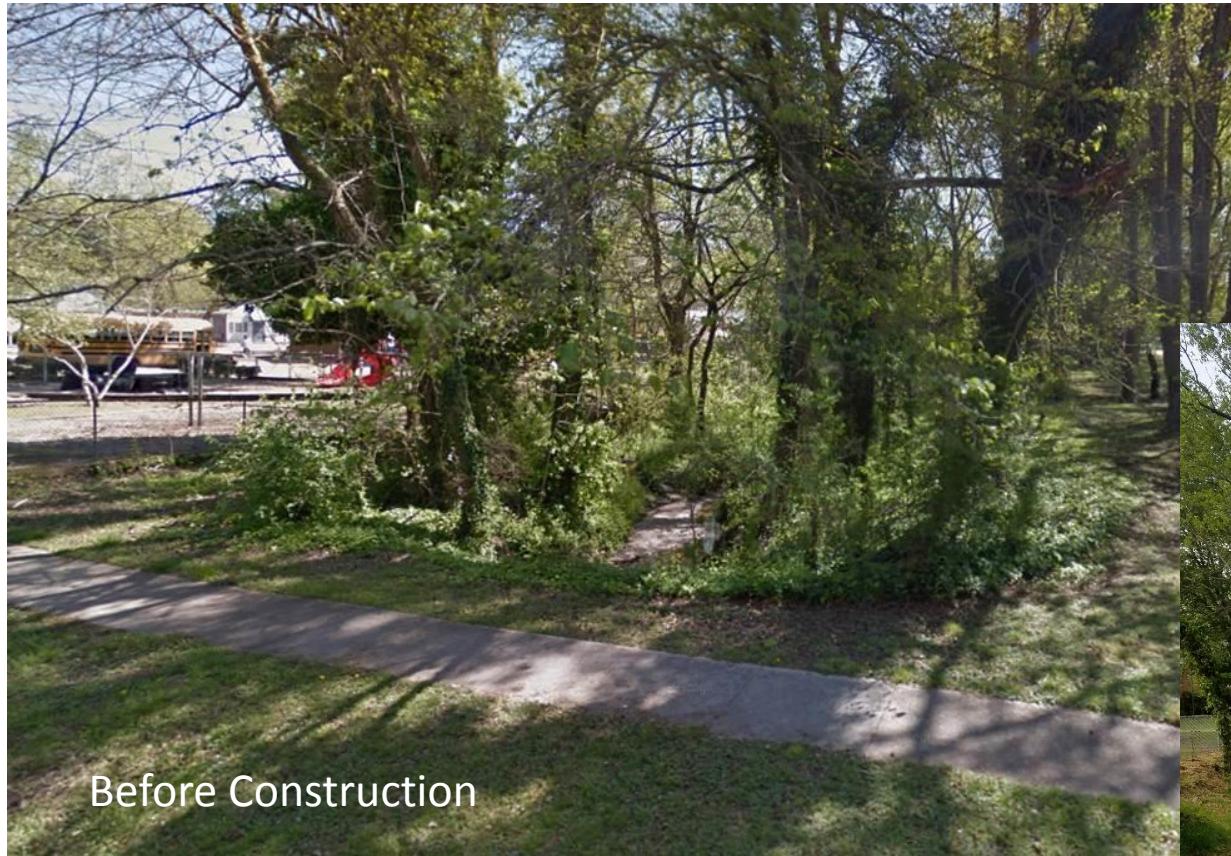
Before Construction

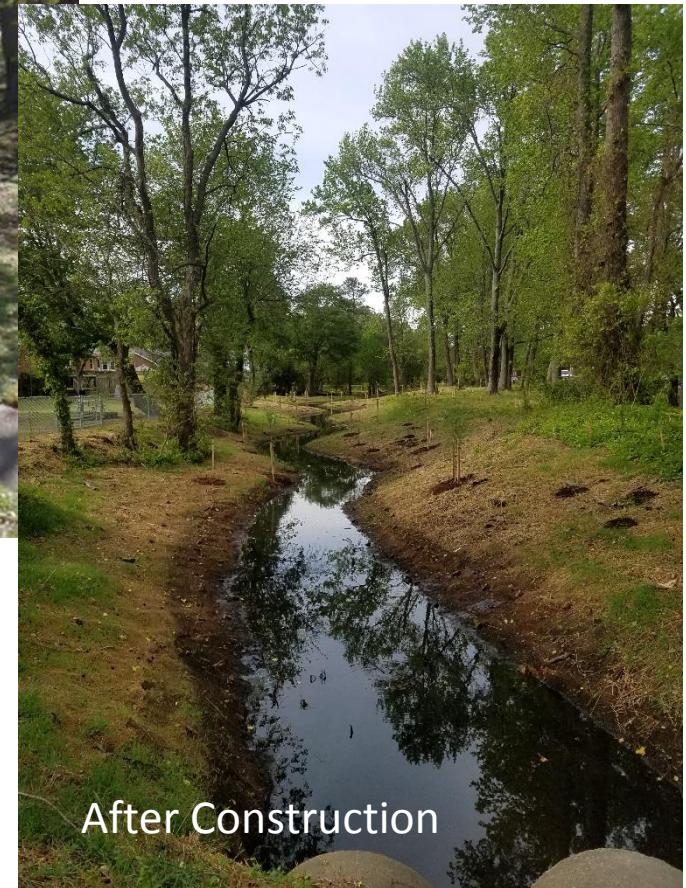
After Construction

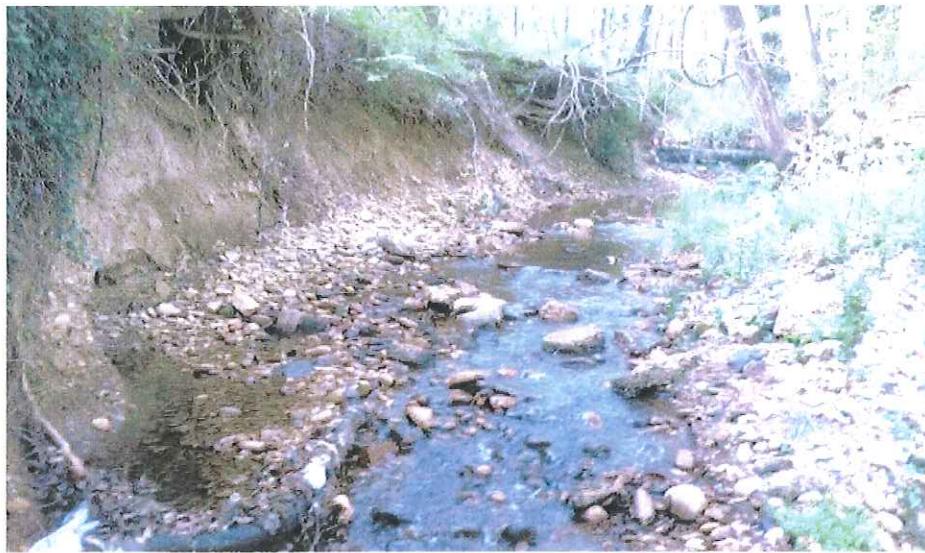
VDOT anticipates restoring Pikes Branch near Telegraph and Old Telegraph Road in late 2018.

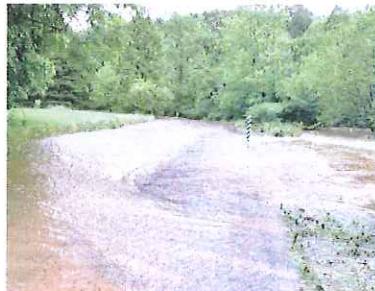
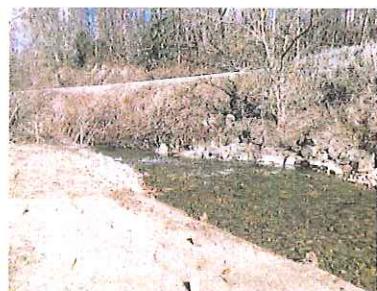
### Lithia Road

VDOT re-aligned a problematic section of stream channel along Back Creek in Botetourt County adjacent to Lithia Road. This project was to correct major flooding of the roadway while also providing a stable plan and profile and reconnecting the stream to a natural floodplain. The site has been planted and this spring we should see it looking green! See images for the project's before and after conditions.

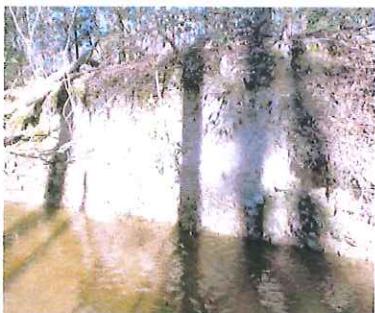
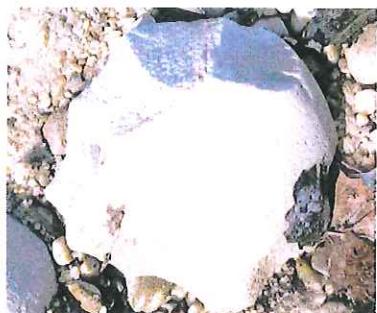
### Timsbury Creek at Richmond District Complex

Several thousand feet of Timsbury Creek flow through the Richmond District Complex. The site was identified as a potential candidate in 2016. Streambanks were experiencing active erosion and are now 20 foot vertical walls in an unstable condition. Construction began in December 2017. Approximately 2,150 linear feet will be restored with an anticipated construction completion date of April 2018. A unique challenge posed by this project was the presence of centuries' old tool making activities on site. A thorough archaeological investigation was conducted and as a result a portion of the site will be avoided to retain this historical resource.

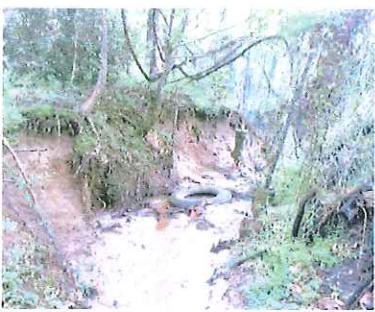
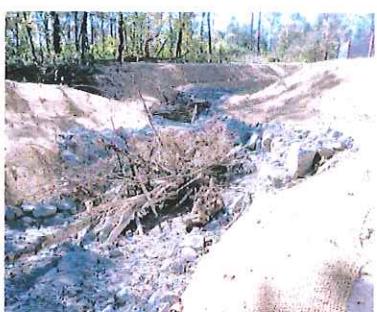
### Tributary to Skiffes Creek at Skiffes Area Headquarters

Skiffes Creek is located in James City County adjacent to VDOT offices northwest of Skiffes Creek Reservoir on Route 143. The site was identified as a potential candidate for stream restoration due to eroding streambanks and deposition to a downstream pond. The final design plan was completed in 2017. A total of 430 linear feet was restored utilizing natural channel design principles with completion in December of 2017. Part of the project incorporated a swale to collect and improve drainage along the perimeter of the VDOT site.

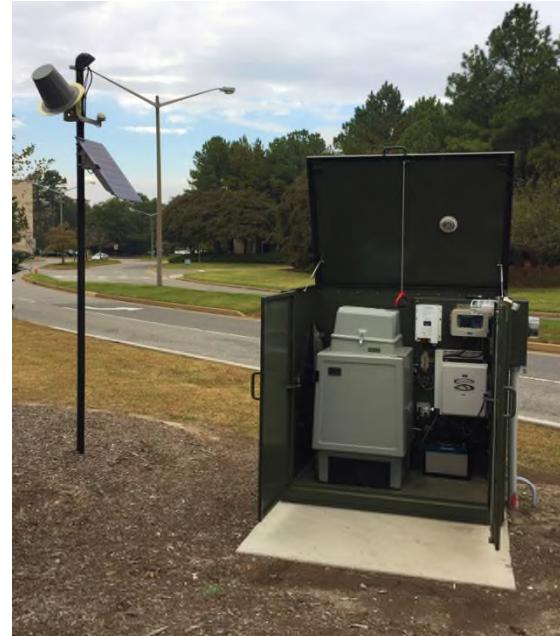
Figure 2. Ruggedized housing and components present at each stormwater monitoring station.

Discrete sampling for nutrients and sediment are triggered by the datalogger when stormflow conditions exist (as indicated by flow and water quality conditions). Samples are retained in the refrigerated sampler ( $\leq 6^{\circ}\text{C}$ ) until retrieved by HRSD field staff. Samples are retrieved within 24 hours of collection, transported in coolers ( $\leq 6^{\circ}\text{C}$ ), and delivered to the laboratory for preservation and analysis. The analytes measured have defined laboratory methods within 40 CFR Part 136 and TN is calculated as the sum of TKN and nitrate + nitrite. Detailed standard operating procedures for nutrient and sediment analysis are maintained at HRSD's CEL and available upon request.

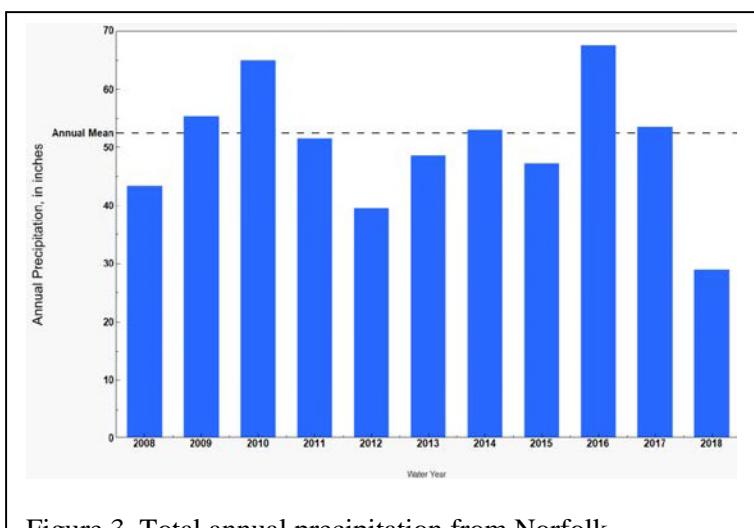
Figure 3. Total annual precipitation from Norfolk International Airport (NOAA) for water years 2008-2018 (blue bars) and the 10-year mean (dashed line).

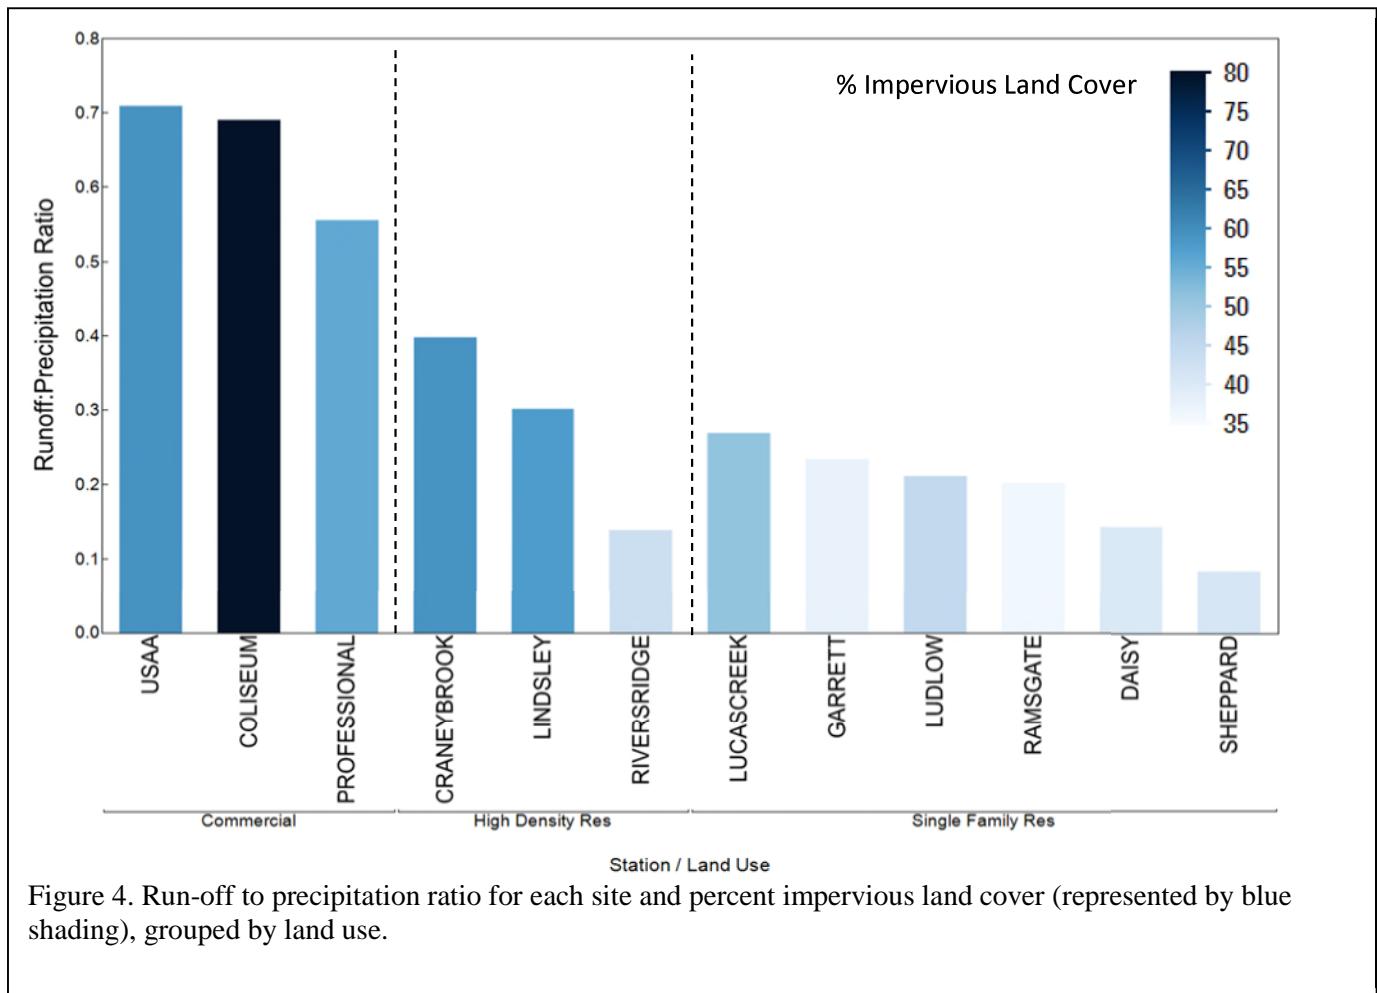
Figure 4. Run-off to precipitation ratio for each site and percent impervious land cover (represented by blue shading), grouped by land use.

As observed in the previous year's analysis, total annual discharges were highest at the commercial sites, followed by high density residential, and single family residential (Fig. 4). Commercial sites had the greatest amount of impervious surface compared to other land use types which were comprised more of turf grass and tree cover.

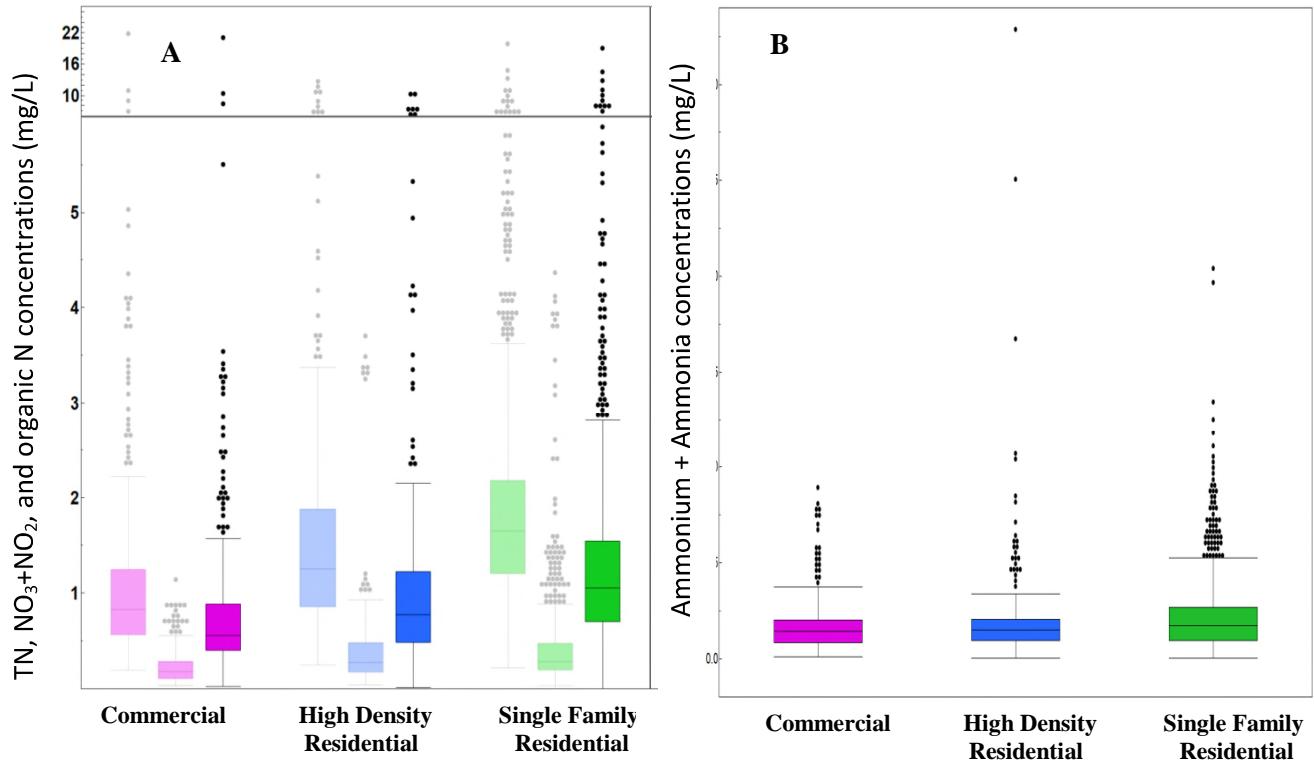
Figure 5. Box and whisker plots of concentrations (mg/L) for TN (left box), nitrate + nitrite (middle box), and organic N (right box) (A) and ammonium + ammonia (B) for the three land use types for water years 2016 and 2017. Outliers (black dots) denote concentrations outside error bars from higher discharge events. Solid line denotes break in scale.

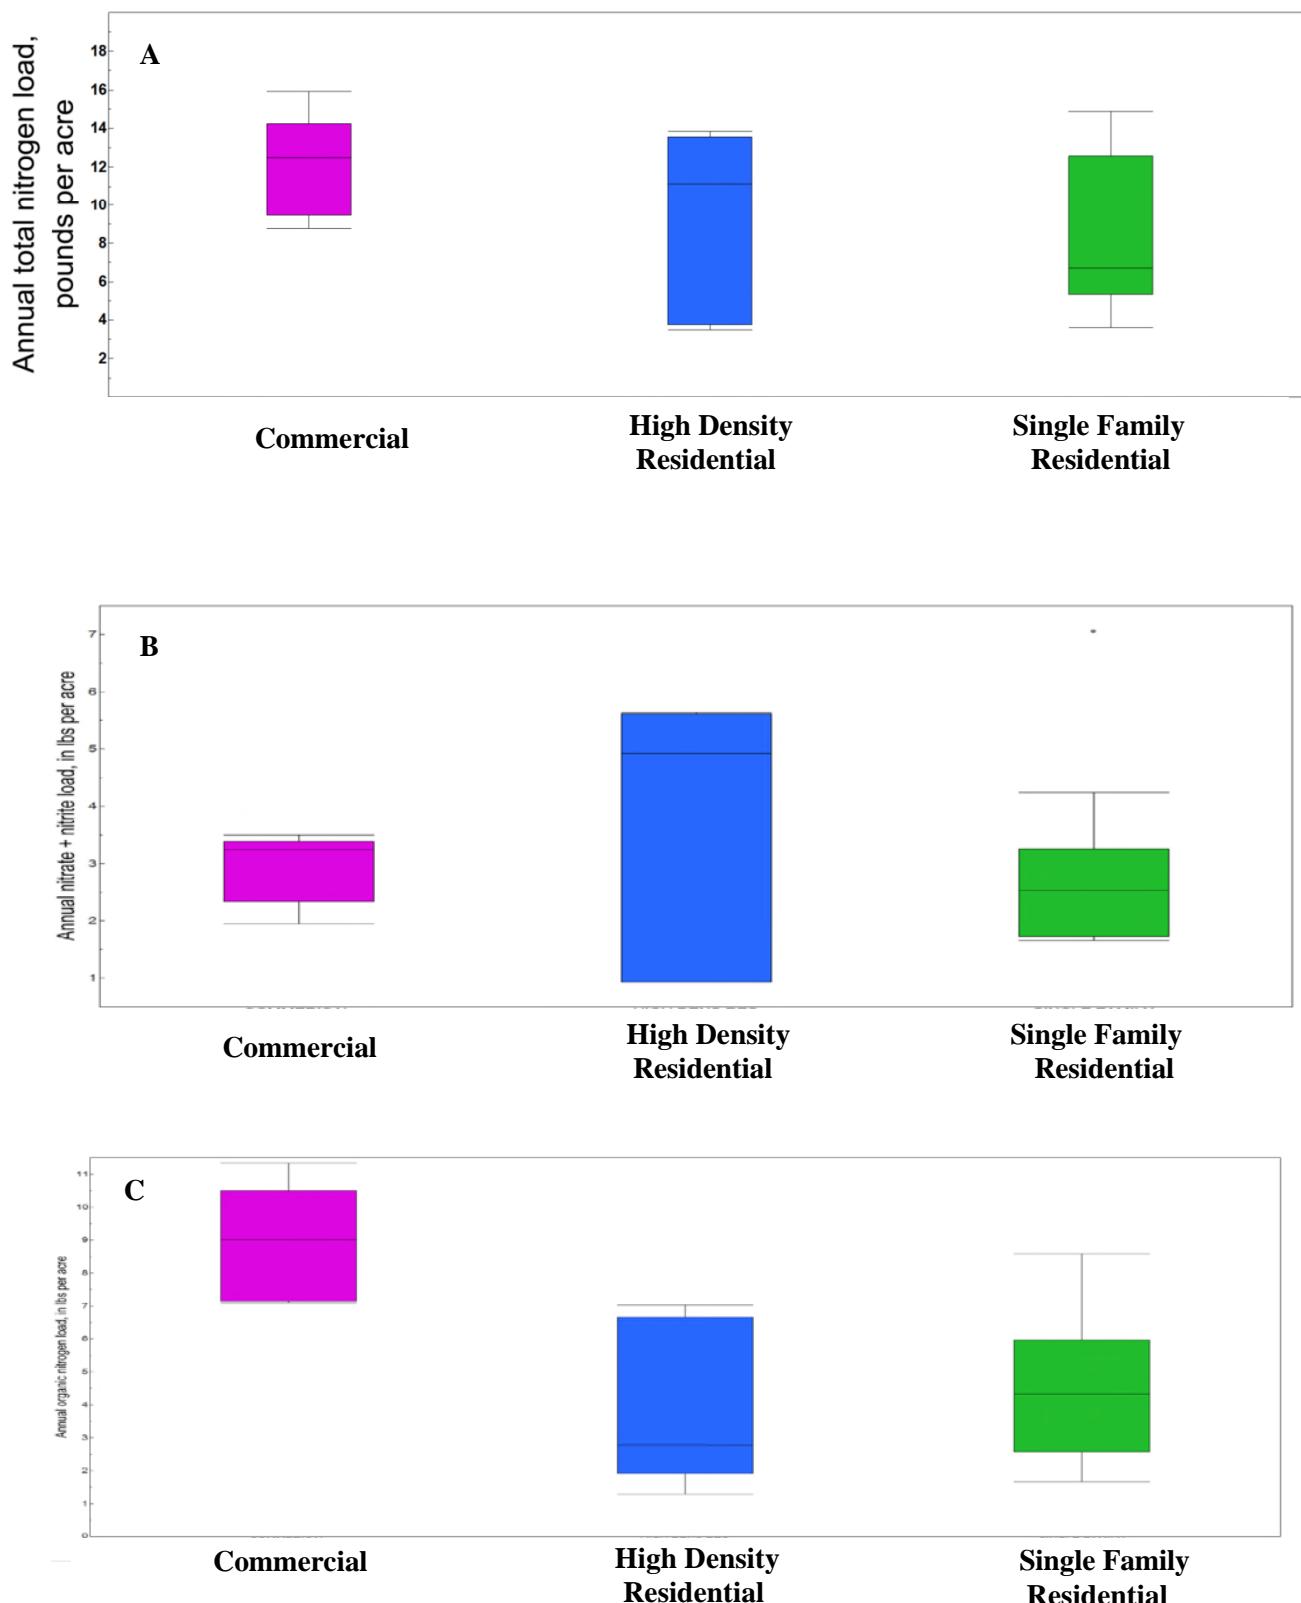
Figure 6. Box and whisker plots of total annual load (lbs/acre) for TN (A), nitrate + nitrite (B), and organic N (C) for the three land use types for water years 2016 and 2017.

compared to the residential land uses (Fig. 6C). For all land use types, the bulk of the TN load was comprised of organic N (Fig. 7).

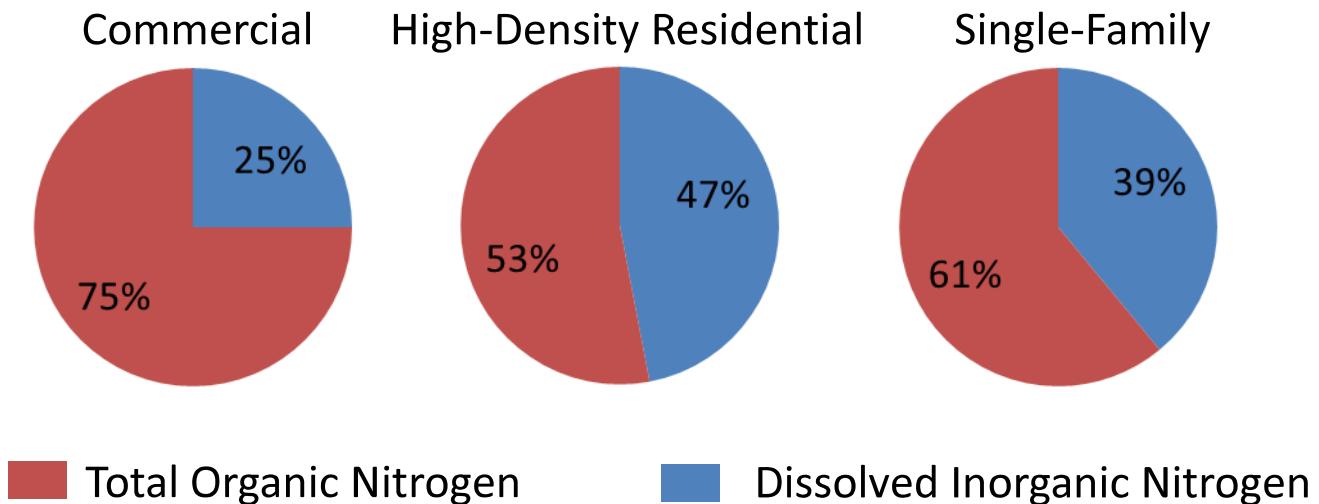
Figure 7. Relative percent of dissolved inorganic nitrogen (DIN) to total organic N for all samples collected.

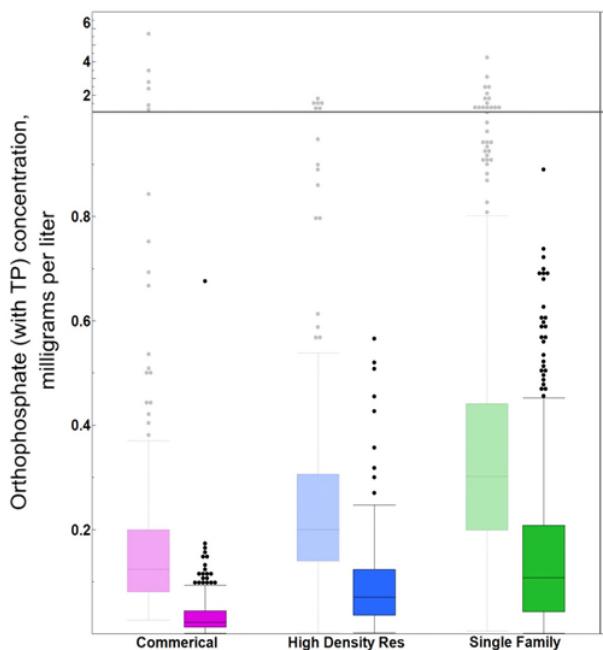
Figure 8. Box and whisker plots of concentrations (mg/L) for TP (left box) and orthophosphate (right box) for the three land use types for water years 2016 and 2017. Outliers (black dots) denote concentrations outside error bars from higher discharge events. Solid line denotes a break in the scale.

TP and orthophosphate concentrations were also significantly different among all land uses, with higher concentrations observed for the single family residential land (Fig. 8). There were no significant differences among land use types for total annual loads for TP or orthophosphate (Fig. 9A & 9B). Similar to TN speciation, the majority of the phosphorus pool was made up of organic or particulate P (Fig. 10).

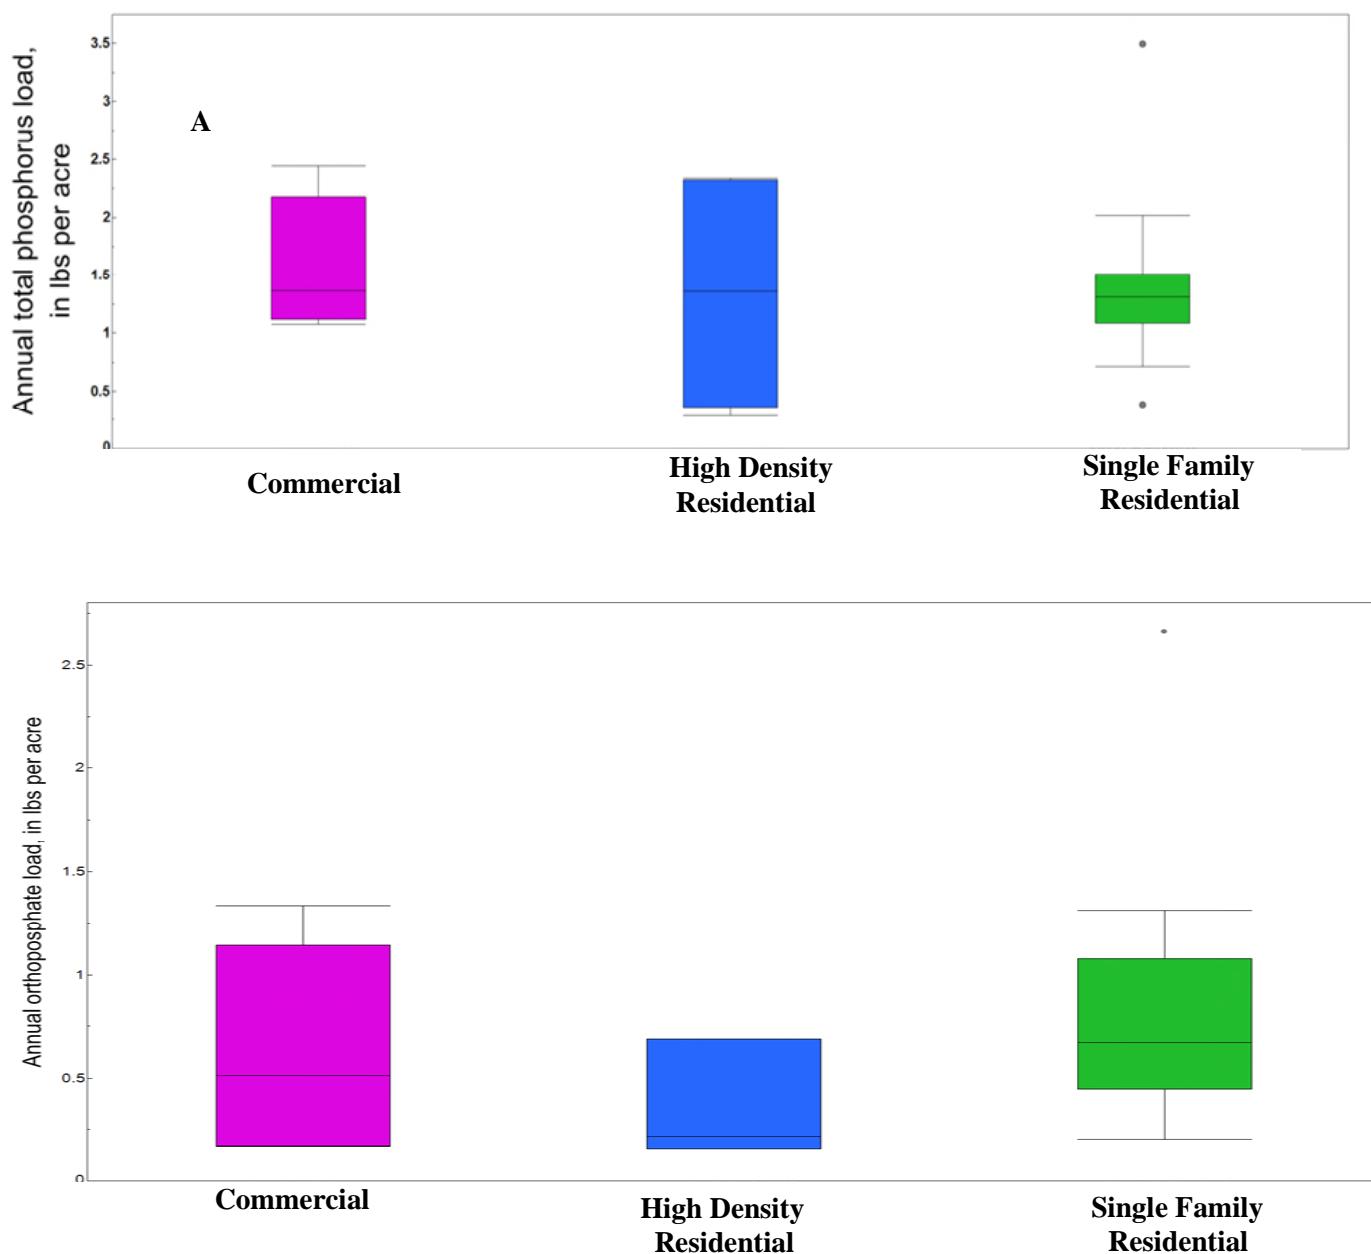
Figure 9. Box and whisker plots of annual total loads (lbs/acre) for TP (A) and orthophosphate (B) for the three land use types for water years 2016 and 2017. Median values are not statistically different.

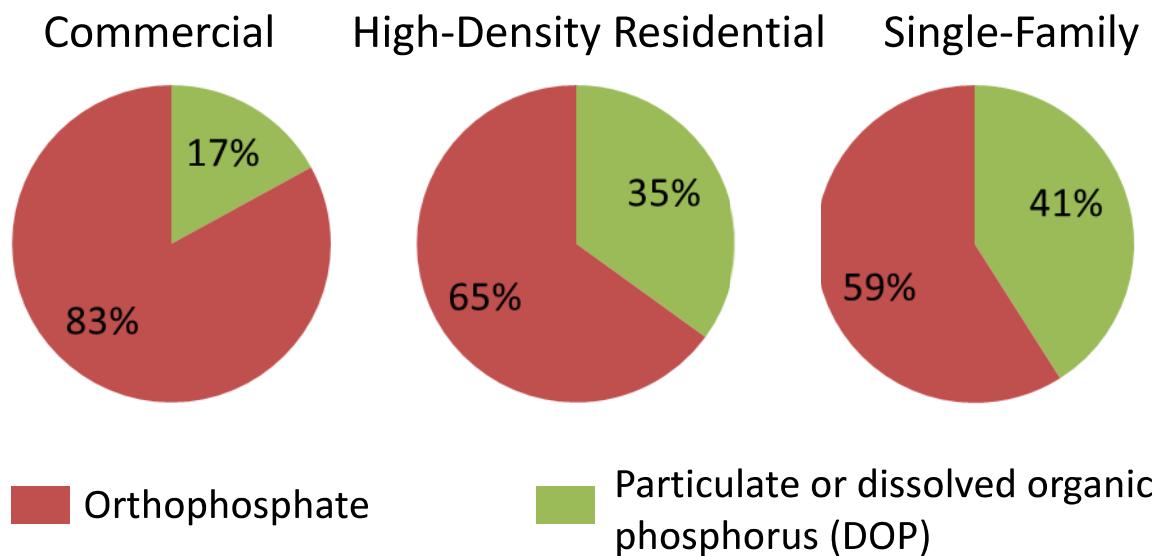
Figure 10. Relative percent of orthophosphate and dissolved organic phosphorus (DOP) for all samples collected.
