GRANBY STREET BIKE LANE CONCEPT

Willow Wood Dr to Admiral Taussig Blvd

THE CITY OF
NORFOLK

CRASH ANALYSIS
MEMO

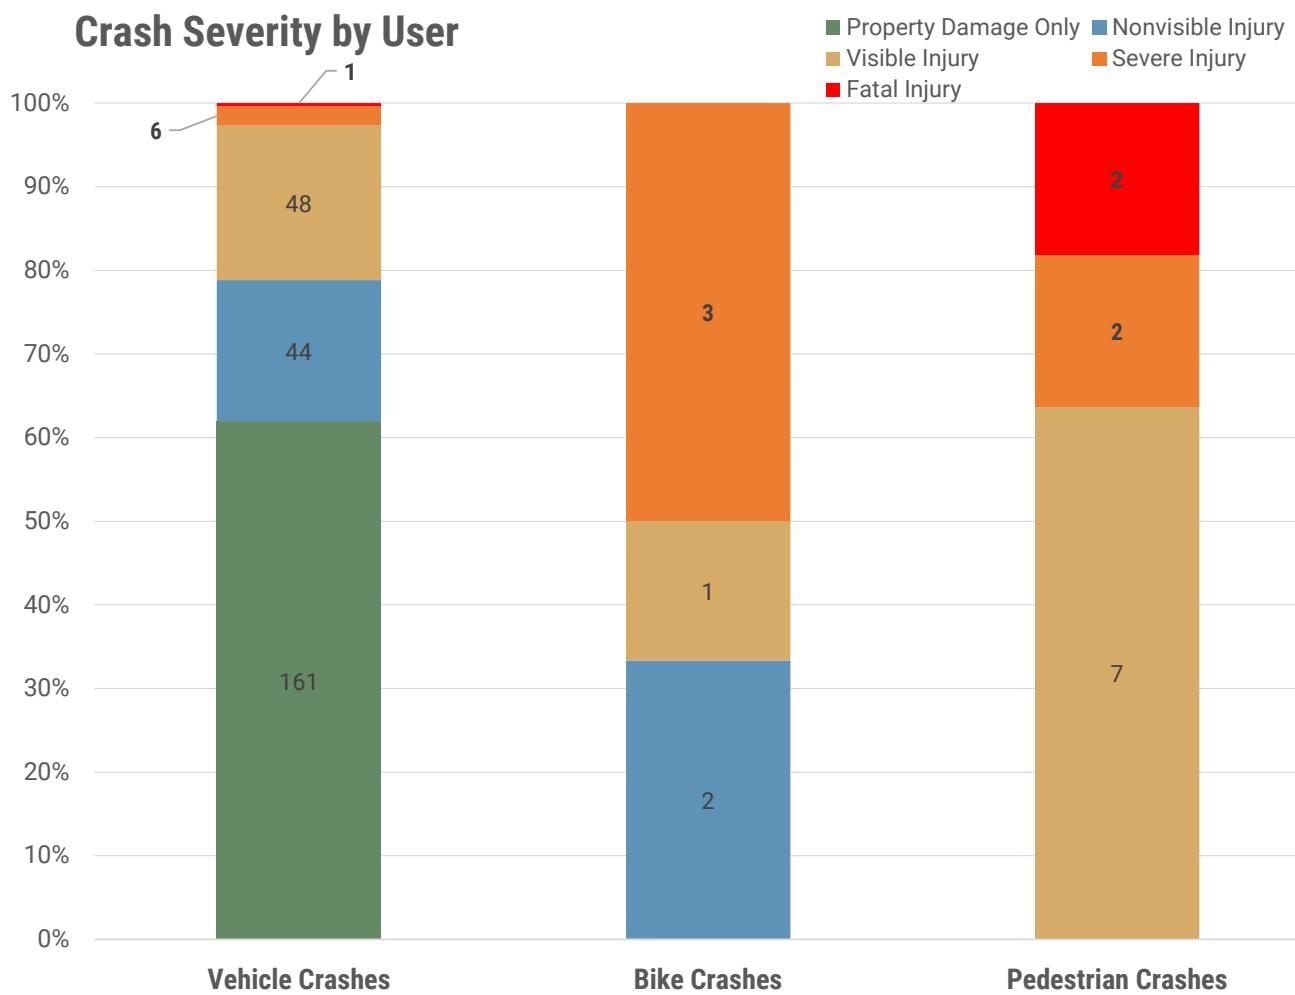
- Bicycle and pedestrian crashes are more severe than vehicle crashes.** As the chart below shows, bicycles and pedestrians suffered much higher rates of fatal and serious injury than vehicles. 2 out of the 11 pedestrian crashes (18%) resulted in the death of a pedestrian, and another 2 pedestrian crashes (18%) resulted in a pedestrian being seriously injured. Half of bicycle crashes (50%) resulted in a cyclist being seriously injured. In comparison, the fatality and serious injury rates for crashes involving only vehicles was less than 0.4% and 21%, respectively.

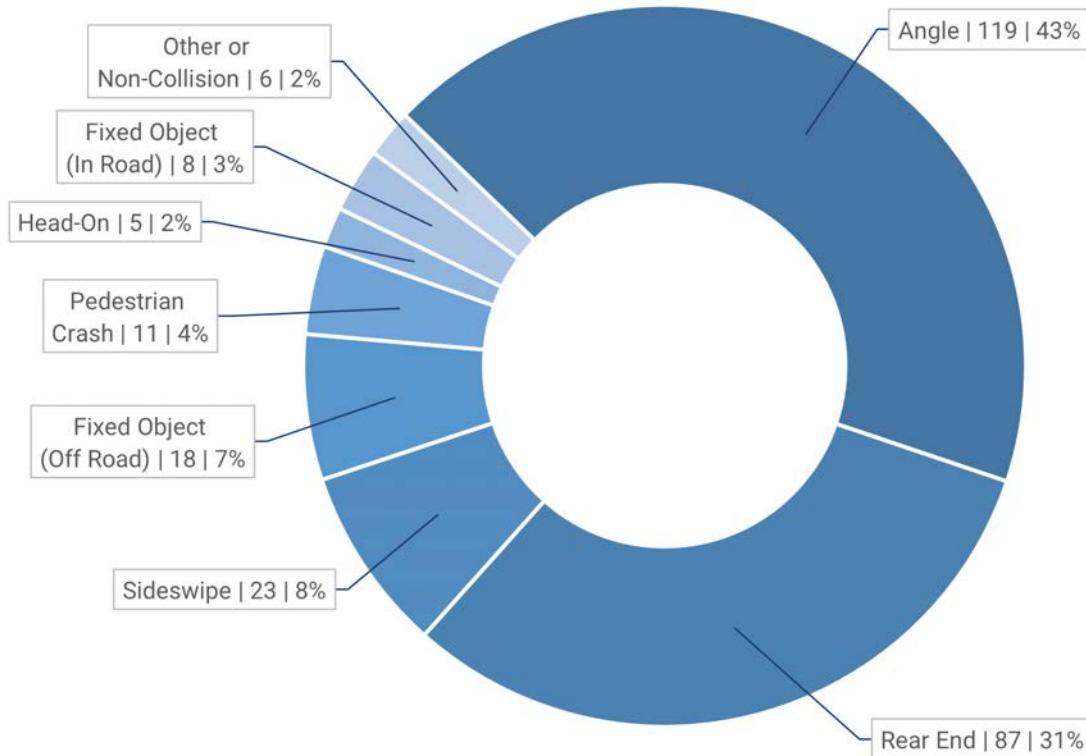
Crash Types

- **Visibility could be a factor in pedestrian crashes.** 7 of the 11 pedestrian crashes occurred at night.
- **Crash types support other data the other key points in this section related to high rates of speeding and intersection conflicts.** The chart below shows that 43% of all crashes were “angle” crashes and 31% were “rear end” crashes. Paired with the other key points in this report, this crash type data suggests that many crashes involved turning movements at intersections (evidenced by the high proportion of “angle” crashes) and speeding and/or distracted driving (evidenced by the high proportion of “rear end” crashes).

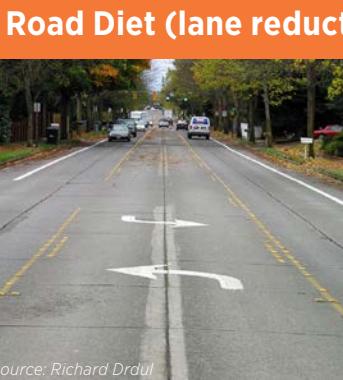
Road Diet (lane reduction)/Lane re-utilization

The conversion of a roadway that features a reduction of travel lanes. A common Road Diet treatment reduces a four-lane road to two lanes with a two-way left-turn lane in the center. Reclaimed pavement from the reduction in travel lanes can be used for a variety of purposes—such as on-street parking, transit access, and bicycle and pedestrian amenities—depending on the community's needs.

CRF: 19% to 47%

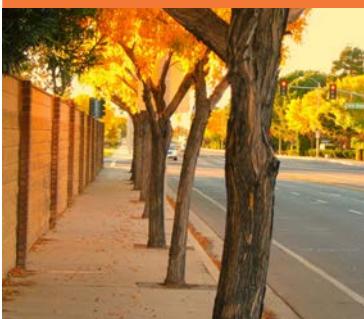
The intentional placement of trees along the outer edge of the roadway to provide additional separation for motorists and pedestrians, reduce the visual width of the roadway, and provide a pleasant street environment for all. Trees should be trimmed up to at least 8 to 10 feet to ensure that sight distances and head room are maintained and personal security is not compromised.

CRF: 38% to 41%

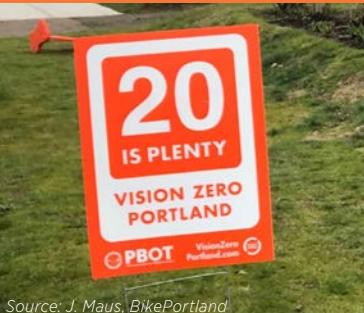
Lower speed limits

A systematic reduction of the posted speed limit to decrease vehicle speeds and improve pedestrian safety. Lowering the speed limit may require enacting state or local legislation.

CRF: 15% to 44%

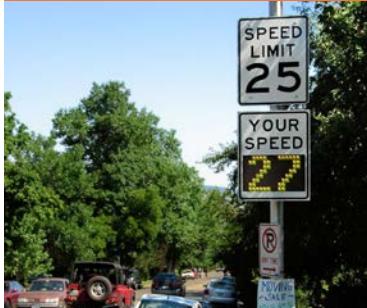
Radar speed display/dynamic speed feedback signs

A sign board, screen, or similar device that is used by police departments and transportation agencies as educational tools to enhance speed compliance enforcement efforts. Speed radar trailers are best used in residential areas and may be used in conjunction with Neighborhood Speed Watch or other neighborhood safety education programs.

CRF: 5% to 7%

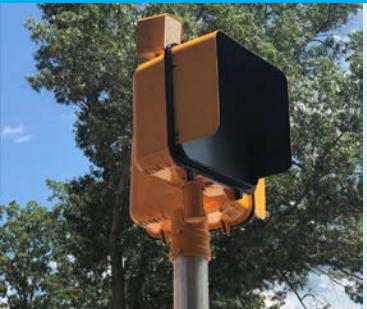
Accessible Pedestrian Signals (APS)

Signals that provide supplemental information in non-visual formats such as audible tones, speech messages, and/or vibrating surfaces. Signal activation should be placed within reach of pedestrians and located where pedestrians wait to cross.

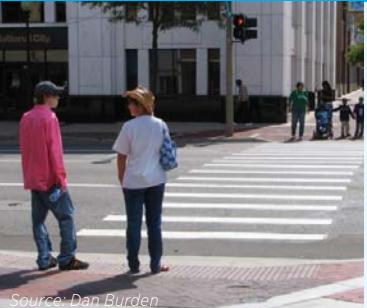
Automatic pedestrian detection devices

A device near an intersection that is able to sense when a pedestrian is waiting at a crosswalk and automatically send a signal to switch to a pedestrian "WALK" phase.

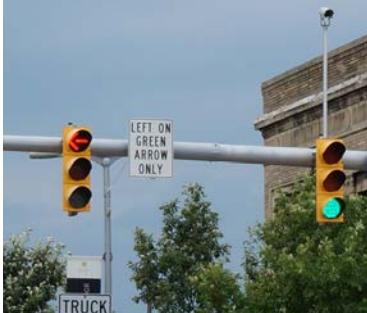
Convert permissive or permissive/protected to protected left-turn phasing

The protected left-turn phase provides a green arrow for left-turning vehicles while stopping both oncoming traffic and parallel pedestrian crossings. This countermeasure can reduce conflicts with pedestrians crossing parallel to vehicle traffic by eliminating competition between vehicles turning left and pedestrians crossing during the concurrent signal phase.

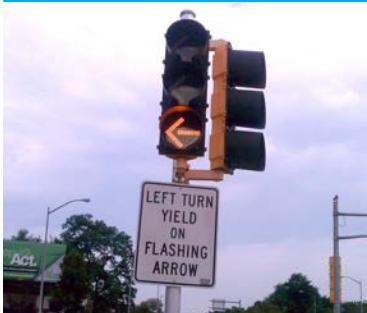
Flashing Yellow Arrow (FYA) for left turns

Provides an alternative signal phasing option where left-turning vehicles are given an extended transition before a red arrow to prevent high speed left turns into small gaps of oncoming traffic. Implementing this modification of permissive left-turn phasing can reduce conflicts with pedestrians crossing parallel to vehicle traffic.

CRF: 0% to 14%

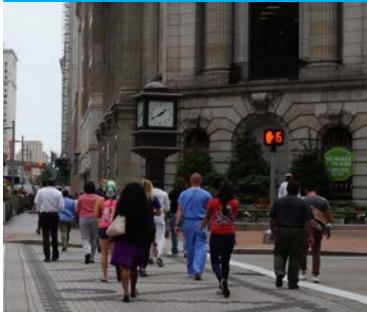
Increase pedestrian crossing time

The extension of the "WALK" interval during the pedestrian signal phase that provides ample time for pedestrians to cross the roadway. The length of the crossing time extension may be dependent on pedestrian volumes, behavior, characteristics (such as age), and mobility.

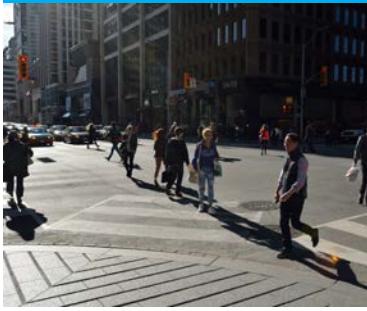
Pedestrian scrambles (Barnes dance)/exclusive ped phasing

A pedestrian phase that is active only when all conflicting vehicle movements are stopped across an approach to an intersection. Intersections deploying this type of signal phase often feature pedestrian crossing markings indicating that pedestrians may walk diagonally across the intersection.

CRF: -10% to 50%

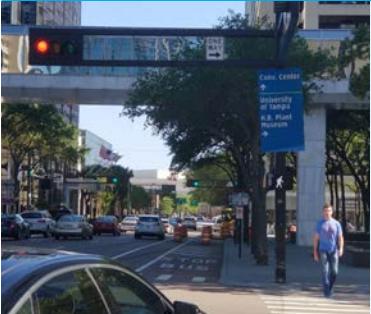
Leading pedestrian interval

A signal timing improvement where pedestrians are given an advance walk signal before motorists get a green signal, providing the pedestrian several seconds to start walking in the crosswalk before a concurrent signal is provided to vehicles. This makes pedestrians more visible to motorists and motorists more likely to yield to them.

CRF: 29% to 45%

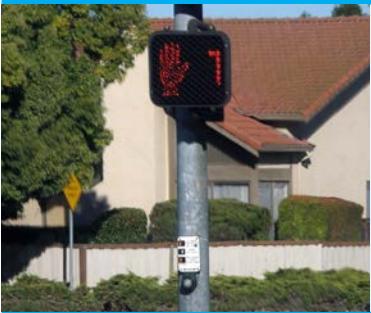
Pedestrian countdown signal

A pedestrian signal head that begins a visible and potentially audible countdown at the beginning of the walk phase or at the beginning of the clearance (i.e., DON'T WALK) interval. The incorporation of a pedestrian countdown signal provides pedestrians with information that has been demonstrated to reduce pedestrian crossings when only a few seconds remain.

CRF: 55% to 70%

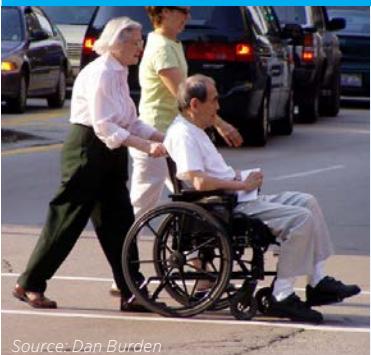
Pedestrian detection to extend crossing time when pedestrian is detected within the intersection

A system that detects the presence of pedestrians in crosswalks to determine whether the pedestrian phase of a traffic signal or beacon should be extended or canceled. Pedestrian detection systems are typically deployed on multilane roads or areas with a population that has difficulty walking. The goal of the system is to reduce waiting times for both pedestrians and motorists while making sure that slower pedestrians can safely cross the street.

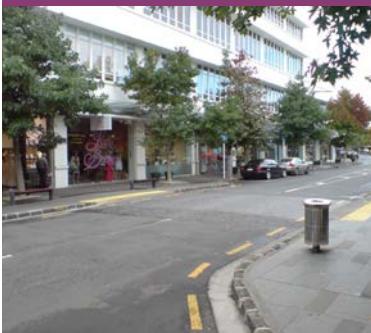
Choker

Curb extensions that narrow a street by widening the sidewalks or planting strips, effectively creating a pinch point along the street and are intended to slow vehicles at midblock locations. Chokers can be created by bringing both curbs in, or they can be done by more dramatically widening one side of the curb at a midblock location. They can also be used at intersections, creating a gateway effect.

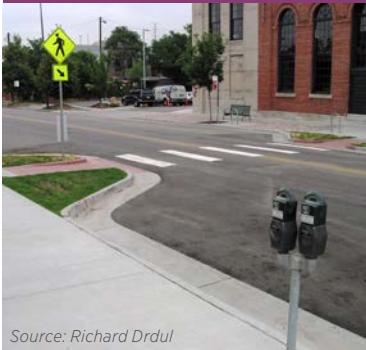
Corner bulb outs and chokers/curb extensions

An extension of the sidewalk or curb line out into the parking lane that reduces the effective street width at a location. Curb extensions improve pedestrian crossings by reducing pedestrian crossing distance and exposure, visually and physically narrowing the roadway, improving visibility for pedestrians and motorists, and allowing space for the installation of a curb ramp. Curb extensions are only appropriate where there is an on-street parking lane.

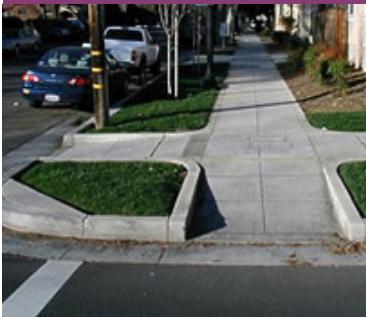
Curb radius reduction

The selection of the smallest practical actual curb radii based on how the effective curb radius accommodates the design vehicle. Smaller radii can improve pedestrian safety by requiring motorists to reduce vehicle speed to make the sharper turns, and shortening pedestrian crossing distances, which thereby improves signal timing.

CRF: -16% to 57%

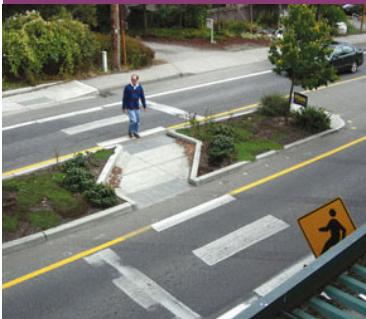
Danish offset (also known as angled median crosswalks and split pedestrian crossover (SPXO))

A "Z"-shaped marked midblock crosswalk that typically crosses four or more vehicular lanes and includes an elongated pedestrian refuge. Pedestrians begin crossing after activating a pedestrian signal at either end of the crossing and use the pedestrian refuge island to orient themselves towards oncoming traffic before completing the crossing. May be installed midblock or at signalized intersections.

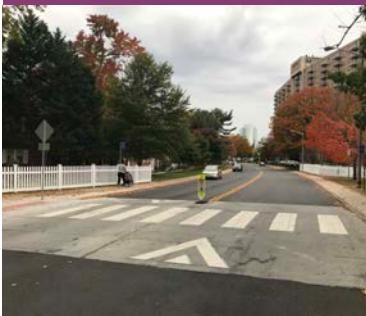
Install raised ped crossing/raised crosswalks/speed tables

A speed table covering an entire intersection or midblock crossing that also functions as a marked crosswalk. The crosswalk is at the same level as the sidewalk, eliminating the need for curb ramps.

CRF: 30% to 45%

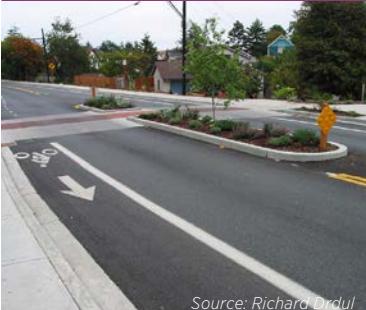
Install refuge islands/raised median

Raised islands placed in the center of the street at intersections or midblock crossings that are intended to help protect crossing pedestrians from motor vehicles. Pedestrian refuge islands allow pedestrians to cross one direction of traffic at a time by stopping in the median refuge to wait for an adequate crossing gap.

CRF: 46%

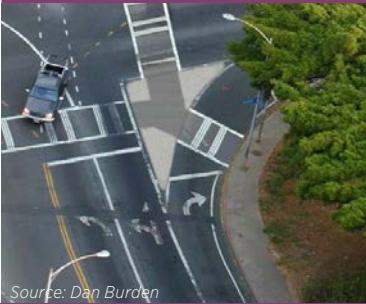
Install/modify design of channelized right turn lane

A raised island or platform that accommodates waiting pedestrians between a travel lane and channelized right turn lane. The crosswalk should be oriented at a 90-degree angle to the right-turn lane to optimize sight lines. The island should include the same accessibility features as the pedestrian refuge island.

CRF: 44% to 60%

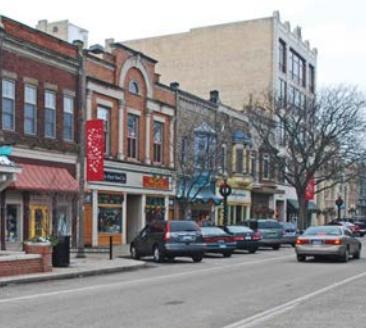
On-street parking enhancements/restrictions

The incorporation of parking on the edge of the roadway to encourage lower roadway speeds and narrow the effective crossing width for pedestrians. When designed appropriately, on-street parking can support a pedestrian commercial environment, generate revenue (if parking is priced), and provide a traffic calming function. However, parking should be prohibited where it obstructs pedestrian and motorist sightlines near intersections.

CRF: 20% to 48%

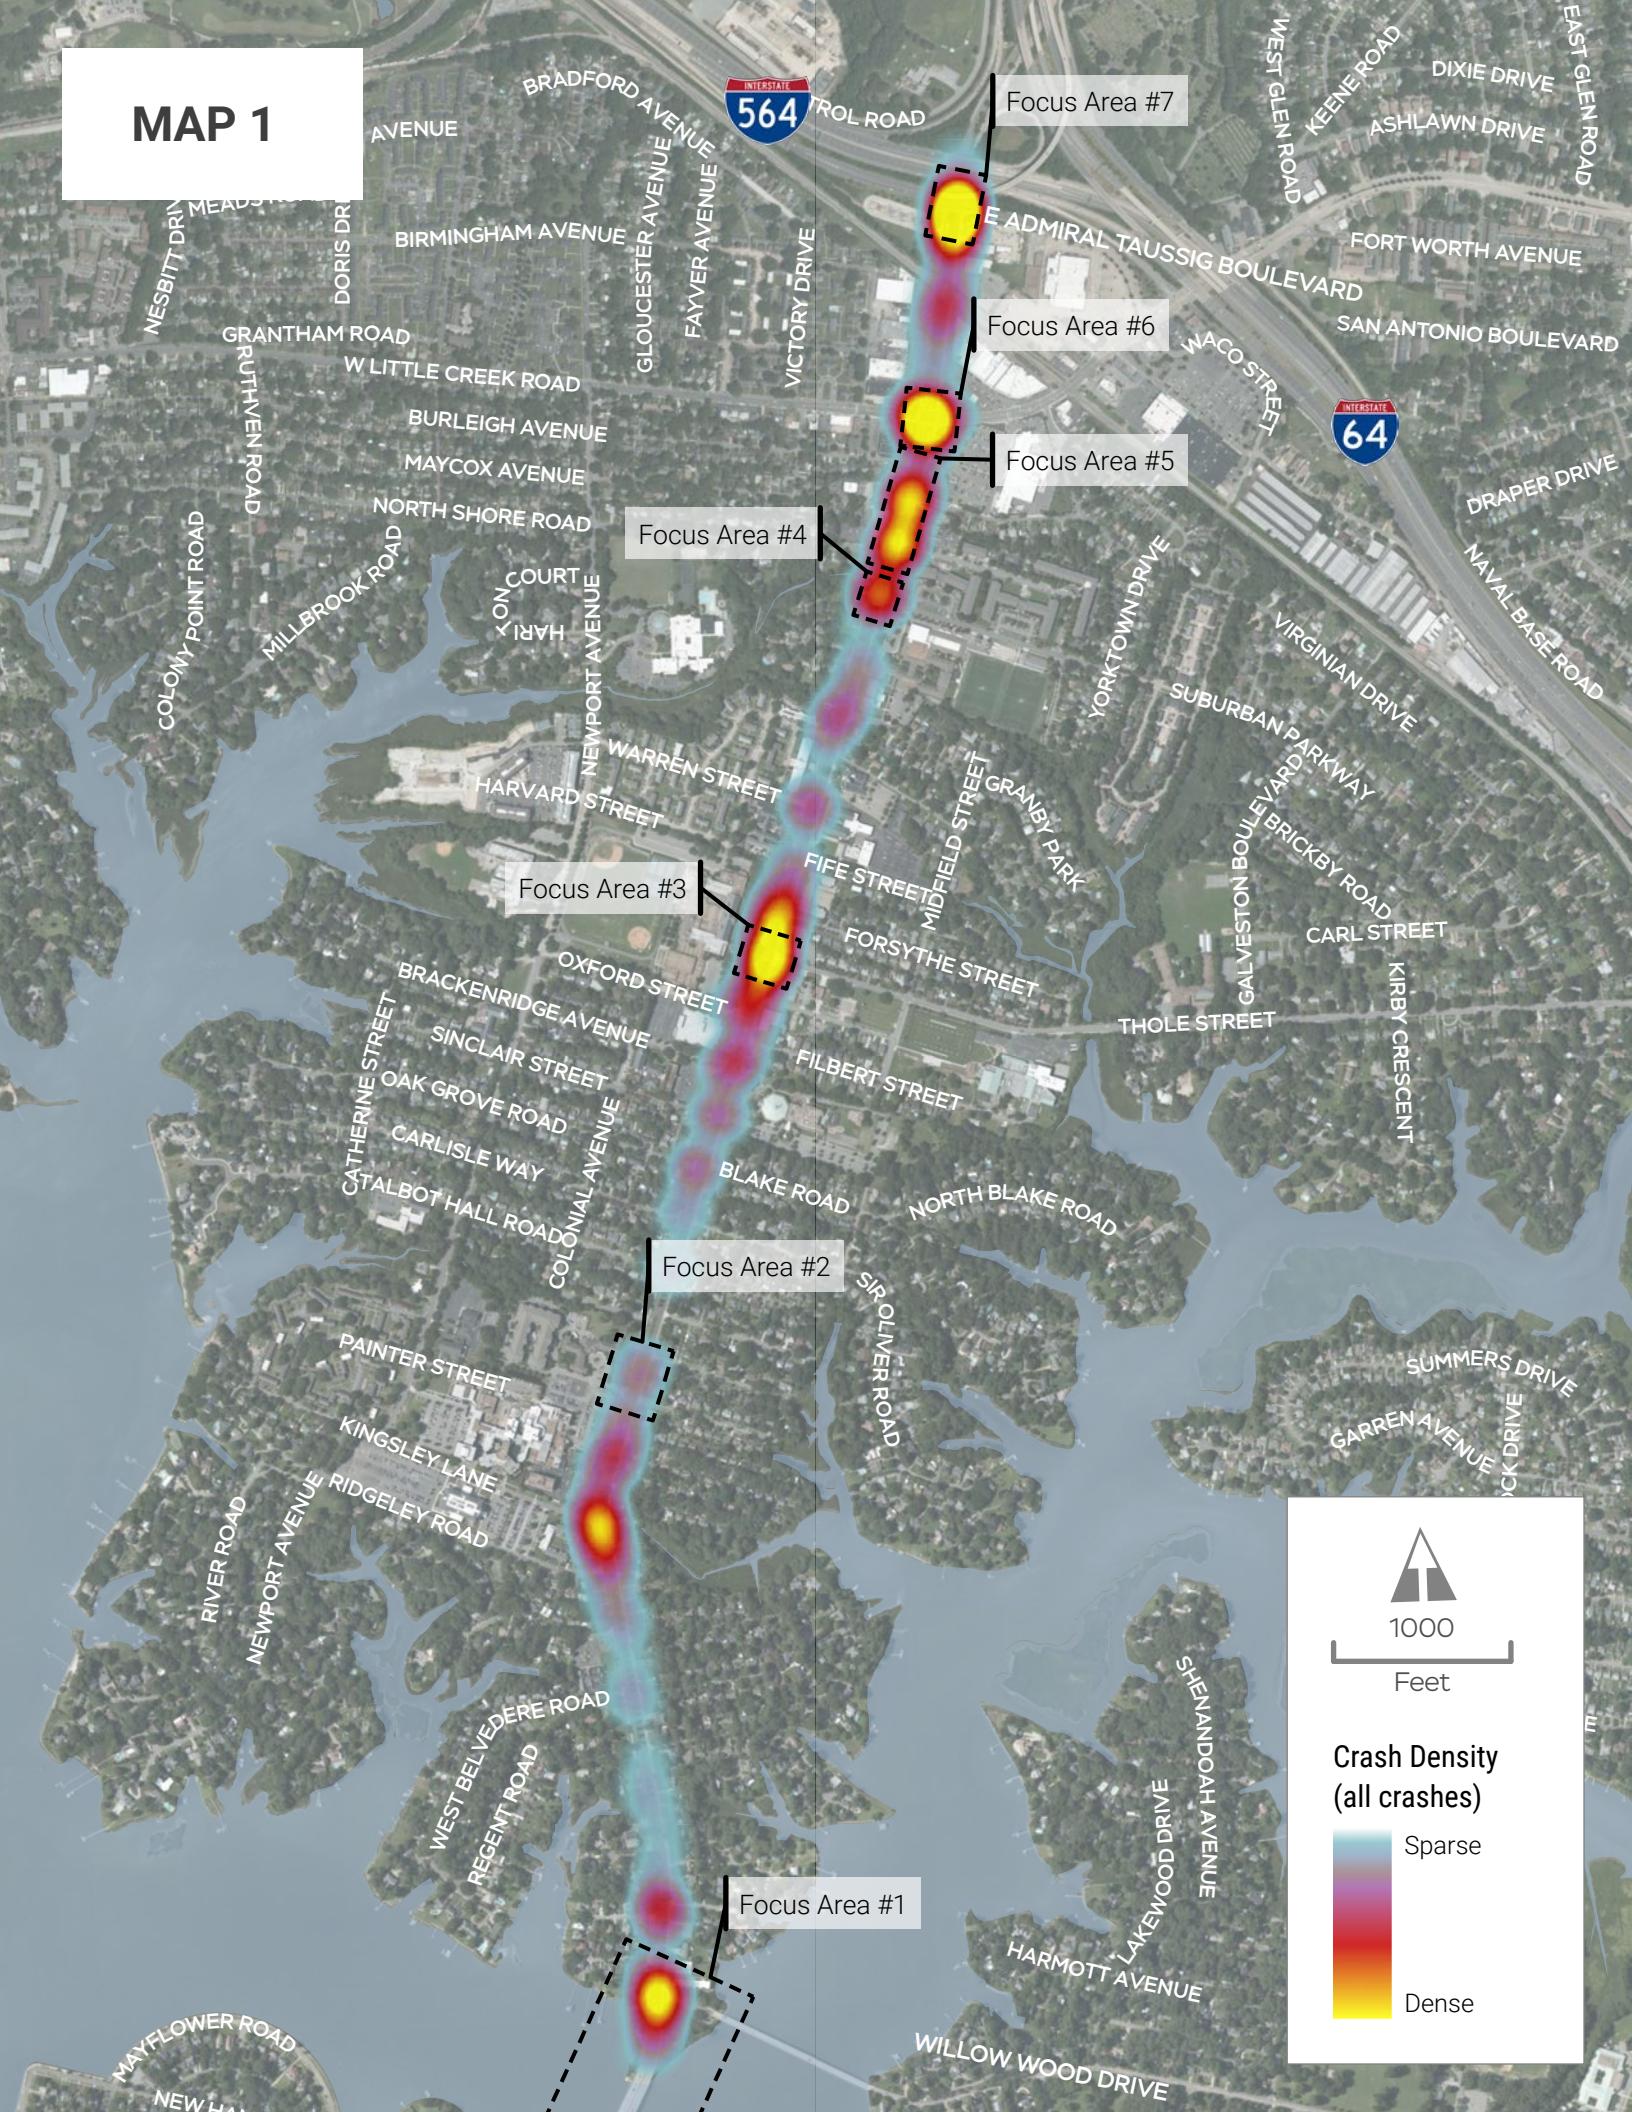
MAP 1

The crash maps on the following pages show where crashes occurred, visualizing the same data crash data along the Granby Street project corridor from 2015-2019 as the Crash Analysis section above. The maps focus on displaying how severe those crashes were, and if they involved bicycles or pedestrians. Map 1 shows the density of all crashes (vehicle, bicycle, and pedestrian) along the corridor. Maps 2 and 3 show the location and severity of bicycle and pedestrian crashes along the corridor, and Map 4 shows the location of all fatal and severe crashes. Maps 5 through 15 provide a detailed look at each part of the Granby Street corridor and displays the location and severity of vehicle, bicycle, and pedestrian crashes while also identifying crashes that involved speeding.

- **Intersections are major conflict points, especially for bicycle and pedestrian crashes.** All crashes involving bicycles and pedestrians occurred at intersections. In addition, 5 of the 6 bicycle crashes occurred at intersections when a vehicle was making a turn. When considering all crashes, the heat map in Map 1 shows that many crashes occurred at larger, busier intersections.
