# COLONIAL AVENUE PEDESTRIAN IMPROVEMENTS

July 2023

The City of Norfolk requested an evaluation and determination of planning-level concepts for pedestrian improvements along Colonial Avenue between W Princess Anne Road and W 27<sup>th</sup> Street to improve pedestrian safety, provide traffic calming, and improve the pedestrian experience along this multi-modal corridor. This project is part of the Complete Streets Initiative.

A field investigation was performed along the project corridor in March 2023. The section of roadway currently consists of eight (8) unsignalized intersections, four (4) signalized intersections, and one rail crossing. The existing intersections are as follows and are illustrated in **Figure 1-1**:

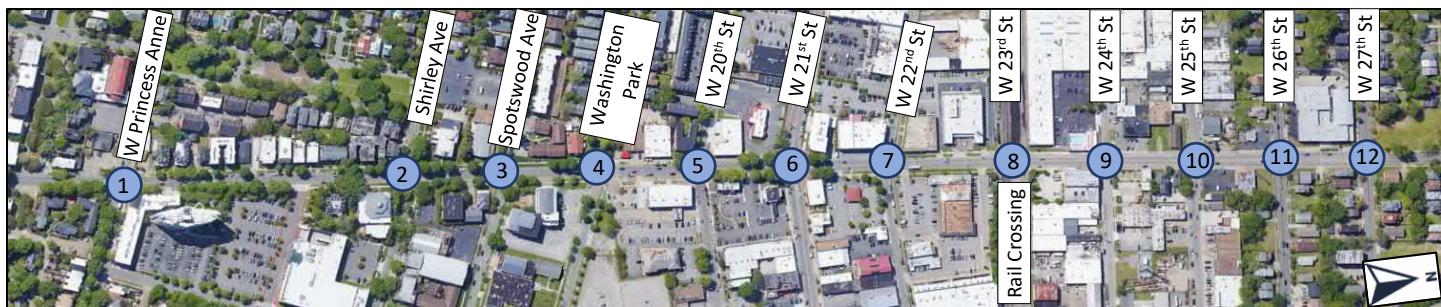
**Figure 1-1. Study Area Intersections**

1. W Princess Anne Road and Colonial Avenue (Signalized)
2. Shirley Avenue and Colonial Avenue (Unsignalized)
3. Spotswood Avenue and Colonial Avenue (Unsignalized)
4. Washington Park and Colonial Avenue (Unsignalized)
5. W 20<sup>th</sup> Street and Colonial Avenue (Unsignalized)
6. W 21<sup>st</sup> Street and Colonial Avenue (Signalized)
7. W 22<sup>nd</sup> Street and Colonial Avenue (Unsignalized)
8. W 23<sup>rd</sup> Street (including Rail Crossing) and Colonial Avenue (Unsignalized)
9. W 24<sup>th</sup> Street and Colonial Avenue (Unsignalized)
10. W 25<sup>th</sup> Street and Colonial Avenue (Unsignalized)
11. W 26<sup>th</sup> Street and Colonial Avenue (Signalized)
12. W 27<sup>th</sup> Street and Colonial Avenue (Signalized)

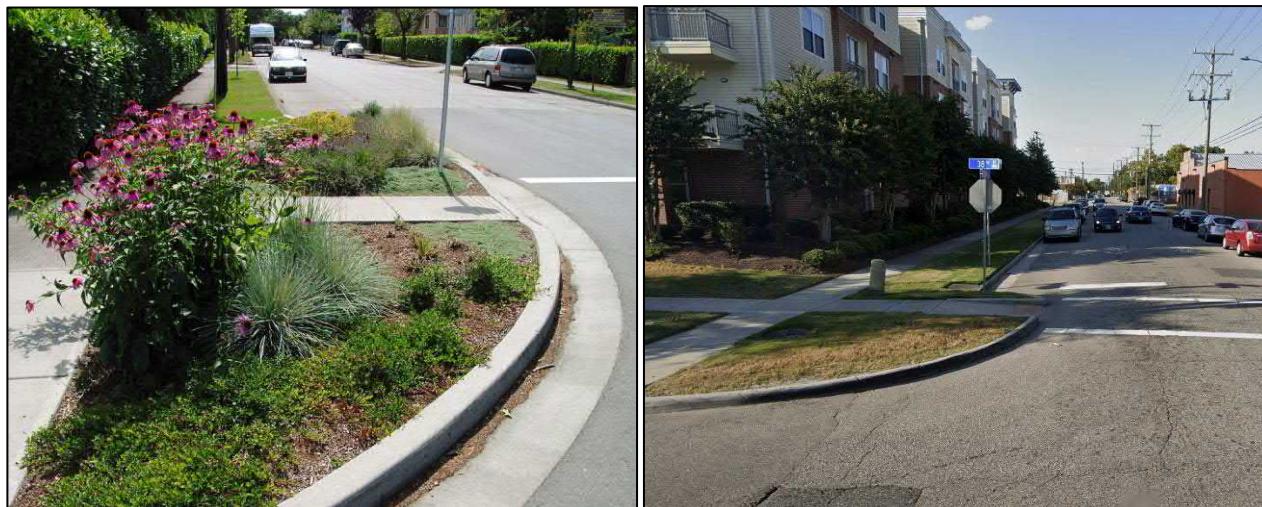
Figure 2-1. Example Bulb-Outs

Bulb-outs (also called curb extensions or bump-outs) increase the space available for pedestrians and narrow the roadway by extending the sidewalk or curb line into the parking lane. The increased space provides additional visibility for crossing and shortens the crossing distance when placed at intersections. The narrow roadways encourage drivers to slow down when approaching the pedestrian crossing and reduces the time pedestrians are exposed to traffic. The bulb-outs can also be transformed into landscaped areas or transit waiting zones. Example bulb-outs are illustrated in **Figure 2-1**. Locations for potential bulb-outs were evaluated in areas with existing on street parking along Colonial Avenue.

Bulb-outs design criteria followed the Curb extension (Bulb-outs) detail in the VDOT Road Design Manual, Appendix B (2). According to VDOT Road Design Manual, bulb-outs should only be used in areas that have on-street parking. Bulb-outs are not applicable to intersections with exclusive right-turn lanes adjacent to the curb or intersections with a high volume of right-turning trucks or buses turning into narrow cross streets. Bulb-outs require a 25' minimum effective radius with space for a 10' crosswalk and 4' minimum stop bar. The offset for the on-street parking is 40' minimum, allowing an 8' parallel parking space.

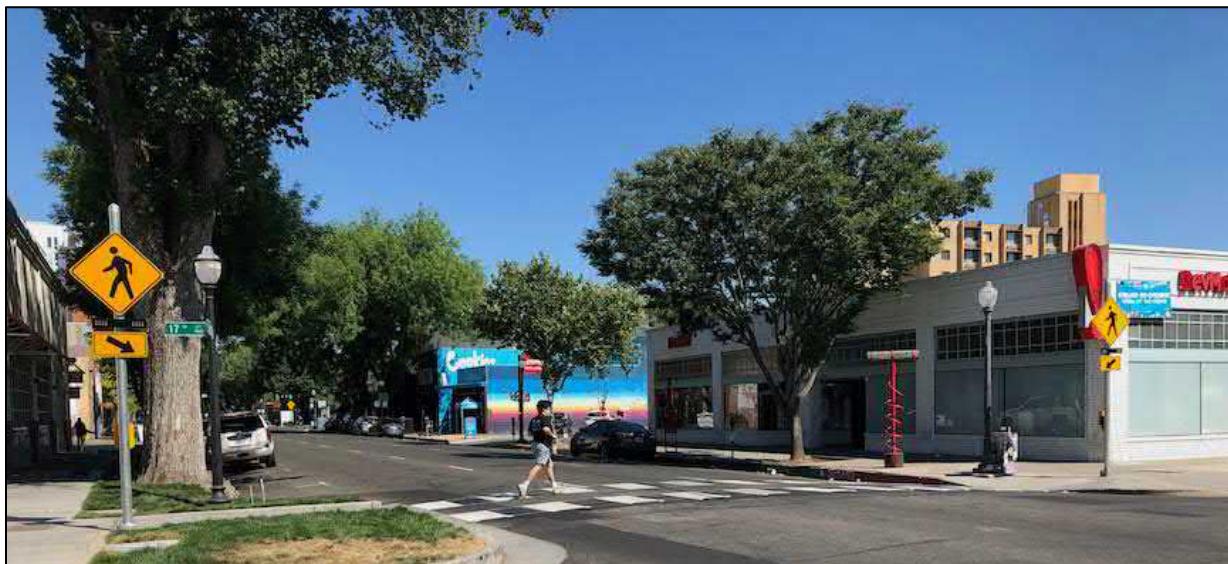
Figure 2-2. Rectangular Rapid-Flashing Beacon (RRFBs)

Due to the moderate pedestrian traffic in the project area and character of the corridor, RRFB treatment options were considered as they are particularly effective at providing enhanced warning to motorists of pedestrian activity. RRFBs are a pair of rectangular yellow indicators that flash to warn drivers of pedestrian crossings when activated. The devices can be pedestrian-actuated via push button or approach automatic sensors. RRFBs can draw power from standalone solar panel units or a traditional power source via wiring. An example of RRFBs is illustrated in **Figure 2-2**.

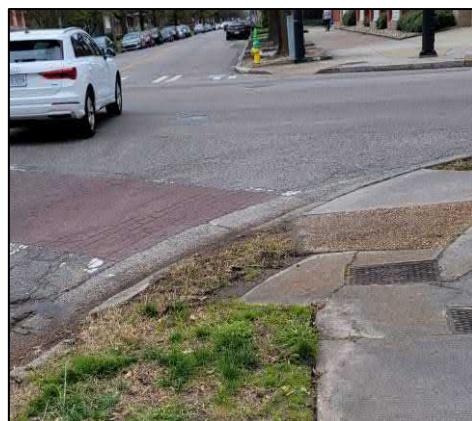
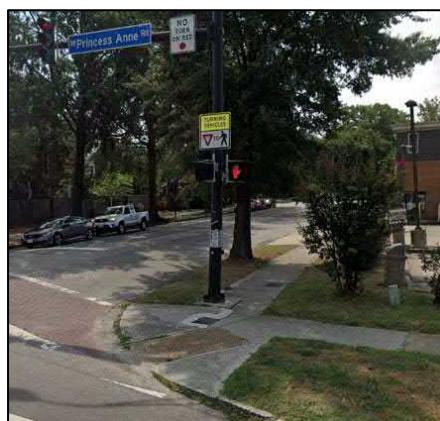
**Figure 3-1. ADA compliance issues in southwest and southeast corners  
W Princess Anne Road intersection**

Marked on-street parking is available on the south leg and unmarked on-street parking is available on the north leg. One curb ramp is overgrown with vegetation on the southeast corner and the mast arm pole in the southwest corner is located within the sidewalk and does not provide three (3) feet of sidewalk clearance as shown in **Figure 3-1**. The City has noted that there are drainage concerns in the southeast corner.

The City of Norfolk distinguished the intersection of W Princess Anne Road as potential for ADA Standard non-compliance. Ramps and pedestrian signal field measurements were obtained through a previous study and evaluated to determine the improvements as part of this project. Previous measurements show that all ramp slopes, all pedestrian signal heads, and all pushbuttons were not ADA compliant. In addition, several of the pedestrian signal poles were located too far from the ramps. The City has since corrected the pedestrian signal heads, signage and pushbuttons. However, the ramps and pedestrian pole locations remain out of compliance.

WSP recommends replacing all existing curb ramps at each corner adding detectable warning surfaces to comply with ADA standards and extending the sidewalk behind the curb ramp to provide adequate landing / sidewalk width for clearance if right-of-way is available, such as in the southwest corner, the sidewalk should be widened to the outside of the signal pole. WSP also recommends connecting storm pipe to a new drop inlet in the southeast quadrant to convey stormwater. The improvements will require manholes to be adjusted to grade.

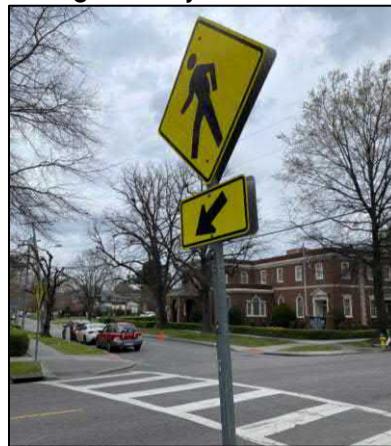
Figure 3-3. Existing Shirley Avenue Crosswalk Signage

Shirley Avenue and Colonial Avenue is a four-leg unsignalized intersection with one-way traffic westbound on Shirley Avenue. A crosswalk is visibly marked on the south leg; however it does not align with the curb ramp on the southeast corner. Dual-sided pedestrian crossing signs are installed on each end of the crosswalk as seen **Figure 3-3**. Crossings are accessible from the adjoining sidewalks by two (2) perpendicular curb ramps with flared sides at each corner. Unmarked on-street parking is available on all legs.

WSP recommends installing bulb-outs at all corners to extend into Colonial Avenue. The installation will require new curb ramps will be installed at all corners to meet ADA standards, re-striping the south crosswalk to align with the curb ramps, replacing existing signs, and relocating existing drainage inlets to the new curb location. Drainage inlets will be impacted on the southeast, southwest, and northeast corners of intersection. Existing storm pipe will need to extend to new inlet locations. The existing fire hydrant in the northeast corner will be required to be relocated with installing the bulb-outs. See **Figure 3-4** for the proposed intersection concept and Appendix A for full concept plans.

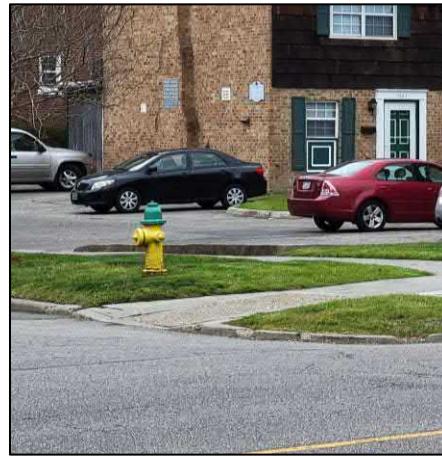
Figure 3-5. Spotswood Avenue Northwest Hydrant

Spotswood Avenue and Colonial Avenue is a four-leg unsignalized intersection with one-way traffic eastbound on Spotswood Avenue. There are no crosswalks or pedestrian signage installed. Crossings are accessible from the adjoining sidewalks by two (2) perpendicular curb ramps with flared sides at each corner. Unmarked on-street parking is available on all legs. Existing curb ramps include detectable warning surfaces and there are no existing drainage structures within the intersection. The relocation of the northwest hydrant is shown in **Figure 3-5**.

WSP recommends installing bulb-outs at all corners to extend into Colonial Avenue, which would require relocating the fire hydrant at the northwest corner and resetting existing signs. All existing curb ramps will be relocated, with detectable warning surfaces included to comply with ADA standards. See **Figure 3-6** for the proposed intersection concept and Appendix A for full concept plans.

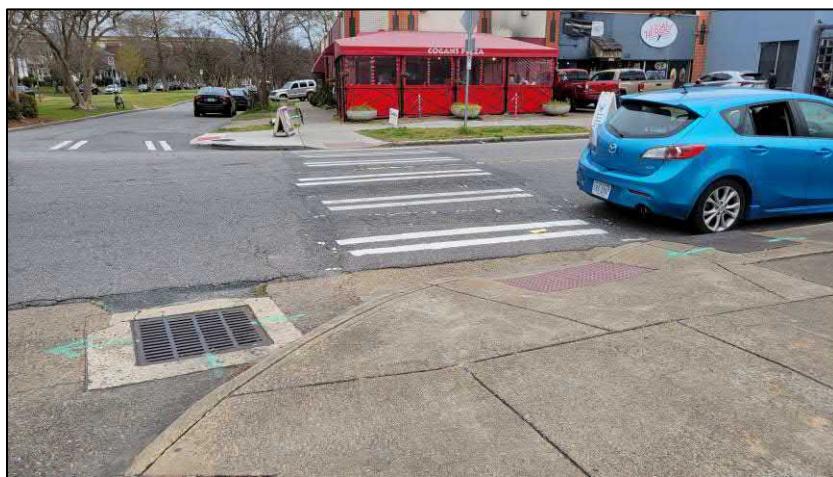
**Figure 3-7. Northeast Washington Park Drainage Drop Inlet**

The existing drop inlet on the northeast corner of Bank of America entrance shown in **Figure 3-7** will be impacted by the proposed recommendations.

WSP recommends installing bulb-outs at all corners to extend into Colonial Avenue. The installation will require relocating the curb ramps, adding an at-grade crossing within the median between Washington Ave and Bank of America driveway for pedestrian refuge to provide a safe path. This crossing would include detectable warning pads on each end of the median cut. The improvements will require re-striping the existing crosswalks to align with the curb ramps, resetting the existing signs, relocating storm drains, and resetting manholes. Impacted inlets on the northeast and southeast corners and the drainage drop inlet will need to be relocated.

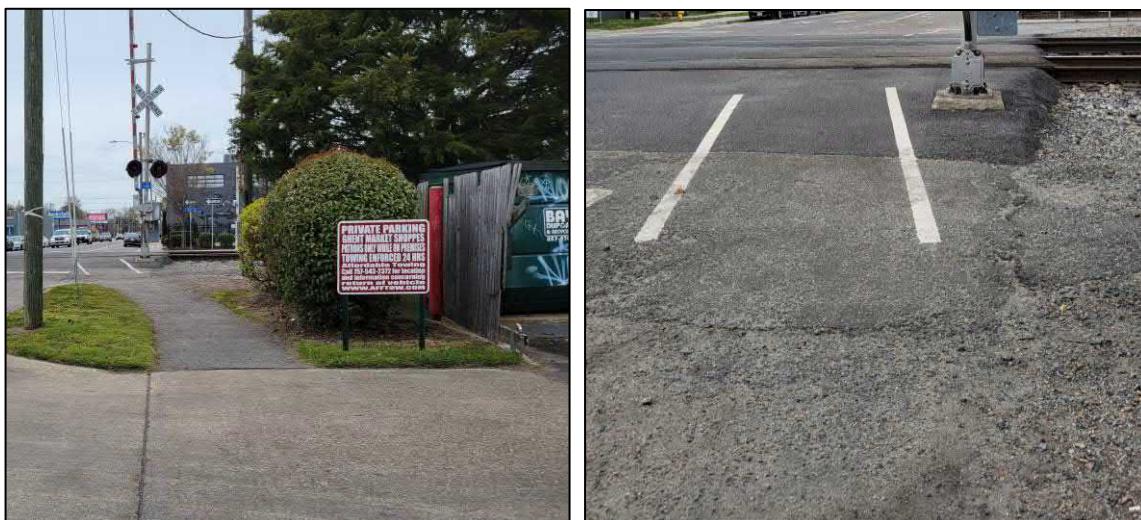
Figure 3-15. Southeast W 23<sup>rd</sup> Street Sidewalk Termination

W 23<sup>rd</sup> Street and Colonial Avenue is a four-leg unsignalized intersection with a two-track rail crossing located just south of 23<sup>rd</sup> Street. There are marked crosswalks installed on the north, east, and west legs. No pedestrian signage is installed. It is noted that a Stop sign located on the northeast corner blocks adequate access of the sidewalk. The sidewalks of the southwest and southeast corners terminate at-grade and transition to marked pathways to cross the tracks northbound and southbound. It is noted the southeast sidewalk has a rough, unfinished surface as shown in **Figure 3-15**. Crossings are accessible from the adjoining sidewalks by one (1) diagonal curb ramp at the northwest corner, one (1) diagonal curb ramp at the northeast corner, directly from the at-grade transition on the southwest corner, and directly from the at-grade transition on the southeast corner.

WSP recommends installing additional signs for the rail crossing (particularly pedestrian-level signs), bike lanes, and Colonial Avenue crosswalk. The Stop sign impeding access on the east leg should be relocated to the inside of the sidewalk for ADA compliance. It is also recommended to improve the existing southeast asphalt/gravel sidewalk with a concrete sidewalk, and detectable warning surfaces be installed at each sidewalk termination as well as on each side of the railroad tracks. Further improvements can be made by installing a crosswalk and pedestrian signs for the south intersection leg as well as finishing the terminated sidewalks as dedicated curb ramps and installing pedestrian stop bars adjacent to the detectable surface or "Stop Here" red-colored pedestrian stop bars. Bulb-outs were investigated and were not considered at this location due to impacts to existing bike lanes and on street parking. See **Figure 3-16** for the proposed intersection concept and Appendix A for full concept plans.

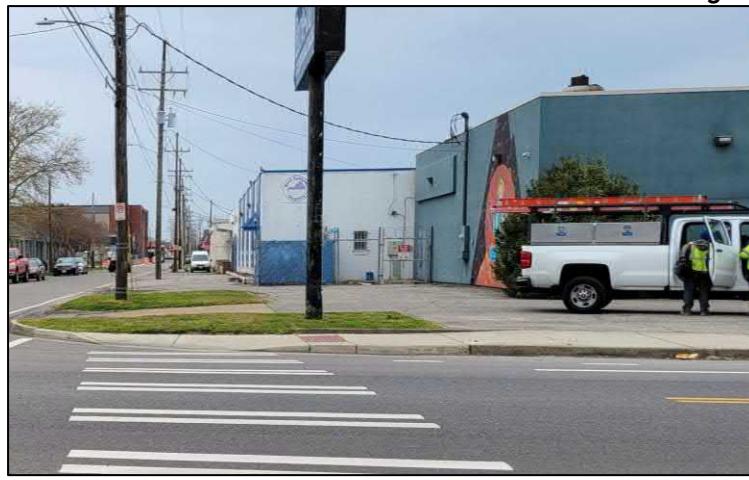
Figure 3-17. Northwest W 24<sup>th</sup> Street Detectable Warning Surface

W 24<sup>th</sup> Street and Colonial Avenue is a four-leg unsignalized intersection. Crosswalks are visibly marked on all four legs and there is no existing pedestrian crossing signage. Dedicated bike lanes run along the northbound and southbound directions, with no existing bicycle lane signage. Crossings are accessible from the adjoining sidewalks by one (1) diagonal curb ramp at each corner. It is noted the detectable warning surface of the northwest and northeast corners are improperly installed as shown in **Figure 3-17**. Marked on-street parking is available on the north and south legs and unmarked on-street parking is available on the east and west legs. No drainage inlets were observed at the intersection.

WSP recommends installing a new detectable warning surface on the northwest curb ramp and removing the improperly installed surface. It is also recommended to install four (4) dual-sided pedestrian signs to be placed at each end of both Colonial Avenue crosswalks. Bulb-outs were investigated and were not considered at this location due to impacts to existing bike lanes and reduction of the number of parking spaces on the street. See **Figure 3-18** for the proposed intersection concept and Appendix A for full concept plans.

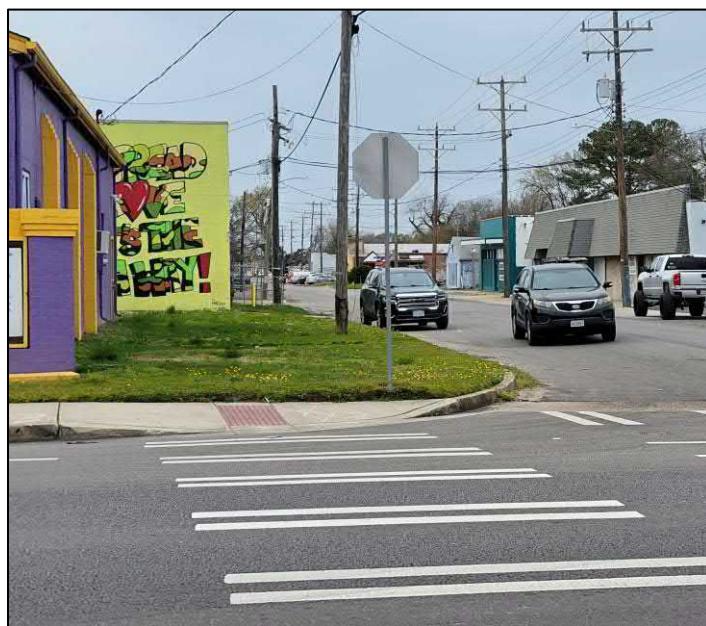
**Figure 3-19. Southwest W 25<sup>th</sup> Street Detectable Warning Surface**

W 25<sup>th</sup> Street and Colonial Avenue is a four-leg unsignalized intersection. Crosswalks are visibly marked on all four legs and there is no existing pedestrian signage. Dedicated bike lanes run along the northbound and southbound directions, with no existing bicycle signage. Crossings are accessible from the adjoining sidewalks by one (1) diagonal curb ramp at each corner. All four ramps were field measured and they do not meet ADA requirements. It is noted the detectable warning surface of the southwest corner is improperly installed as illustrated in **Figure 3-19**. Marked on-street parking is available on the north and south legs and unmarked on-street parking is available on the east and west legs. No drainage inlets were observed at the intersection.

WSP recommends reconstructing all four curb ramps to meet ADA requirements. It is also recommended that four (4) dual-sided pedestrian signs to be placed at each end of both Colonial Avenue crosswalks. Bulb-outs were investigated and were not considered at this location due to impacts to existing bike lanes and reduction of the number of parking spaces on the street. See **Figure 3-20** for the proposed intersection concept and Appendix A for full concept plans.

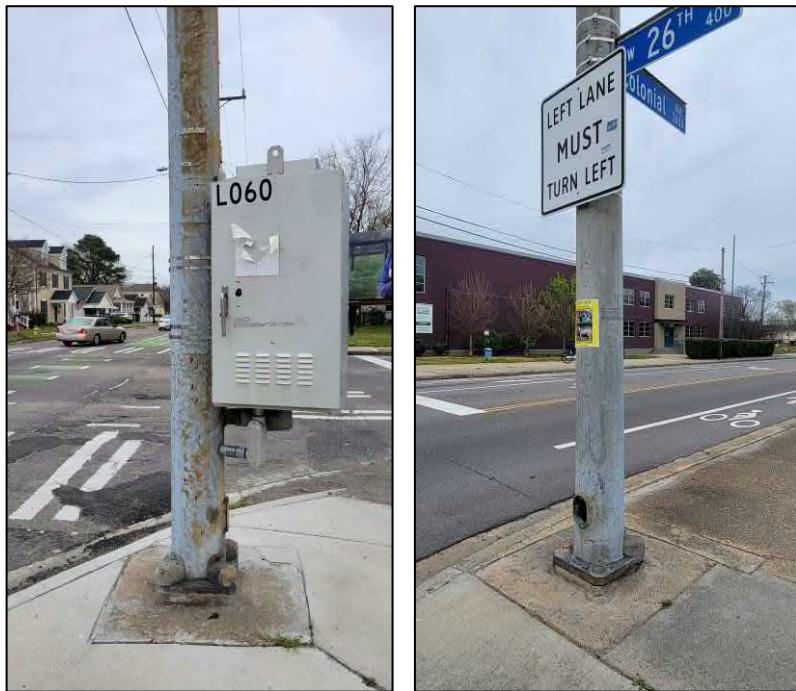
Figure 3-21. W 26<sup>th</sup> Street Existing Signal Poles

The existing signal poles are steel span wire poles and show signs of wear and age, as shown in **Figure 3-21**. There is no pedestrian signal equipment at this intersection.

While the entire signal should be replaced with new mast arm poles at this location, this improvement is beyond the scope of the available budget for pedestrian improvements. In order to provide a benefit to pedestrians that fits within the short-term allowable City funding, WSP recommends placing new pedestrian signals at each corner of the intersection. While retrofitting the existing poles with pedestrian signal equipment may be an option, a structural analysis would need to be completed to assess its' feasibility and practicality. New ADA-compliant pedestal poles should therefore be provided.

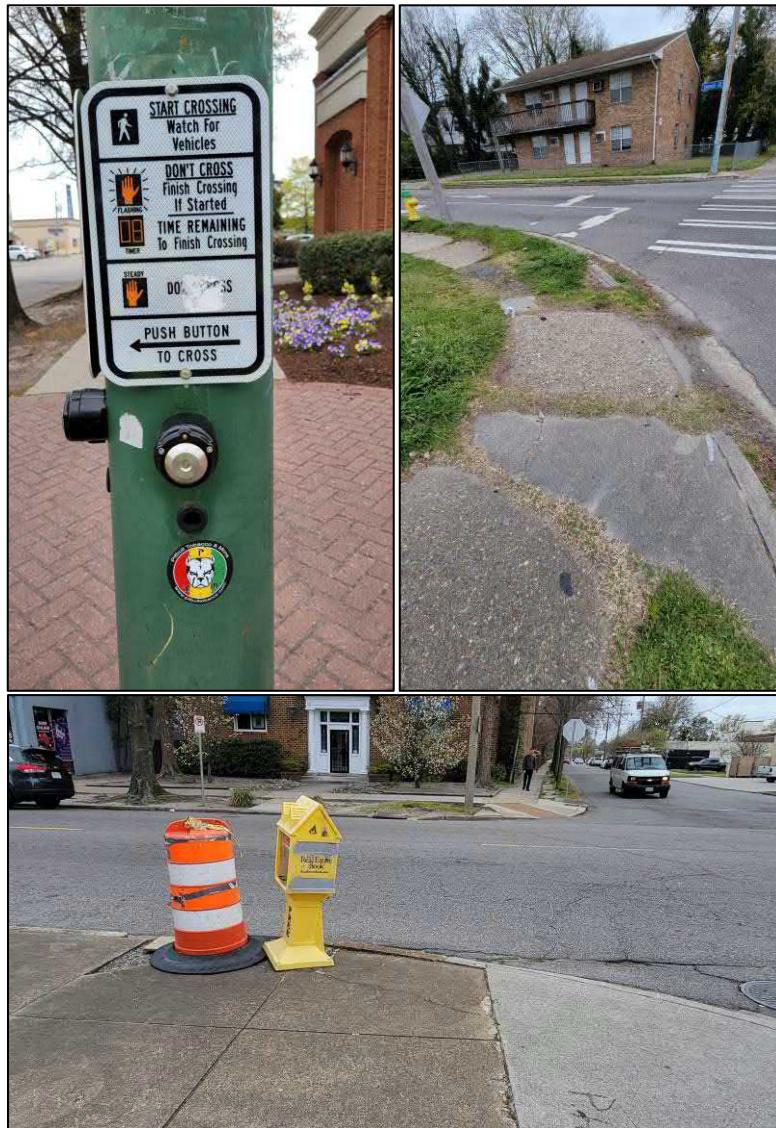
Figure 3-25. General Field Observations

General observations were made regarding improvements to apply throughout the entire corridor. Portions of sidewalk contain uneven slabs or rough surfaces. Segments of curb were either damaged or constructed with fragmented sections of different materials. Signs were defaced with stickers and graffiti. A few of these field observations are illustrated in **Figure 3-25**.

WSP recommends inspecting sidewalks, curbs, and curb ramps to ensure consistent and maintained access is provided throughout the corridor. Ensure walkways are even and free from obstructions. Remove and replace damaged items. Signage should be free of damage and markings. See Appendix A for full plans.
